Evaluations and Recommendations for Stormwater Drainage Improvements within the Shell Point Drainage Basin Area

Beaufort County Shell Point Drainage Improvement Study

2020-0036

Cranston Engineering Group, P.C.
14 Westbury Park Way, Suite 202
Bluffton, SC 29910

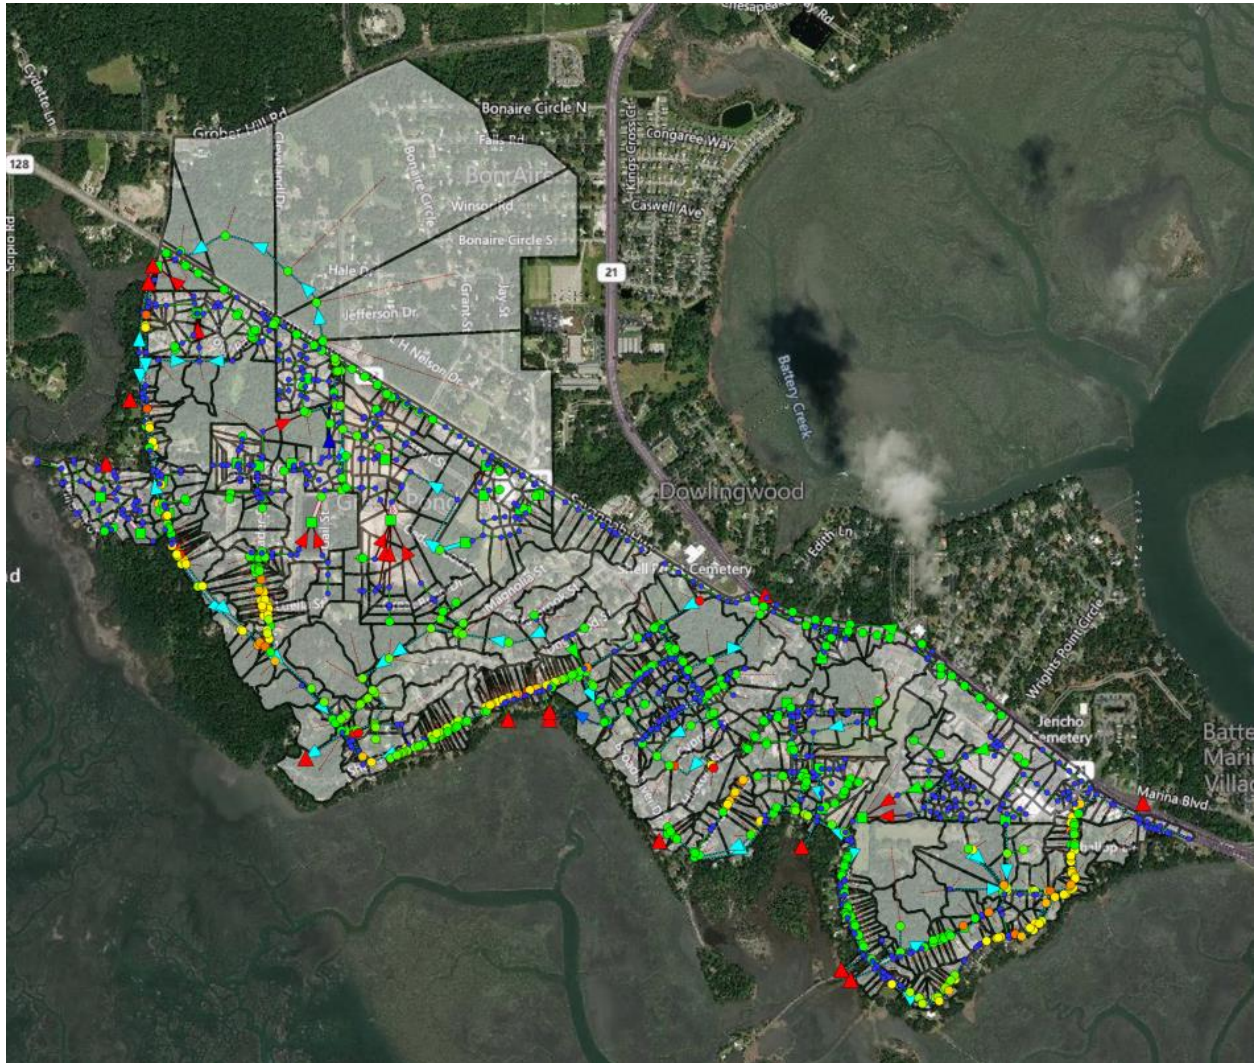
Figure 9: Existing Conditions 25-Year, 24-Hour Storm Results

The existing conditions model results are included in **Appendix C**. It can be seen in these results that the flooding shown in the model is in line with the known problem areas and citizen complaints. This existing condition model provided the base model for the proposed improvements discussed in Section 4 below.

In the figure above, the colored dots represent the hours a given structure, pipe end or ditch point is flooded during the 25-year, 24-hour storm event. The blue dots represent no flooding, the remaining colors represent a flooding period of 0 hours (green) – 24 hours (red). Looking back at Figure 2, the significant flooding is in line with the Beaufort County Connect Citizen Complaint data received at the beginning of the project. The existing conditions model produced approximately 510 structures, ditch points or pipe ends which flooded for an average of 4.77 hours during the 25-year event.

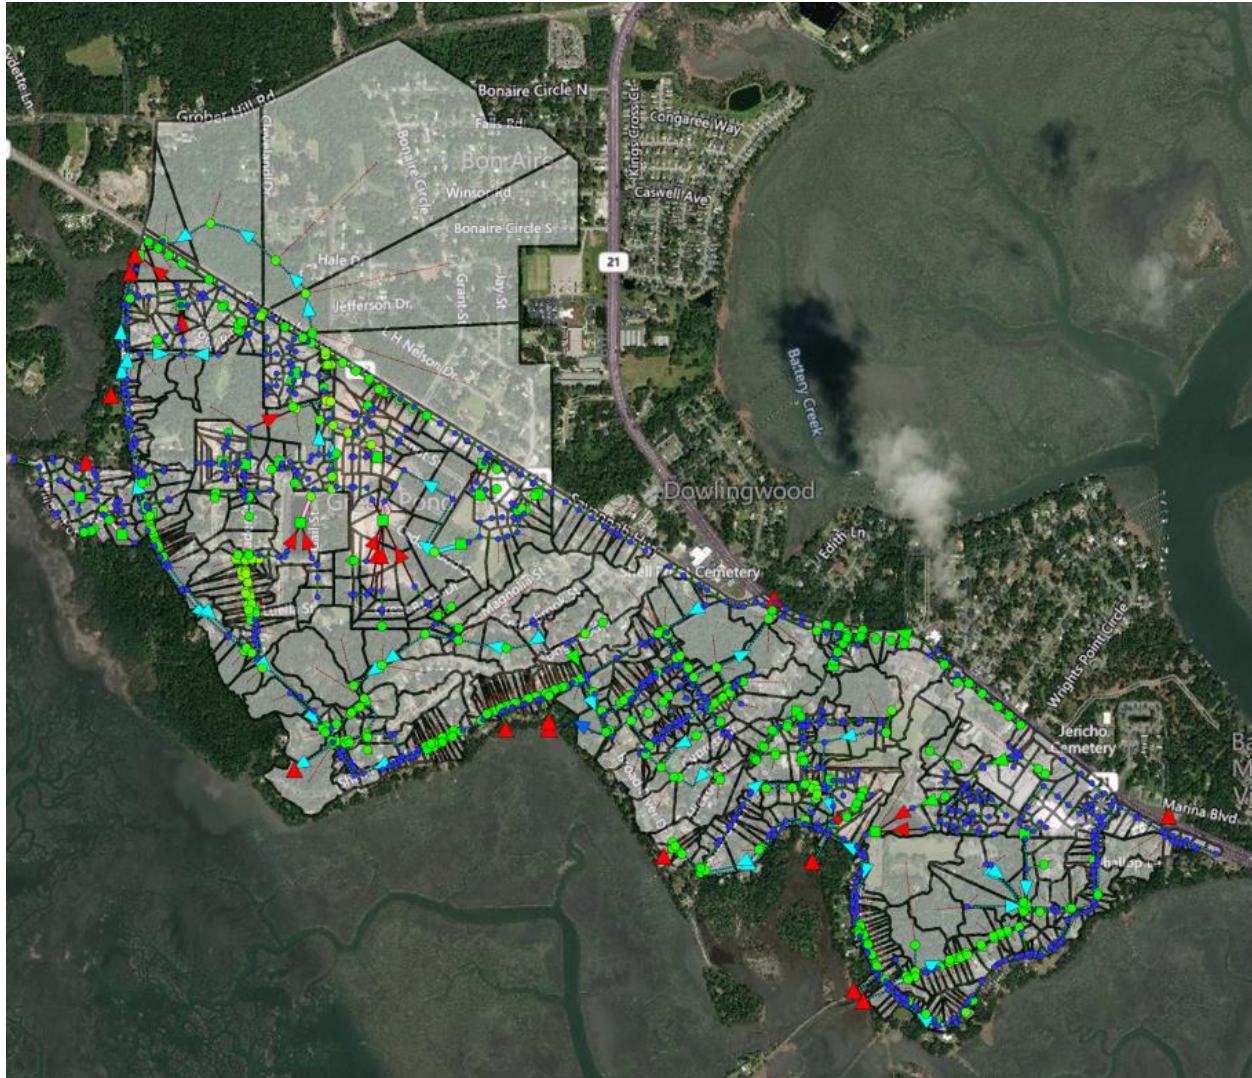
Figure 10: Proposed 25-Year, 24-Hour Storm Results

As seen in Figure 10 below, flooding during the 25-year storm event was significantly through improvements to the problem areas identified areas identified during the existing conditions modeling. Proposed improvements include right of way ditch and culvert cleaning/reshaping, significant channel improvements and stormwater infrastructure improvements, further discussed in Section 4.2. The proposed improvements model reduced the amount of flooded features to approximately 368 (decrease of 142) structures, ditch points or pipe ends which flooded for an average of 0.83 hours (3.94 hour decrease) during the 25-year event.

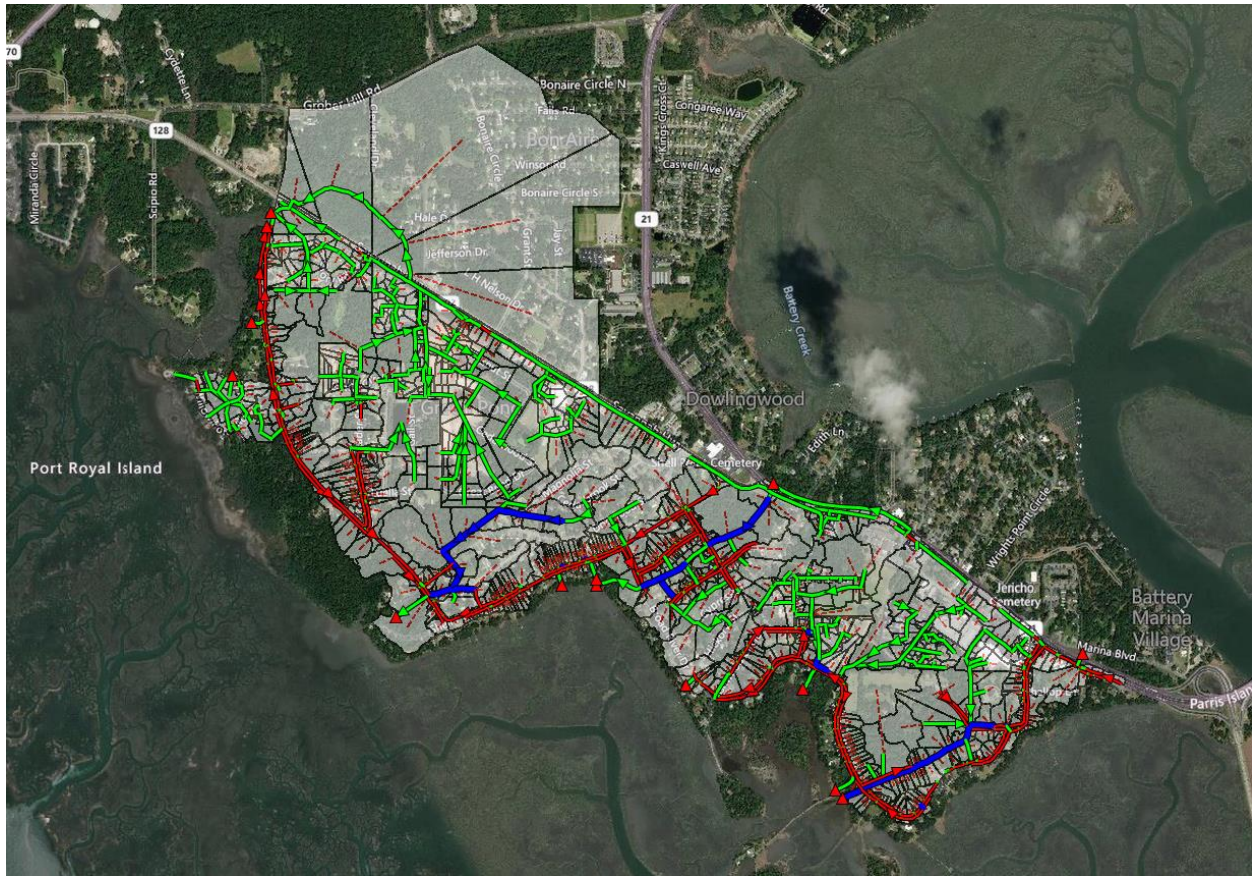
Figure 11: Proposed Improvements

In the figure above, the green represents existing infrastructure not being improved or maintained, the red signifies recommended ditch cleaning and infrastructure maintenance and the blue represents significant improvements. These significant improvements include major channel modifications and 8 road culvert crossings.

The section provides a brief summary of the proposed improvements, detailed information can be found in **Appendix D**. Localized flooding primarily occurs along low areas of the roads and adjacent properties during large storm events at high tides. The following improvements are proposed to alleviate nuisance flooding in the Shell Point area. Figure 11 shows the areas of the proposed improvements. Following a meeting with Beaufort County Public works, improvement prioritization will be provided.

Right of way Ditch Cleaning – 41,163 LF
Right of way Culvert Cleaning – 4,372 LF
Channel Improvements – 6,990 LF
Storm Infrastructure Improvements – 985 LF

1. Baynard Road to Cedarbrook Street Upsizing
 - a. 3 Culvert Crossing replacements (Baynard Rd, Dogwood St, Magnolia St)
 - b. Ditch reshaping (approx. 700 LF)

4. Hamrick Drive Outfall System Upsizing
 - a. 1 Culvert Crossing replacement (Broad River Dr)
 - b. Ditch reshaping (approx. 500 LF)
 - c. Easement Acquisition required along Hamrick Drive

- i. Potential WQ Regional BMP area
5. Shell Point Rec. Park
 - a. 4 Culvert Crossing replacements (Shell Point Rec Park Access, Broad River Drive, 2 private driveway culverts)

- b. Ditch reshaping (approx. 150 LF)
