# STORMWATER MANAGEMENT SYSTEM CONDITION ASSESSMENT

## Shell Point Drainage Improvement Program

Beaufort County Stormwater  
120 Shanklin Rd  
Beaufort, SC 29906

April 2023

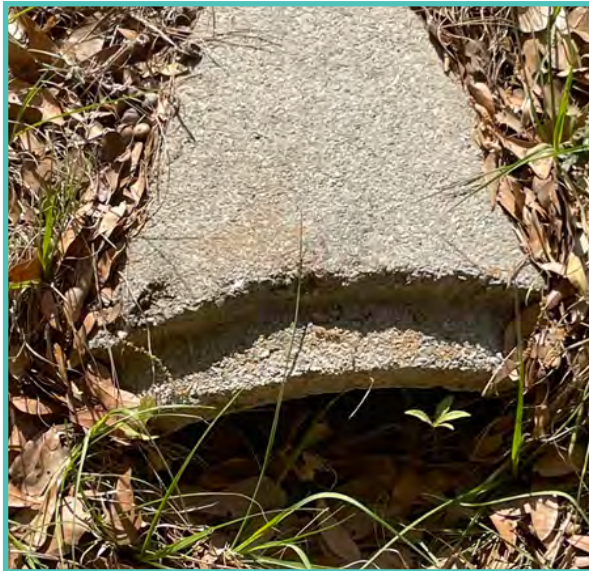
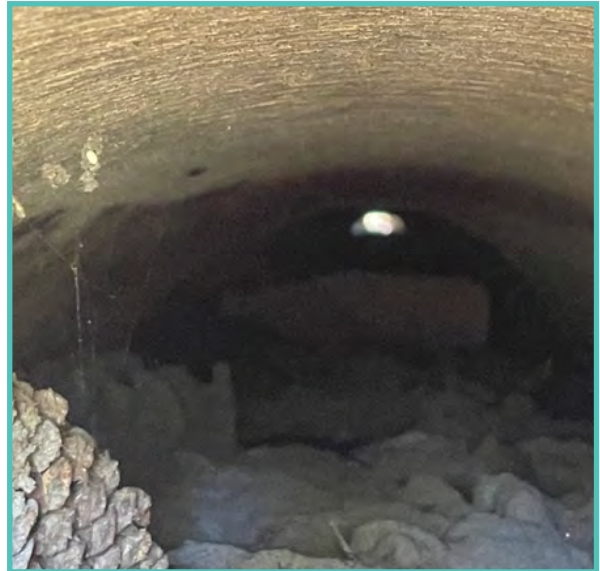
Performance Condition: Poor

Structural Condition: Unknown

Reason: Could not inspect due to sediment.

Recommendation: Clean and reinspect.

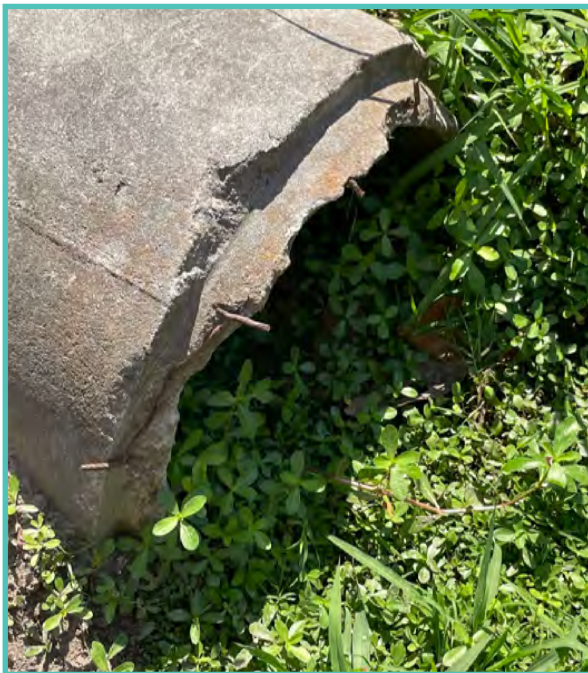
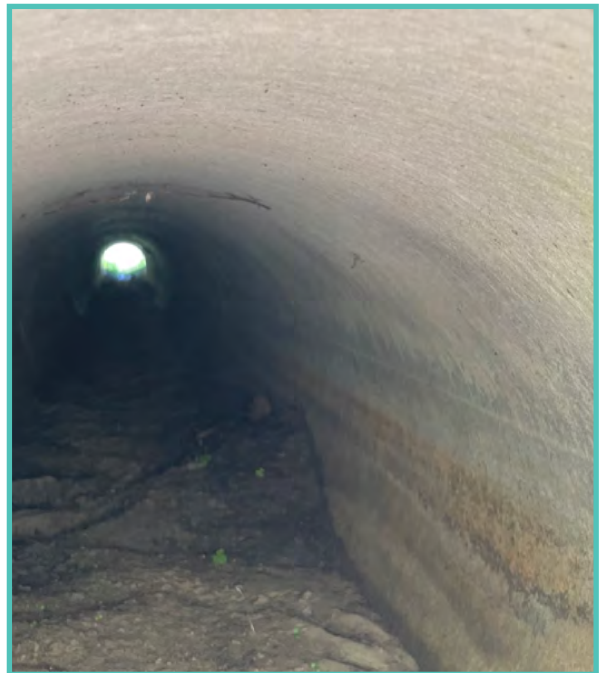
Crossline Pipe Inventory ID: **59368**

Performance Condition: Poor

Structural Condition: Fair

Reason: Broken end bell exposed reinforcement.

Recommendation: Clean and reinspect in 5 years.

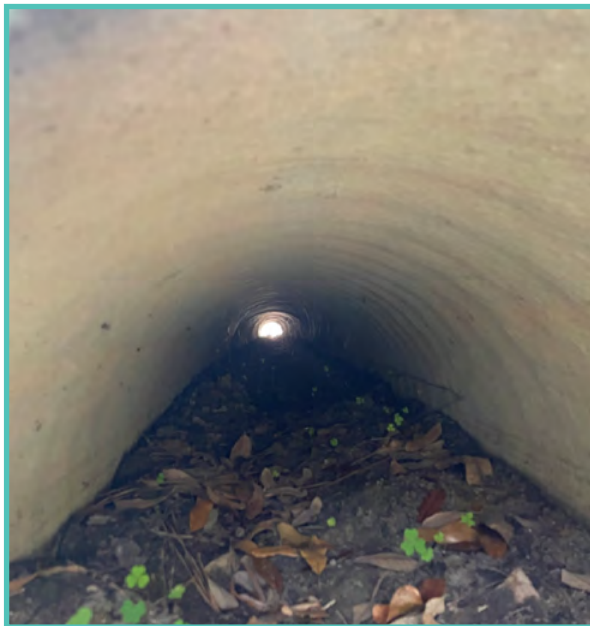
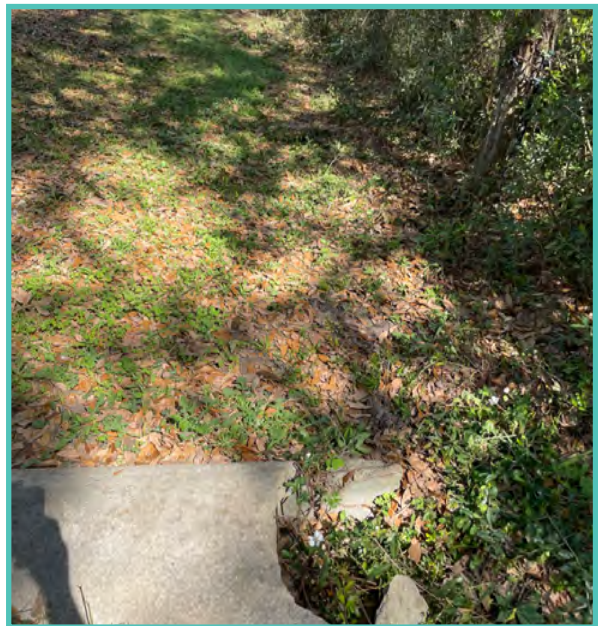
## Crossline Pipe Inventory ID: 71901

Performance Condition: Poor

Structural Condition: Poor

Reason: Broken end bell exposed reinforcement.

Recommendation: Clean and reinspect in 5 years.

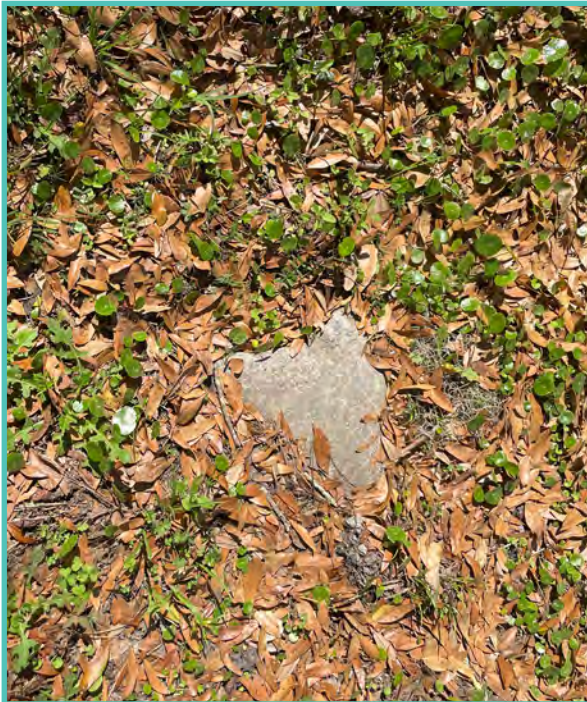
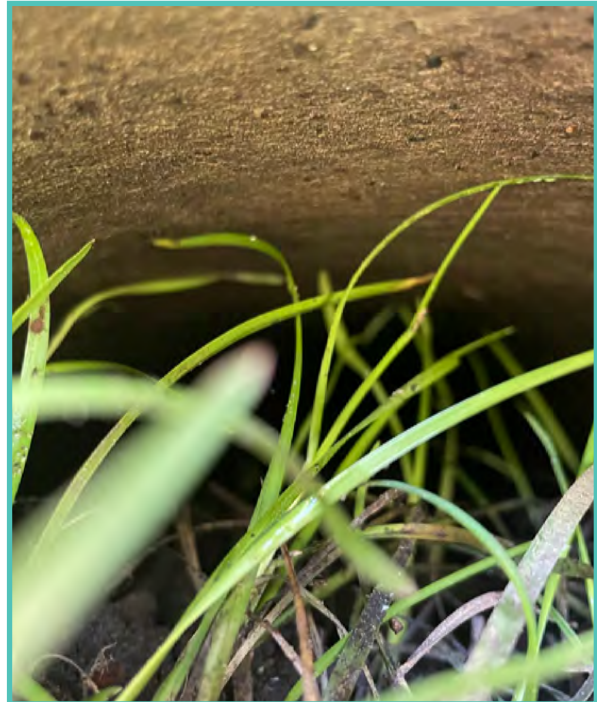
## Crossline Pipe Inventory ID: **83000**

Performance Condition: Poor

Structural Condition: Unknown

Reason: 1. Broken end bell exposed reinforcement.  
2. Not inspectable.

Recommendation: Clean and reinspect.

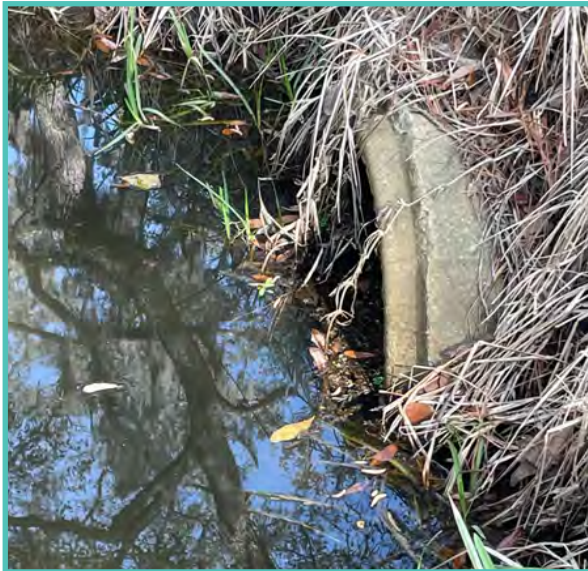
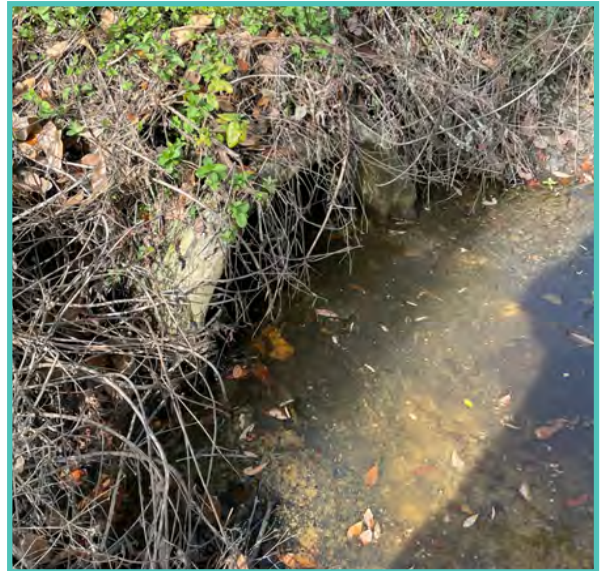
Performance Condition: Poor

Structural Condition: Good

Recommendation: Clean and conduct channel maintenance.

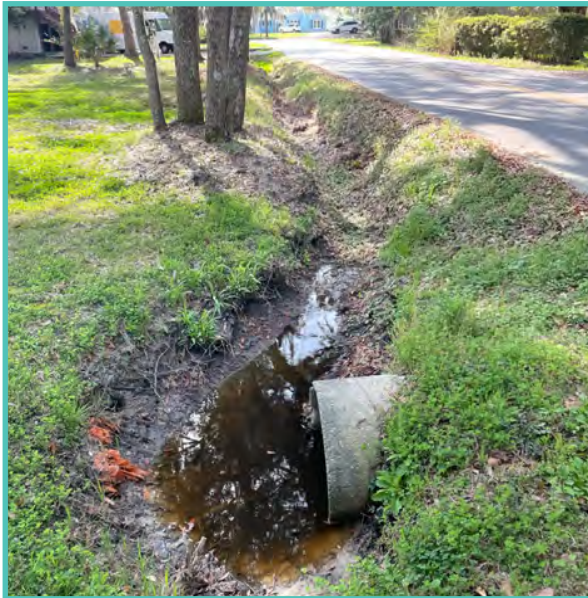
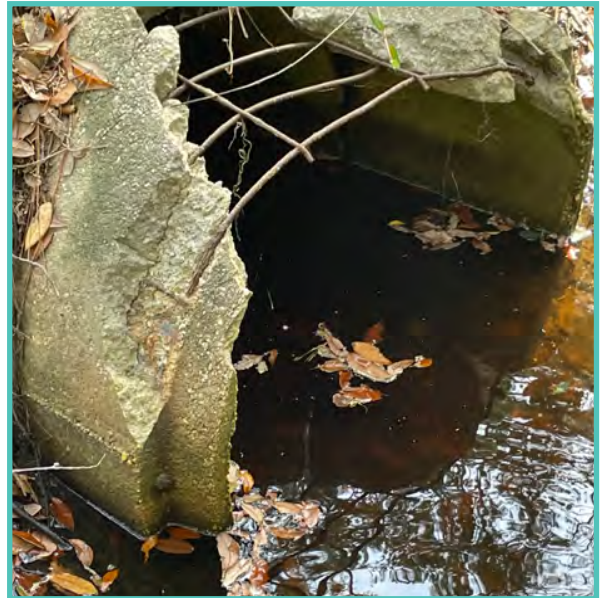
## Crossline Pipe Inventory ID: **52837**

Performance Condition: Poor

Structural Condition: Poor

Reason: Broken end bell exposed reinforcement.

Recommendation: Conduct channel maintenance reinspect in 5-years.

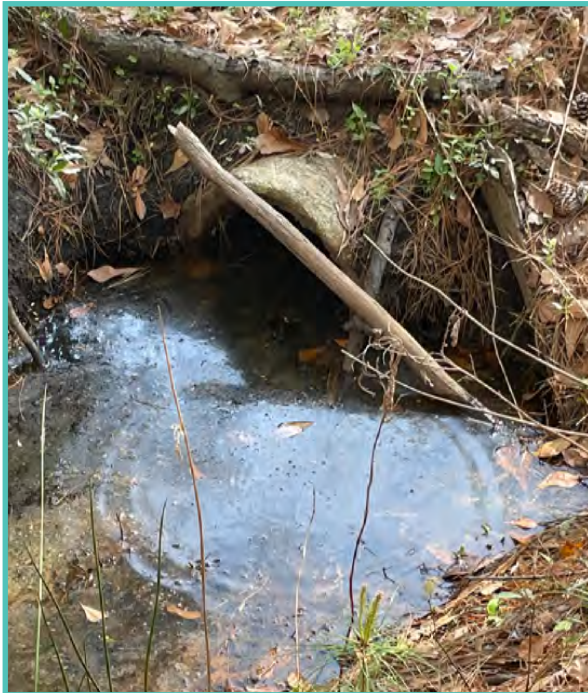
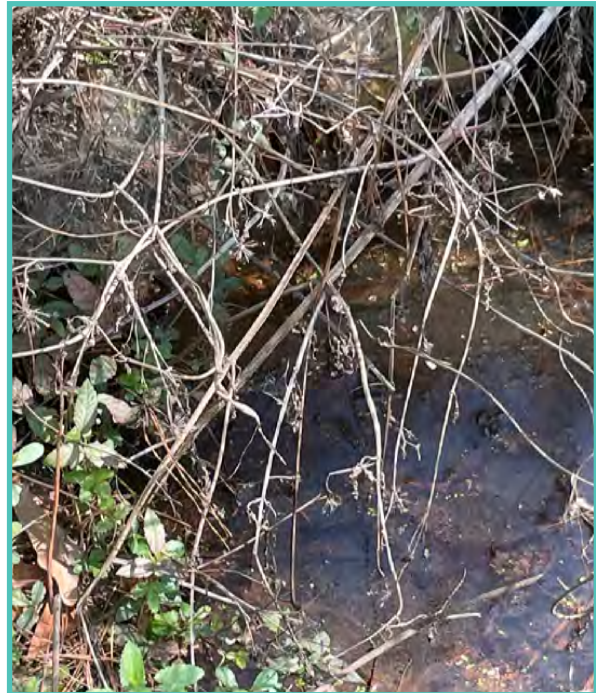
## Crossline Pipe Inventory ID: 23213

Performance Condition: Poor

Structural Condition: Unknown

Reason: Could not inspect due to submergence.

Recommendation: Clean and conduct channel maintenance.

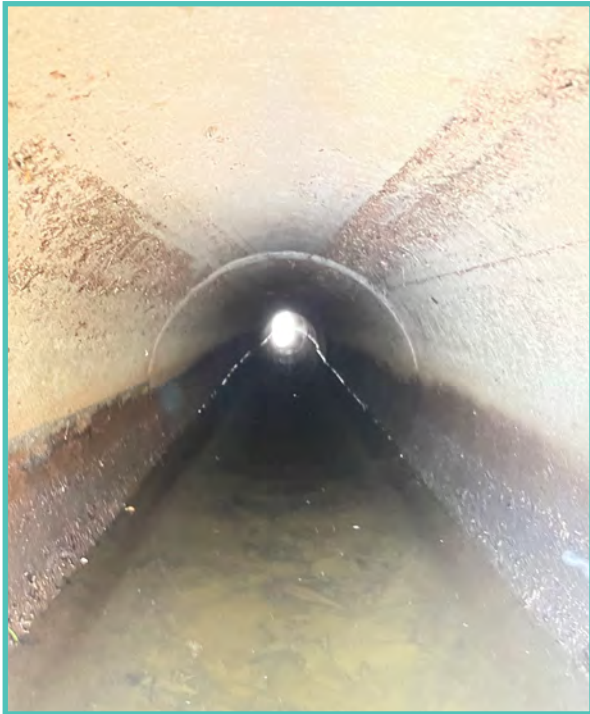
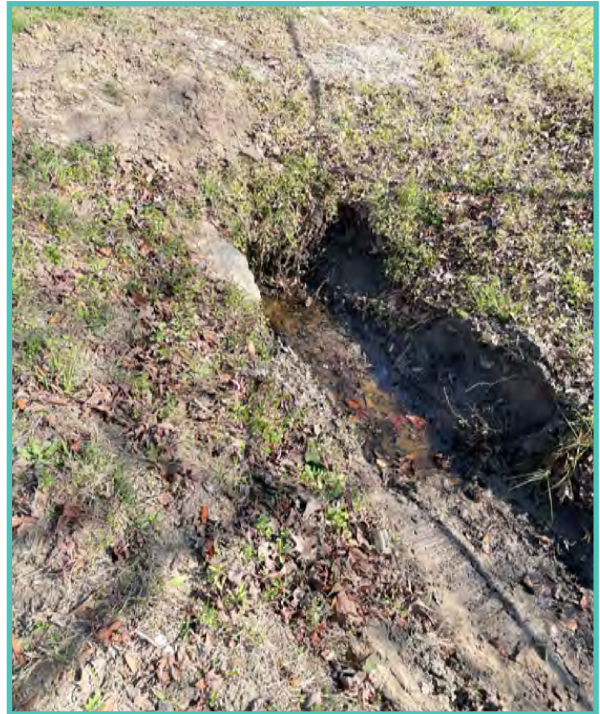
Crossline Pipe Inventory ID: **58515**

Performance Condition: Fair

Structural Condition: Good

Recommendation: Clean.

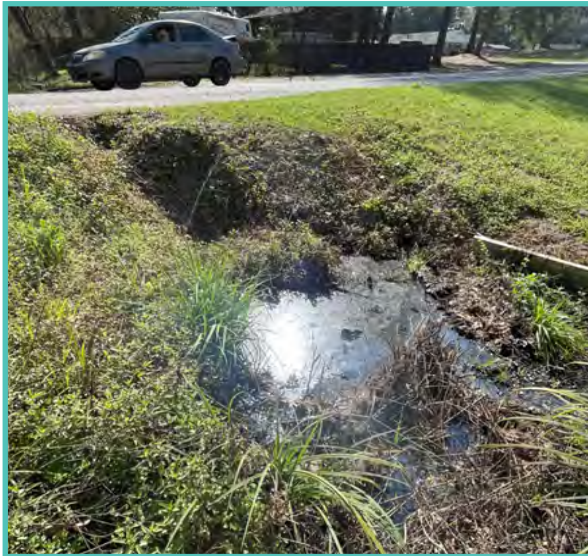
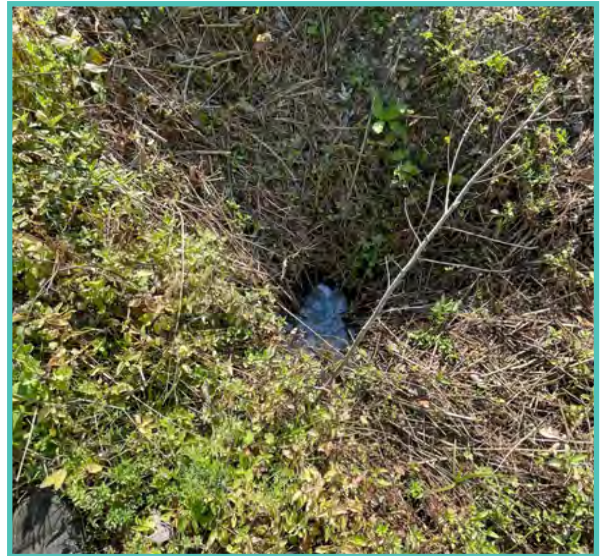
## Crossline Pipe Inventory ID: **37487**

Performance Condition: Poor

Structural Condition: Unknown

Reason: Fully submerged.

Recommendation: Conduct channel maintenance reinspect in 5-years.

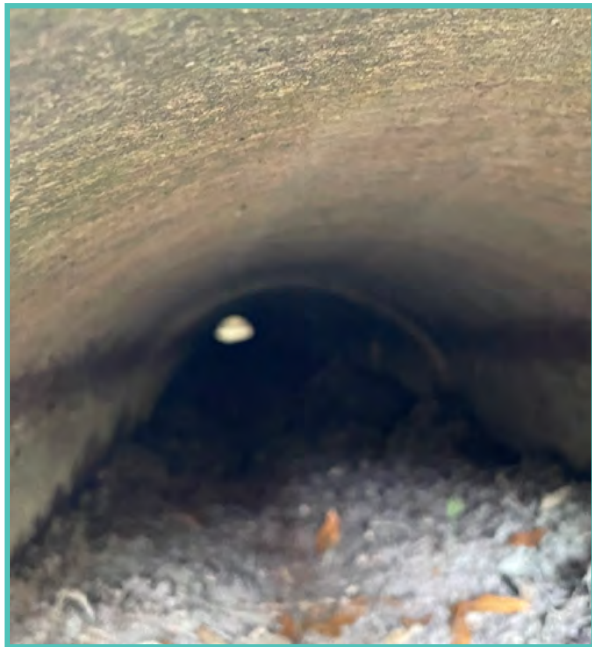
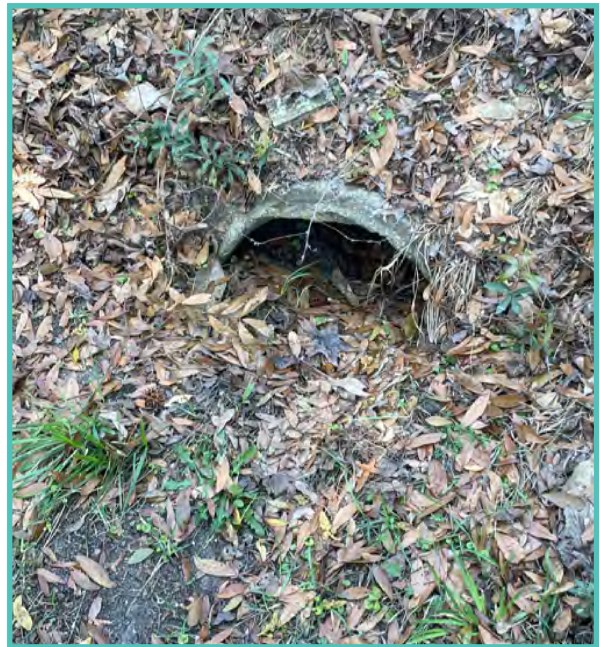
Crossline Pipe Inventory ID: **59364**

Performance Condition: Poor

Structural Condition: Good

Recommendation: Clean.

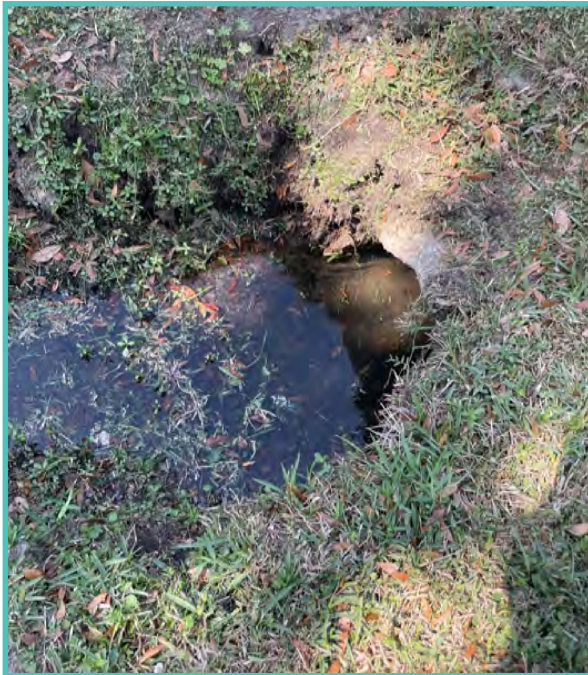
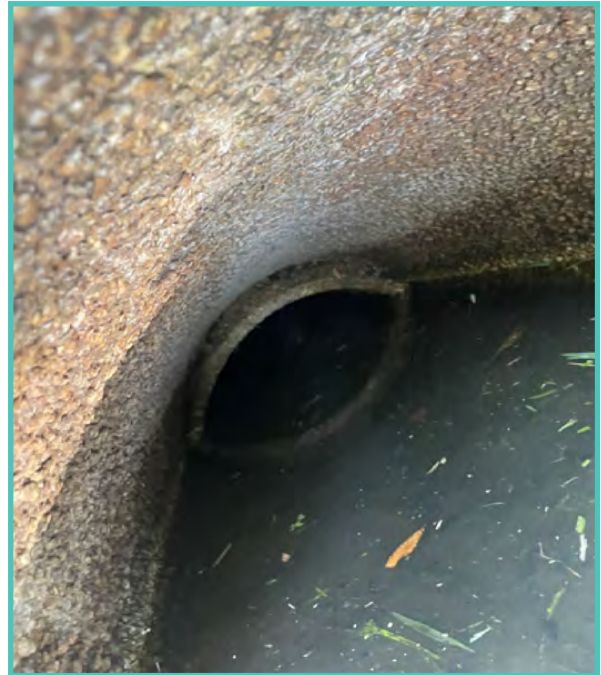
Reason: Not accessible.

Recommendation: Conduct channel maintenance and reinspect.

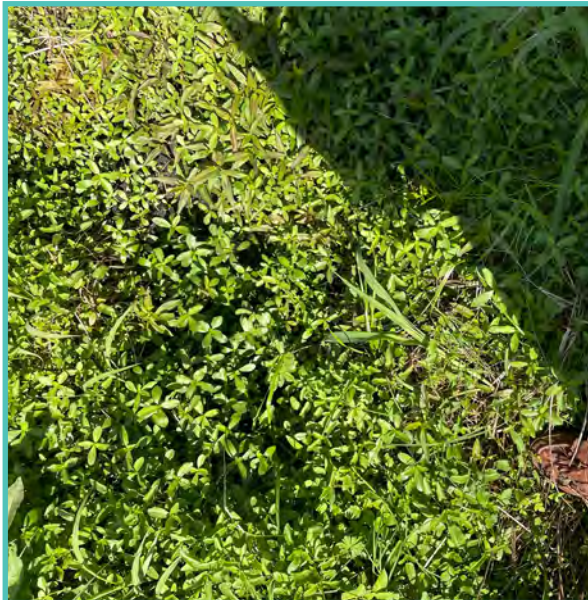
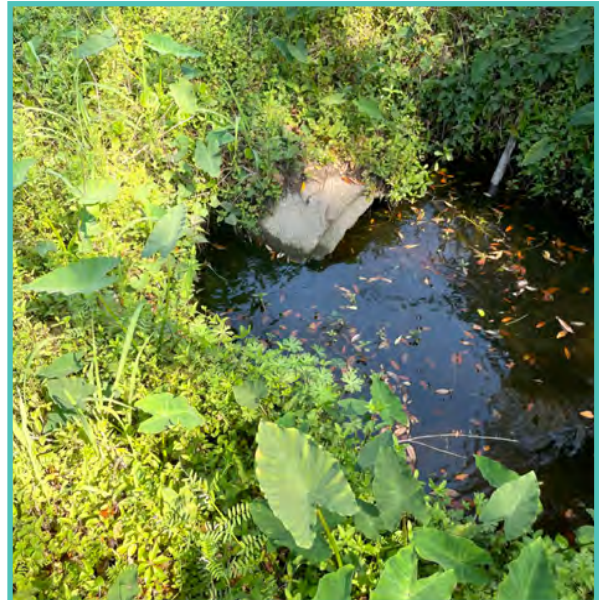
## Crossline Pipe Inventory ID: **58509**

2. Deterioration due to pipe age.

Recommendation: Conduct channel maintenance and reinspect.

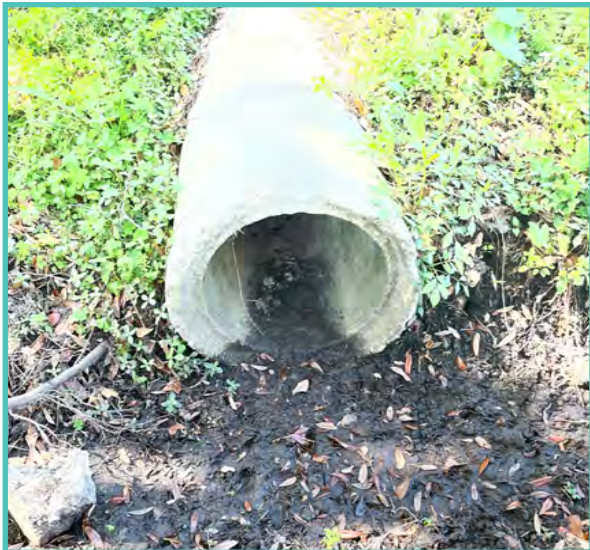
Crossline Pipe Inventory ID: **58508**

2. Deterioration due to pipe age.

Recommendation: Reinspect in 5 years.

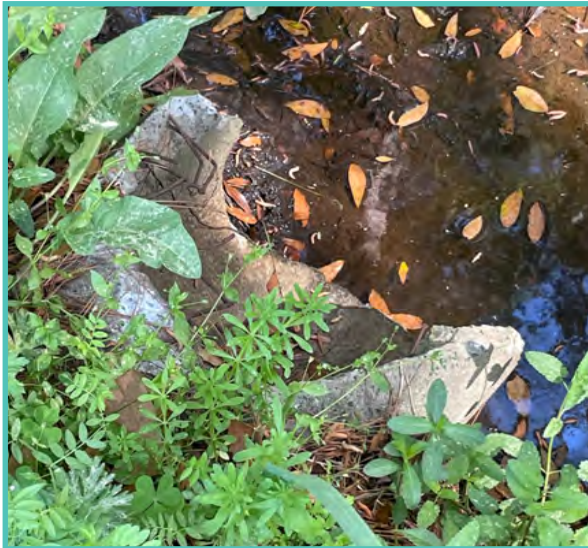
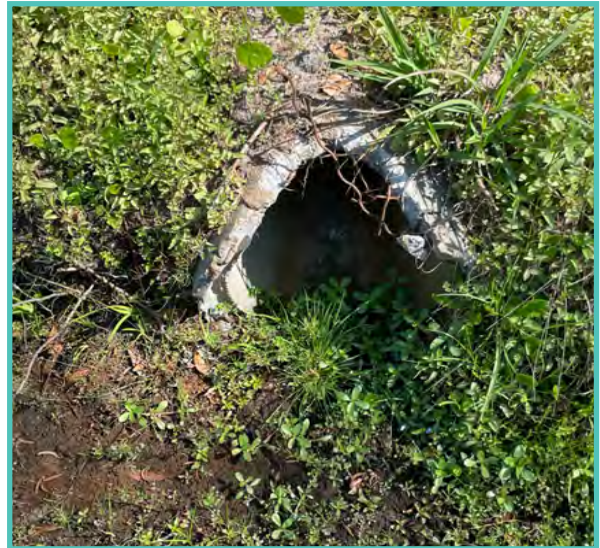
## Crossline Pipe Inventory ID: **78114**

3. Deterioration due to pipe age.

Recommendation: Reinspect in 5 years.

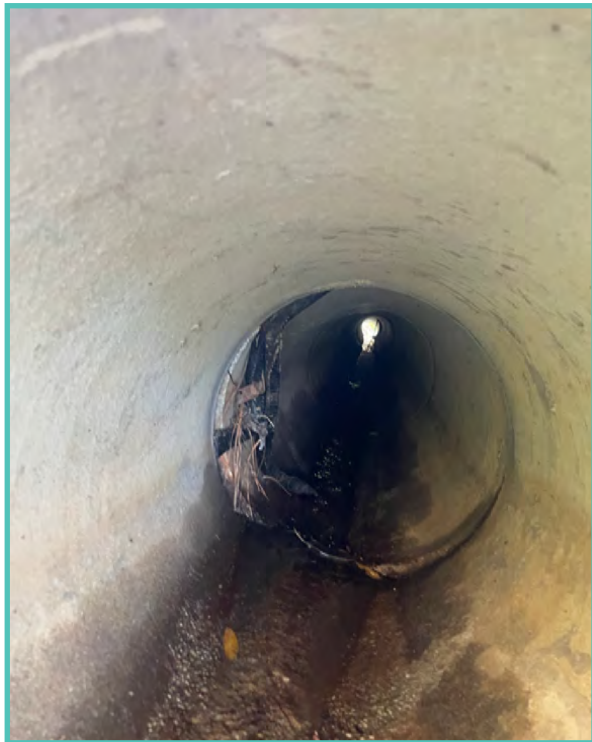
Crossline Pipe Inventory ID: **59739**

Reason: Pipe joint displacement.

Recommendation: Reinspect in 5 years.

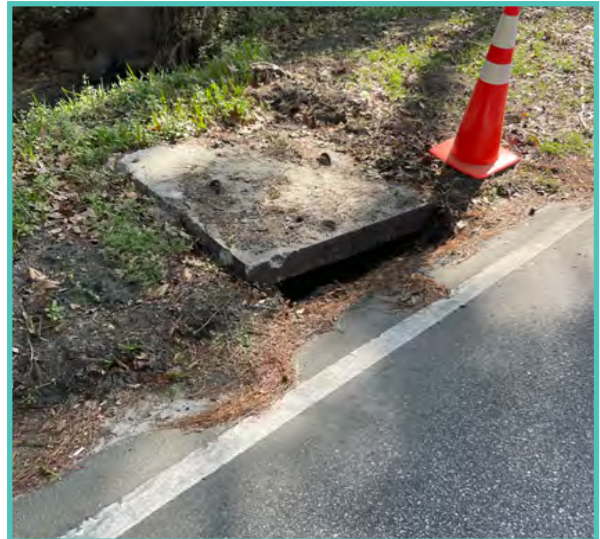
## Crossline Pipe Inventory ID: 52851

4. Deterioration due to pipe age.

Recommendation: Replace pipe.

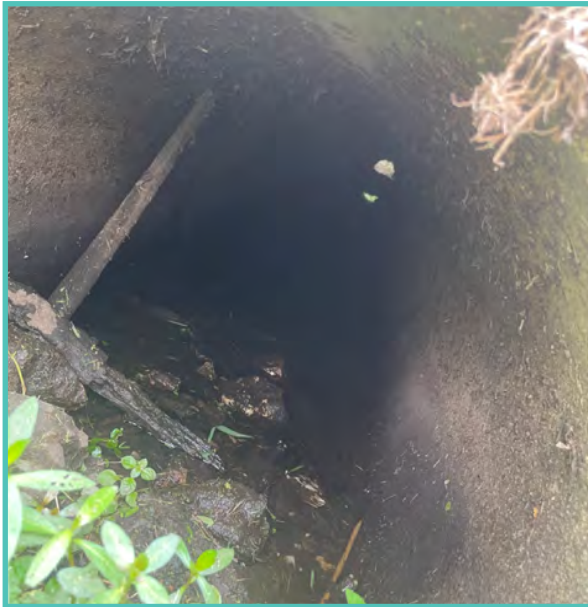
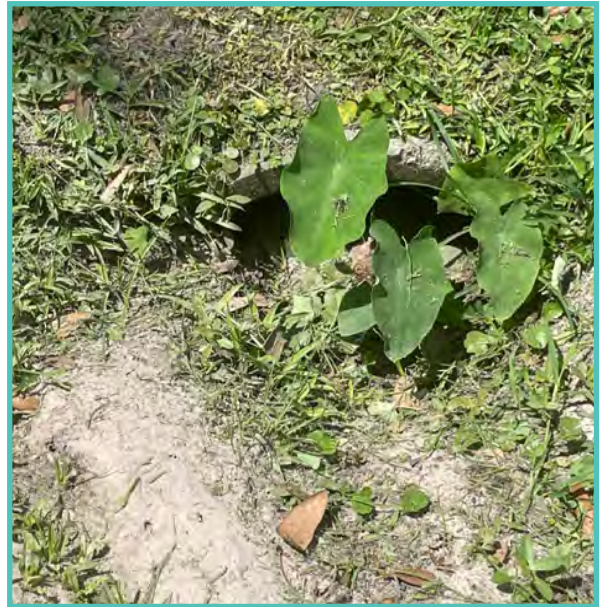
## Crossline Pipe Inventory ID: **59399**

Reason: 1. Broken end bell.  
2. Deterioration due to pipe age.

Recommendation: Hydraulic study with possible pipe replacement.

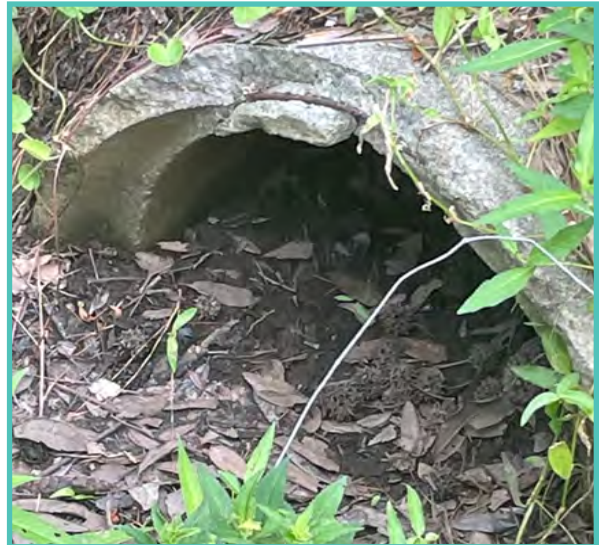
## Crossline Pipe Inventory ID: 83001

Reason: 1. Fully submerged.  
2. Partially full of sediment.

Recommendation: Clean and conduct channel maintenance.

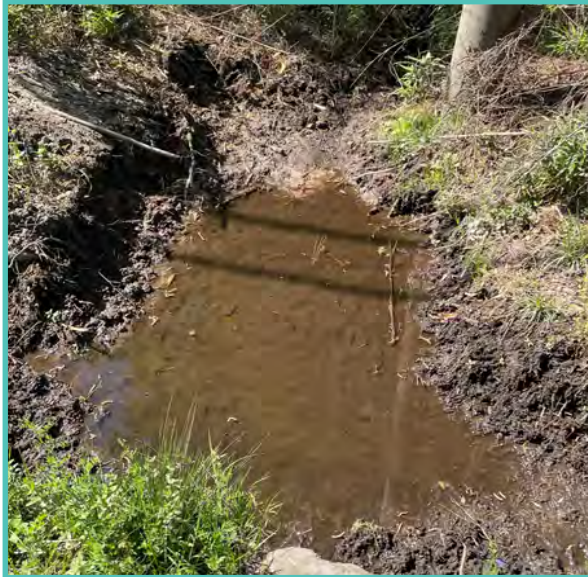
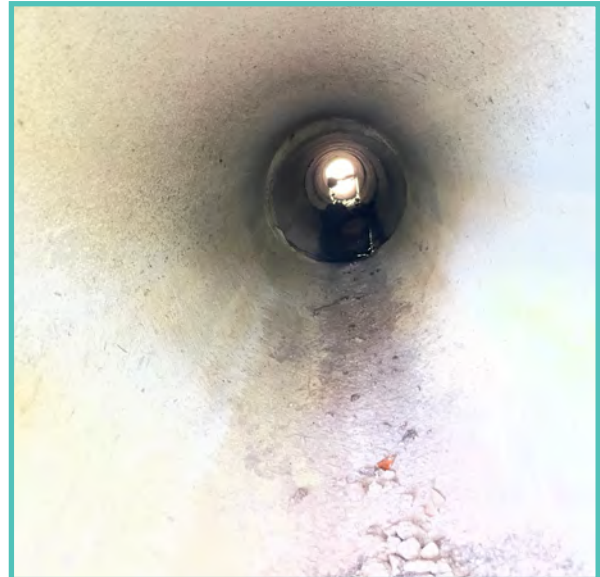
## Crossline Pipe Inventory ID: **59738**

Reason: 1. Broken end bell exposed reinforcement.  
2. Pipe joint displacement.

Recommendation: Reinspect in 5 years.

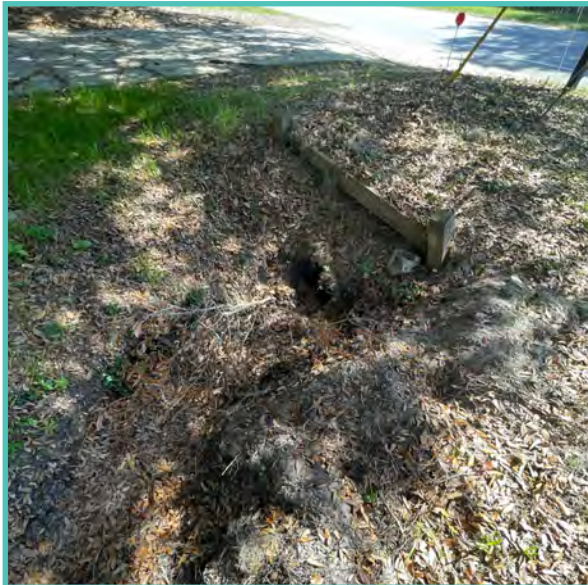
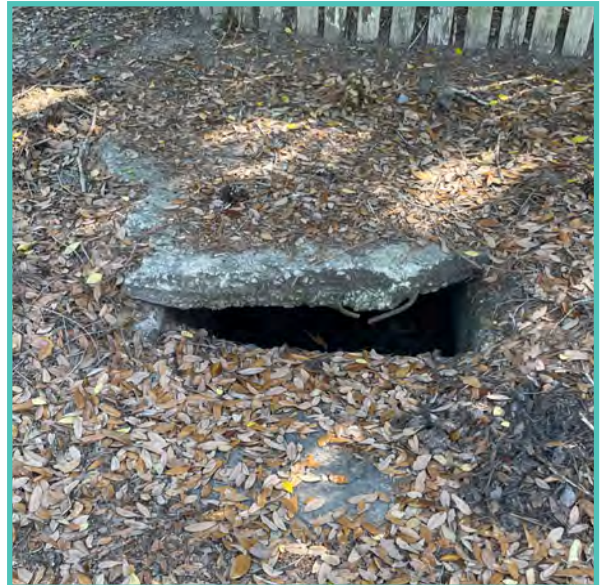
## Crossline Pipe Inventory ID: 52856

3. Unable to inspect east end of pipe, not accessible.

Recommendation: Clean pipe and replace catch basin.

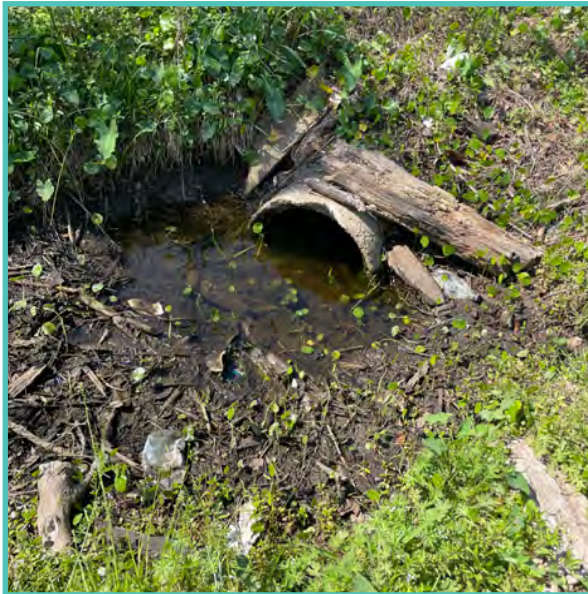
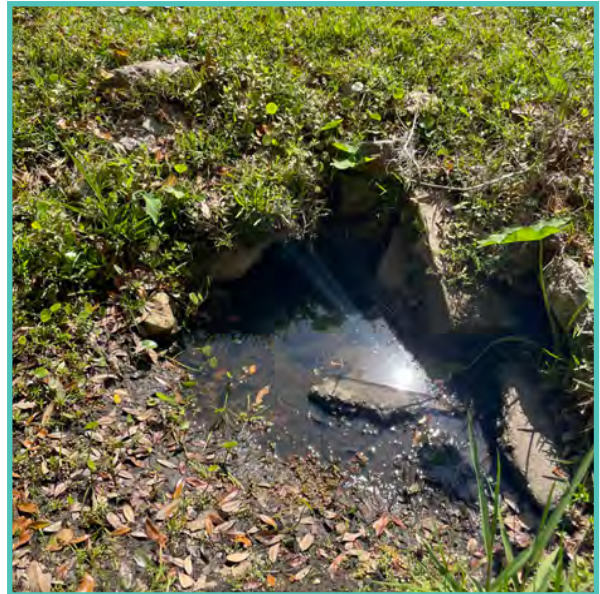
## Crossline Pipe Inventory ID: 71839

Reason: 1. Broken catch basin lid  
2. Deterioration due to pipe age.  
3. Unable to inspect east end of pipe, not accessible.

Recommendation: Replace pipe.

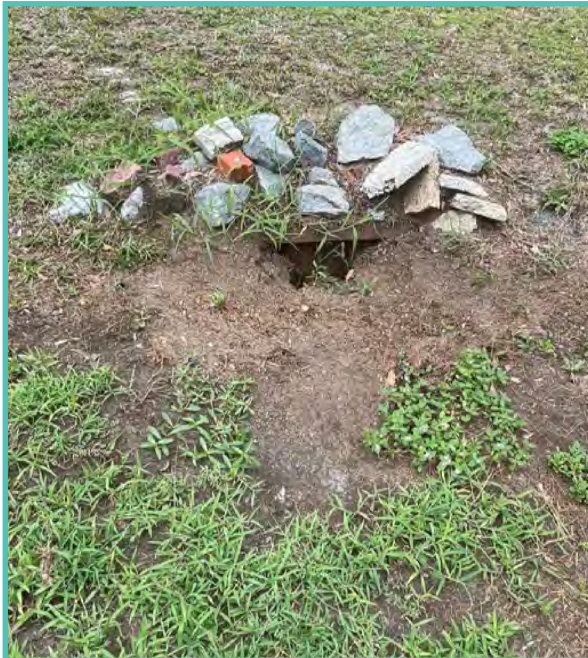
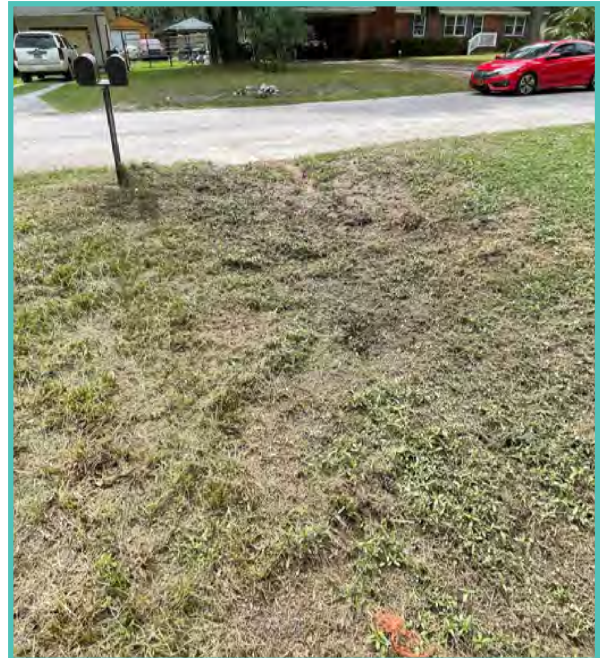
## Crossline Pipe Inventory ID: **71879**

2. Inlet Partially full of debris and sediment.

Recommendation: Clean and reinspect.

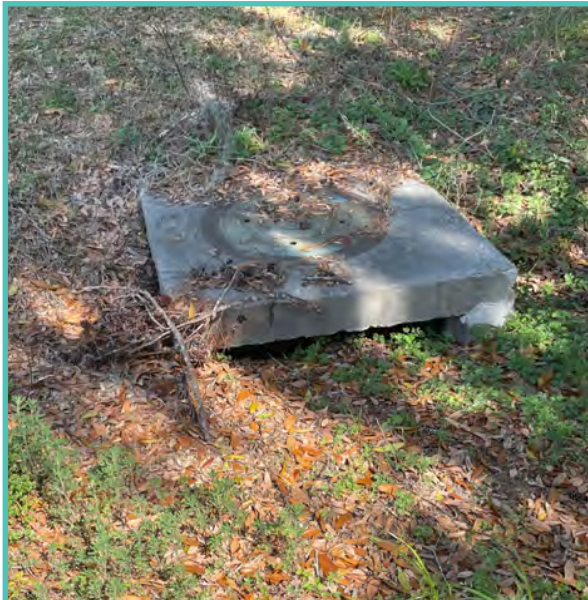
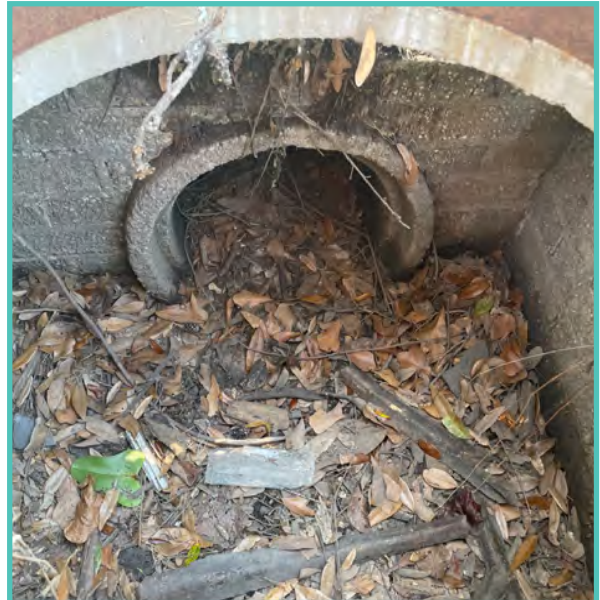
## Crossline Pipe Inventory ID: **52862**

2. Inlet Partially full of debris and sediment.

Recommendation: Clean and reinspect.

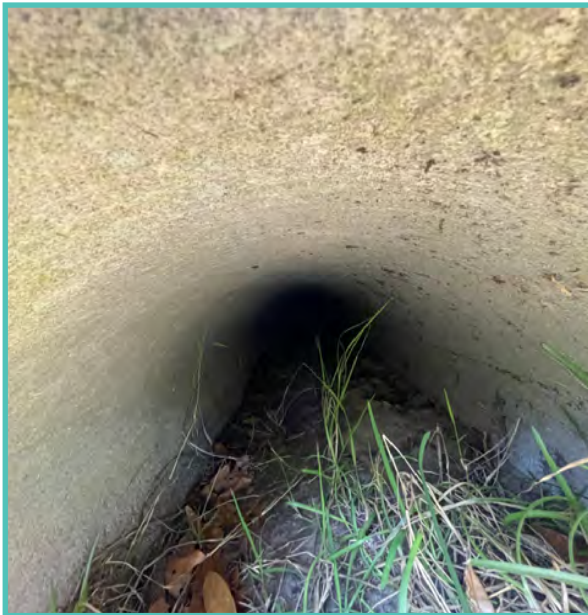
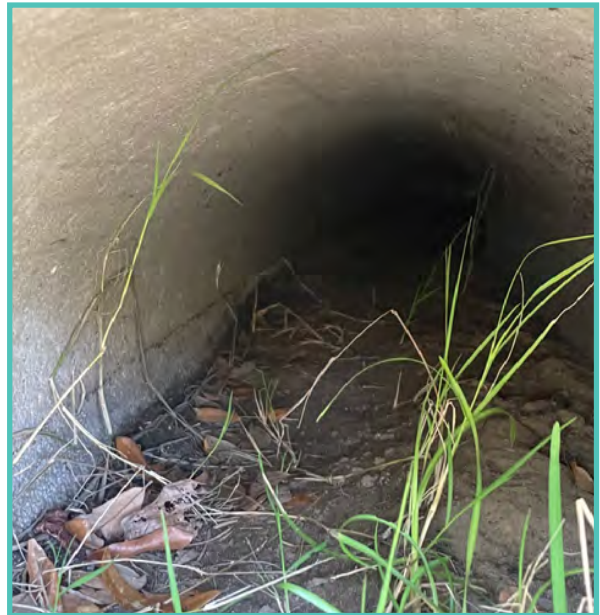
Crossline Pipe Inventory ID: **52857**

Reason: West end of pipe not accessible.

Recommendation: Clean and reinspect.

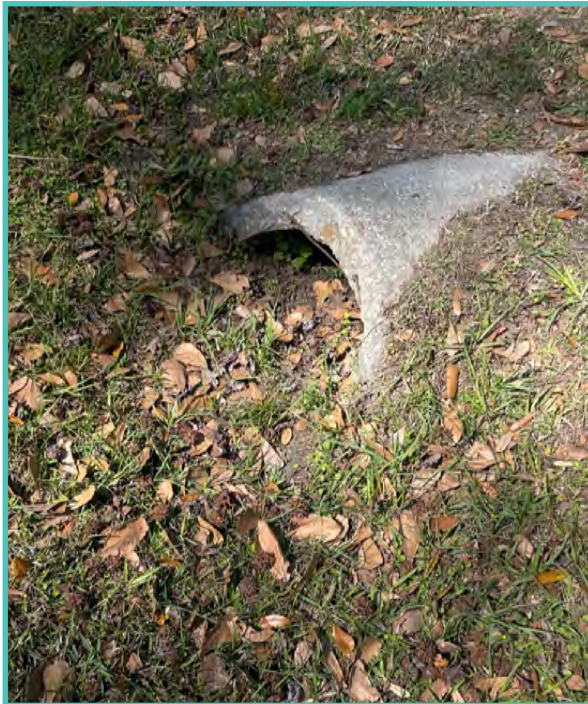
## Crossline Pipe Inventory ID: **59448**

2. Deterioration due to pipe age.

Recommendation: Clean and reinspect.

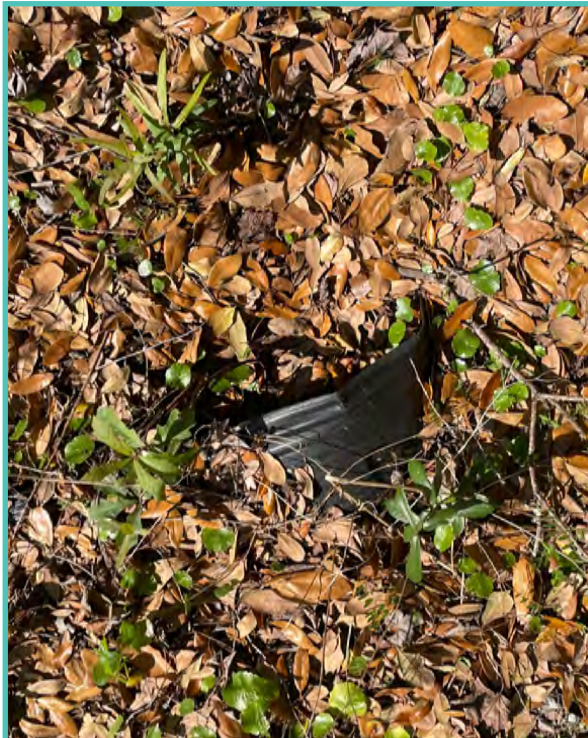
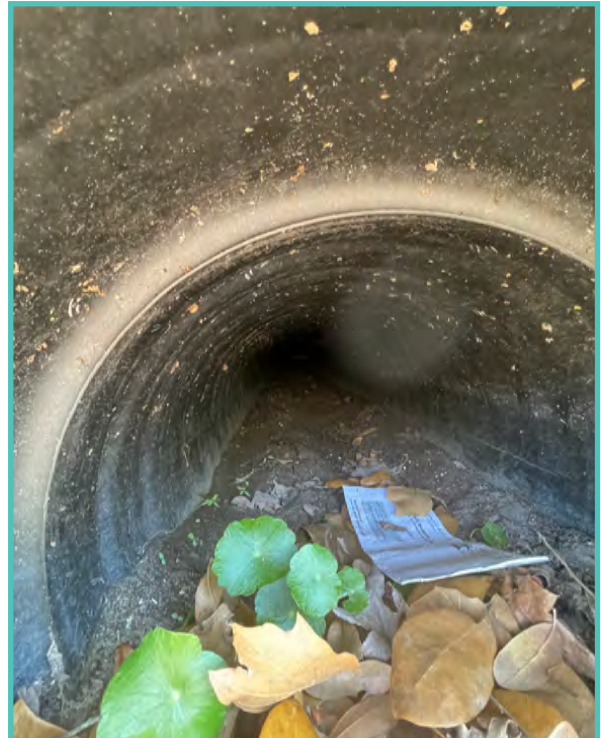
## Crossline Pipe Inventory ID: **83002**

Reason: Not accessible.

Recommendation: Clean and reinspect.

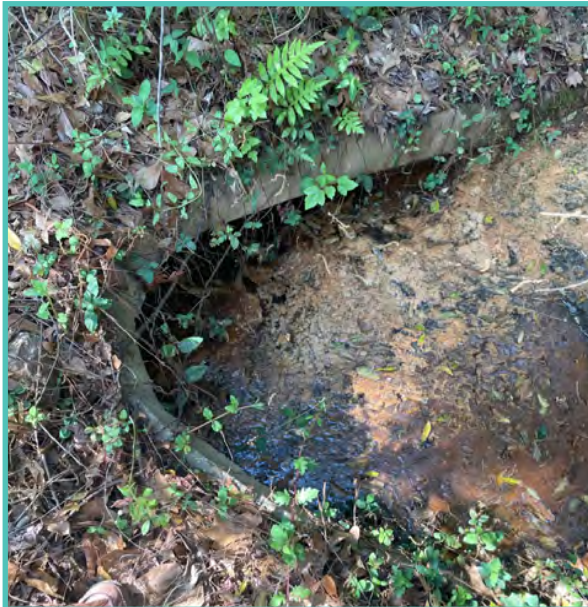
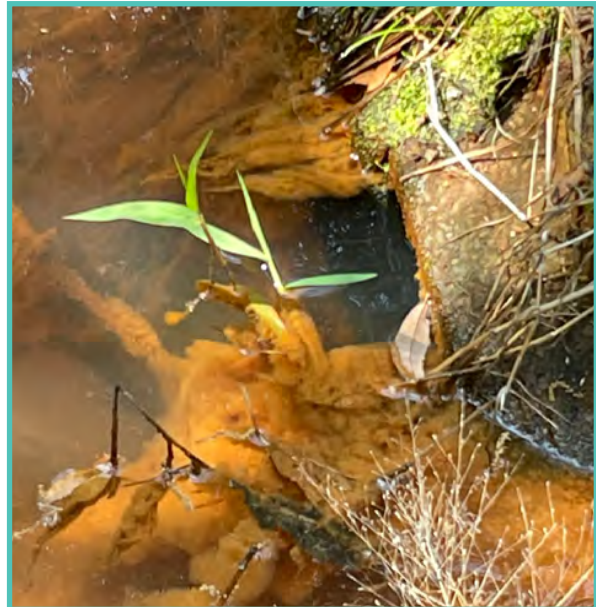
## Crossline Pipe Inventory ID: **71864**

Reason: 1. Broken end bell.  
2. Severe pipe joint displacement.  
3. Deterioration due to pipe age.

Recommendation: Conduct channel maintenance and reinspect.

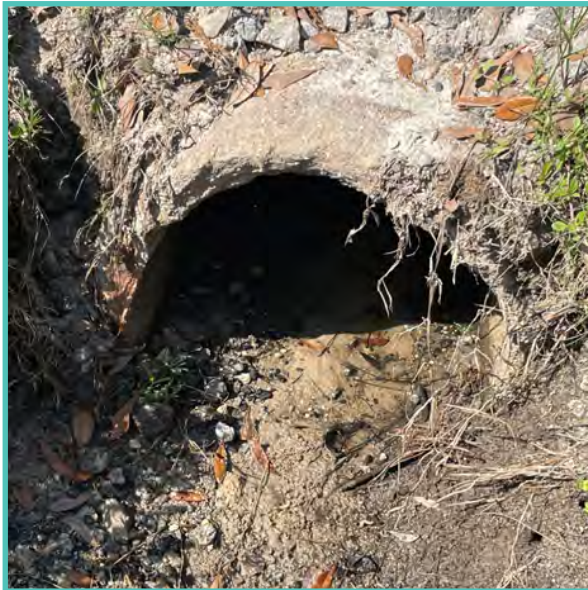
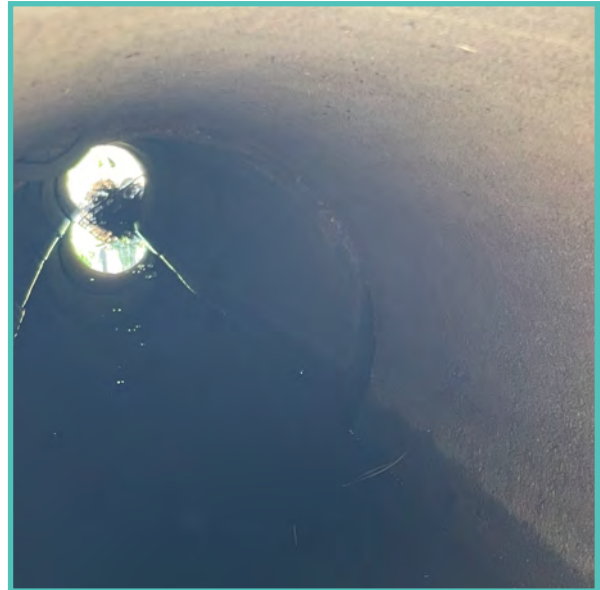
## Crossline Pipe Inventory ID: 57215

Reason: Pipe joint displacement

Recommendation: Reinspect in 5 years.

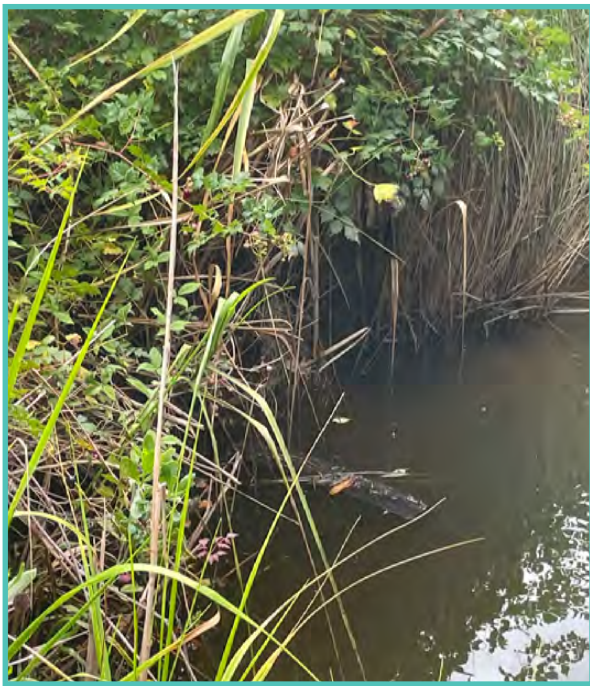
## Crossline Pipe Inventory ID: **60026**

Reason: Not accessible. Pipe size small for drainage area.

Recommendation: Conduct channel maintenance and reinspect.  
Conduct hydraulic study possible pipe replacement.

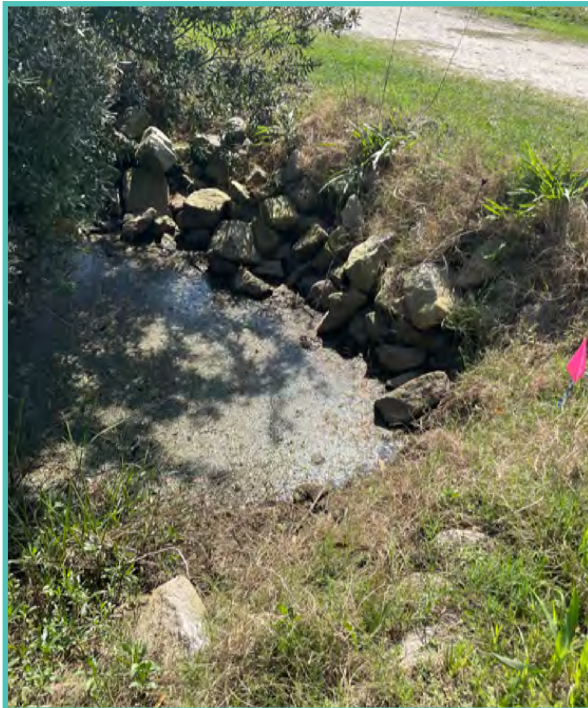
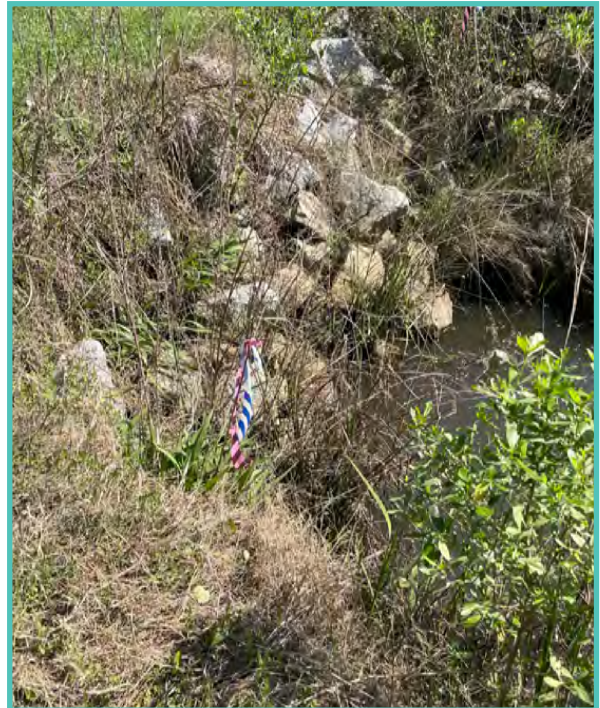
Crossline Pipe Inventory ID: **68742**

Reason: Fully submerged.

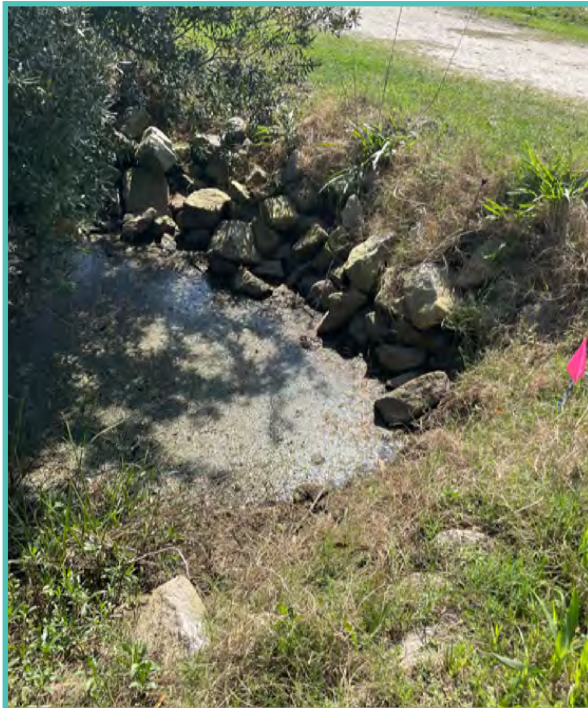
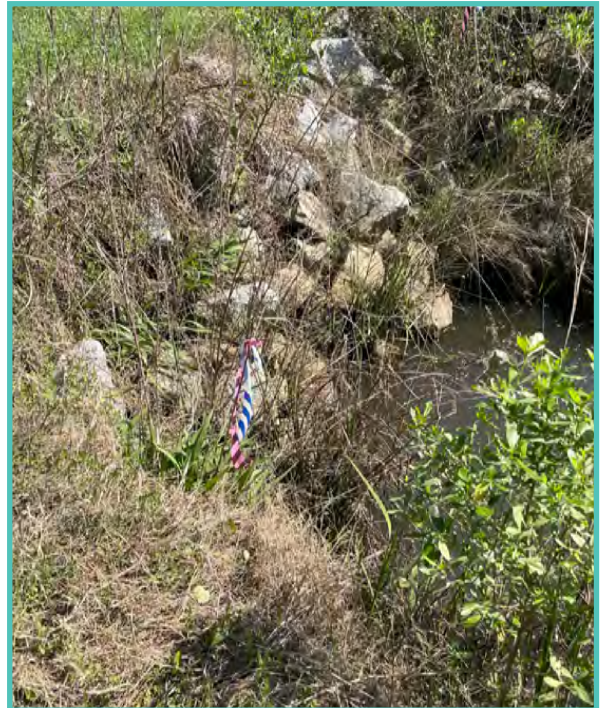
## Crossline Pipe Inventory ID: **53708**

Reason: Fully submerged.

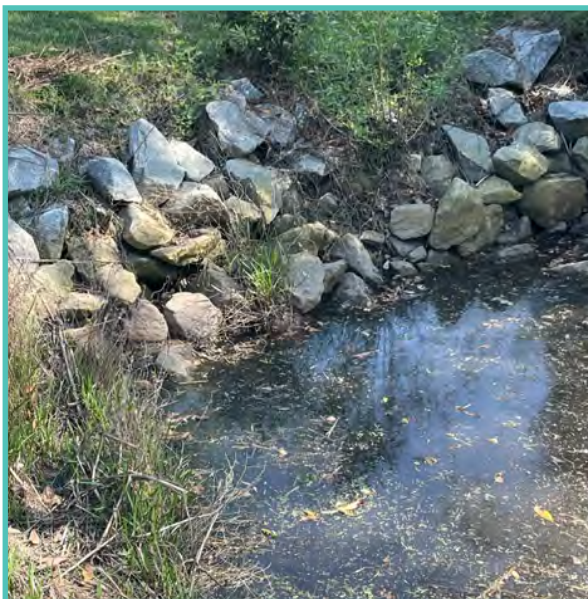
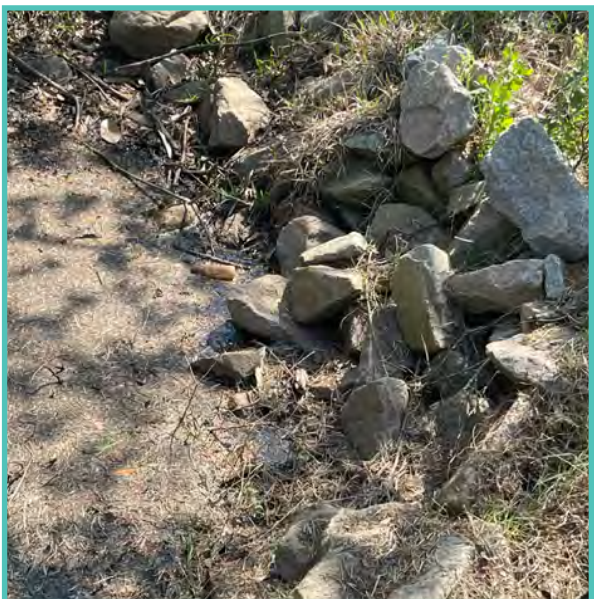
## Crossline Pipe Inventory ID: 22849

Reason: Fully submerged.
