# STORMWATER MANAGEMENT SYSTEM CONDITION ASSESSMENT

## Shell Point Drainage Improvement Program

Beaufort County Stormwater  
120 Shanklin Rd  
Beaufort, SC 29906

April 2023

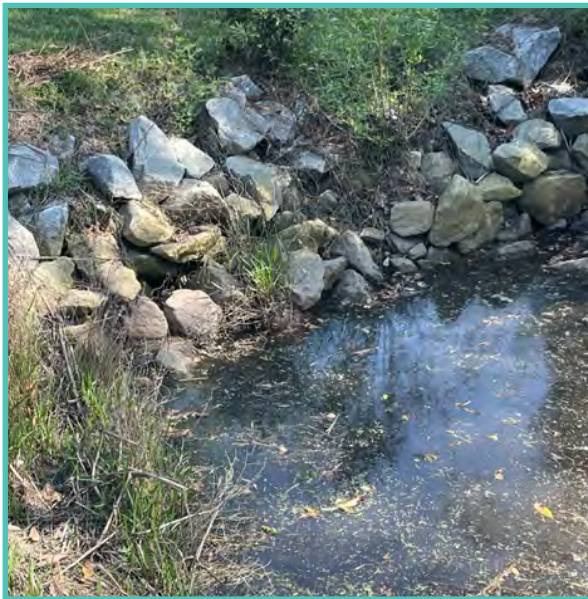
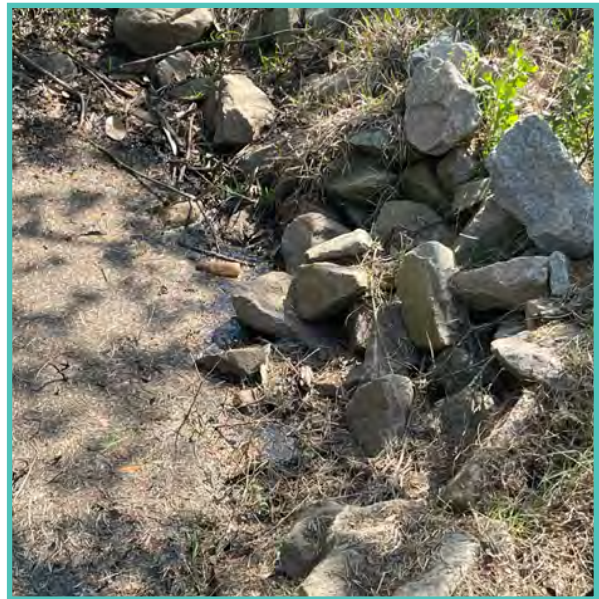
## Crossline Pipe Inventory ID: 53706

Reason: Fully submerged.

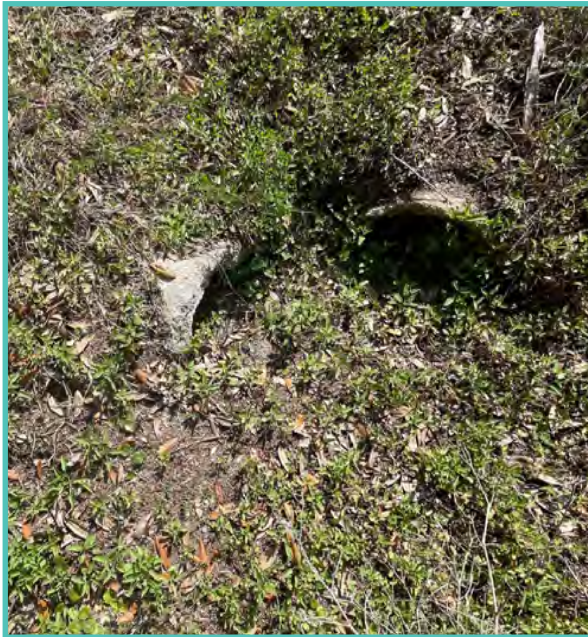
## Crossline Pipe Inventory ID: **78129**

Crossline pipe #78129, located at 410 Broad River Dr (S-287), is buried, and filled with sediment. This pipe was originally designed to convey stormwater to the marsh per SCDOT design plans, File No. 7.370. The east end of the pipe is buried, and the outfall channel has been filled in. Figure 2 below depicts the crossline pipe. As shown the existing 18" crossline pipe conveyed stormwater flows to the marsh. Flows from the contributing area now flow to the upstream side of the outfall (#60026) at Hamrick Dr exacerbating the flooding conditions at that outfall. It should be noted that a Beaufort County Transportation sponsored sidewalk project is proposed for Broad River Dr. It is anticipated that the sidewalk will be placed on the eastern side of Broad River Dr, which may require a closed pipe system to convey stormwater along the eastern side of Broad River Drive to the Hamrick Dr outfall. If this project moves forward the recommendation would be to tie crossline pipe #78129 to the closed pipe system. This recommendation would improve the conditions at the upstream end of crossline pipe #60026 by reducing the amount of contributing area to the crossline.

Reason: Filled and buried with sediment.

Recommendation: Provided in report Section 2.

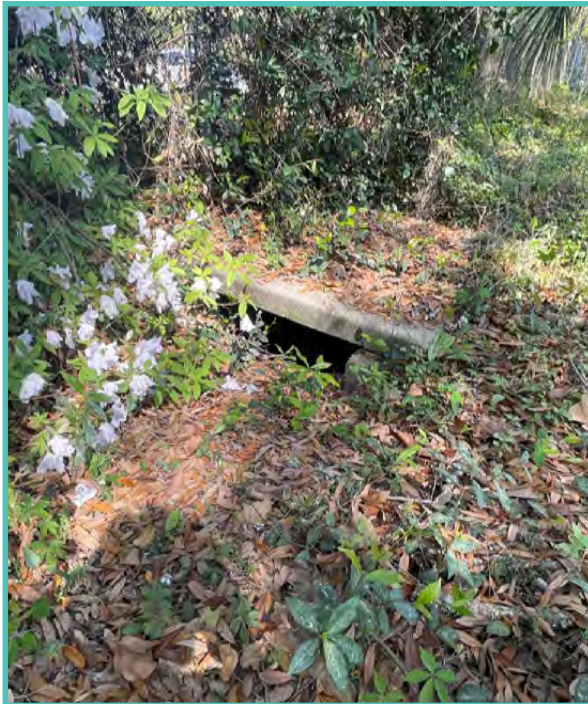
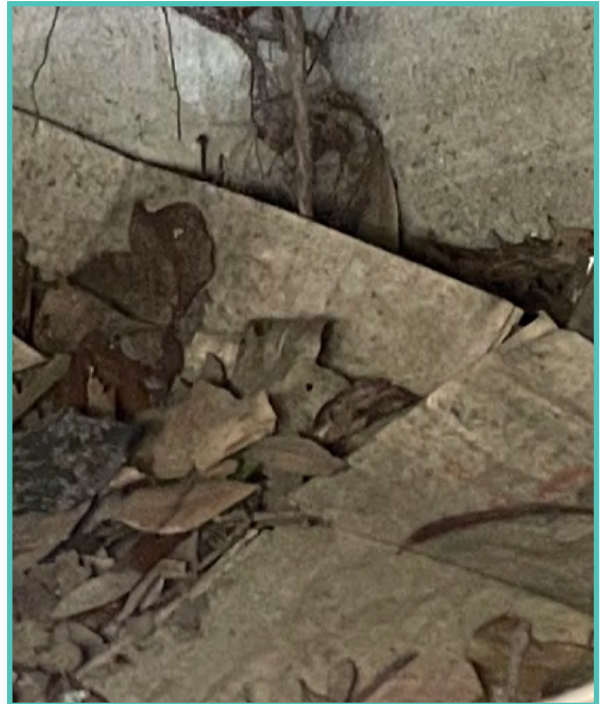
## Crossline Pipe Inventory ID: **78130**

Reason: Inaccessible/Filled with sediment

Recommendation: Clean and CCTV closed system pipe.

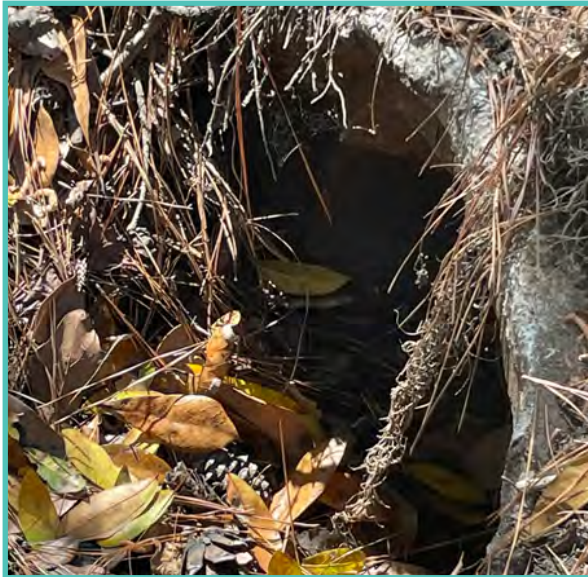
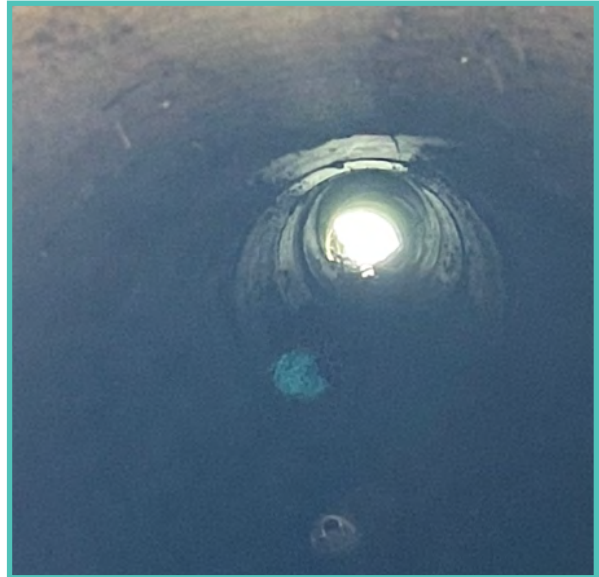
## Crossline Pipe Inventory ID: **83003**

Reason: 1. Broken end bell.  
2. Severe pipe joint displacement.  
3. Deterioration due to pipe age.

Recommendation: Replace pipe.
