# STORMWATER MANAGEMENT SYSTEM CONDITION ASSESSMENT

## Shell Point Drainage Improvement Program

Beaufort County Stormwater  
120 Shanklin Rd  
Beaufort, SC 29906

April 2023

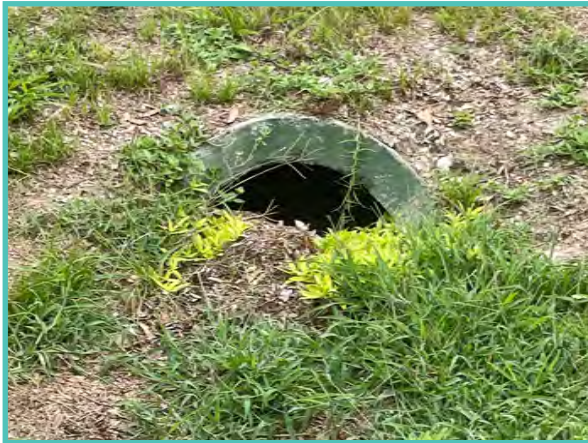
Reason: Could not inspect due to sediment.

Recommendation: Clean and reinspect.

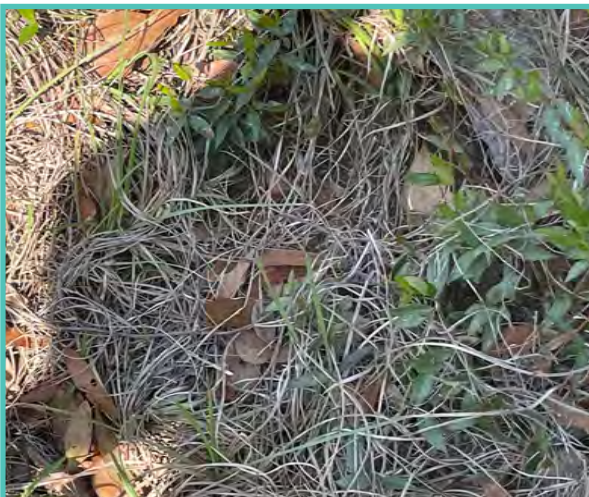
Reason: Could not inspect due to sediment.

Recommendation: Clean and reinspect.

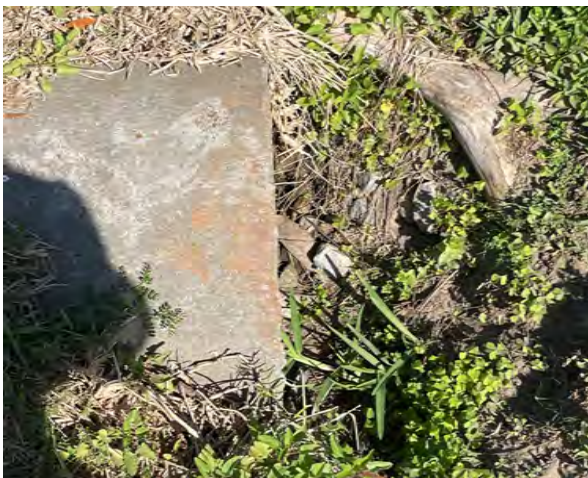
Reason: Broken end bell exposed reinforcement.

Recommendation: Clean and reinspect in 5 years.

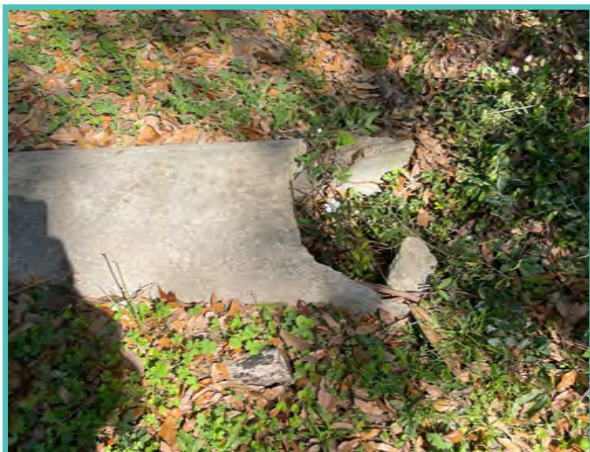
Reason: Broken end bell exposed reinforcement.

Recommendation: Clean and reinspect in 5 years.

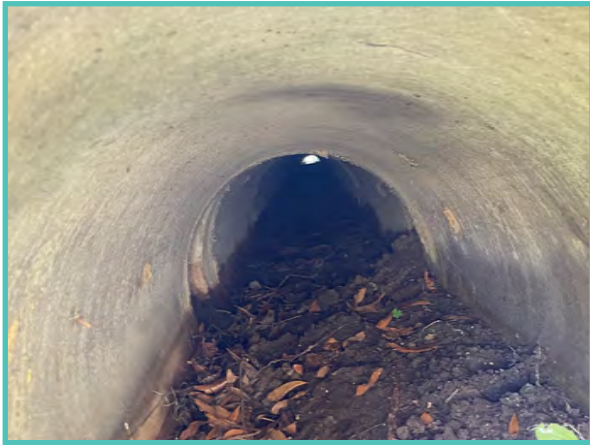
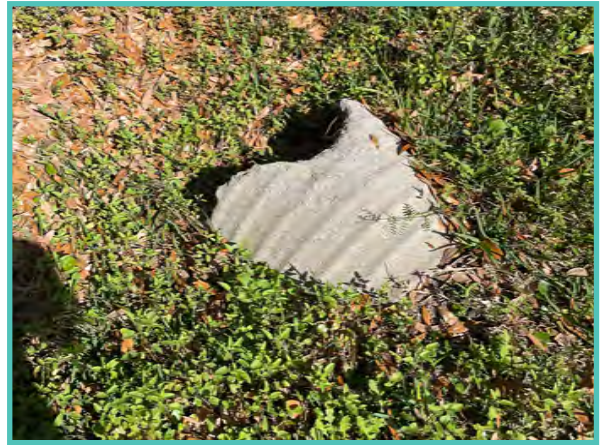
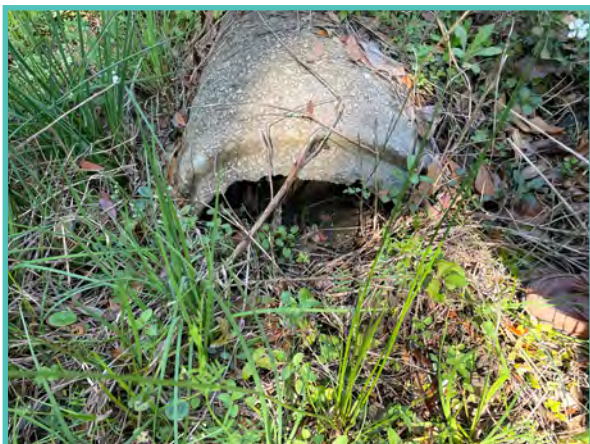
Reason: 1. Broken end bell exposed reinforcement.  
2. Pipe joint displacement.  
3. Deterioration due to pipe age.

Recommendation: Clean and reinspect.

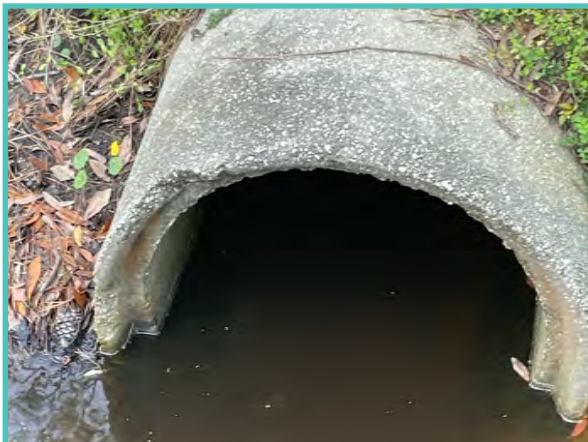
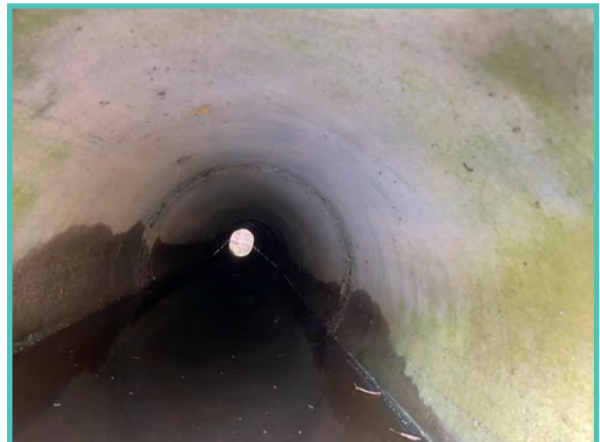
Reason: Broken end bell exposed reinforcement.

Recommendation: Conduct channel maintenance reinspect in 5-years.

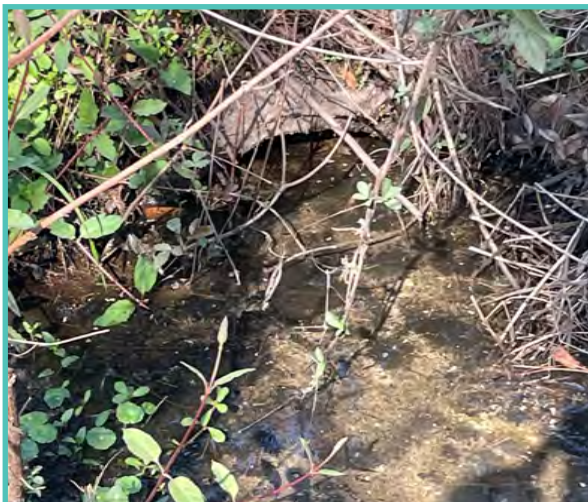
Reason: Fully submerged.

Recommendation: Conduct channel maintenance reinspect in 5-years.

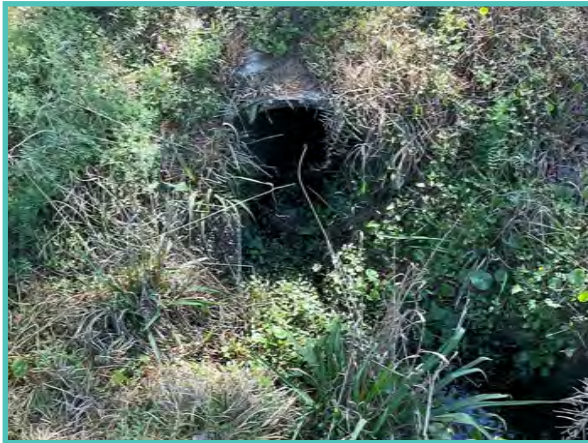
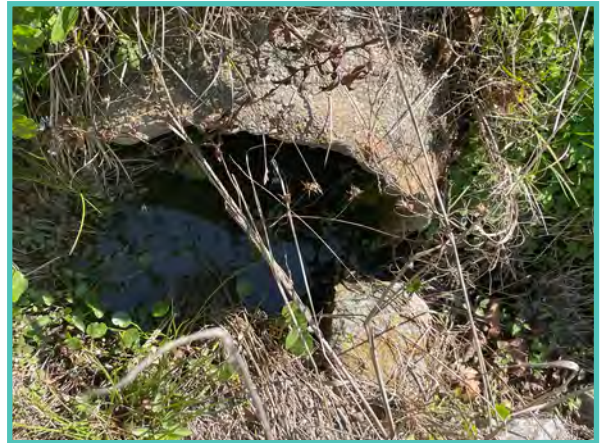
Reason: Filled with sediment.

Recommendation: Clean and reinspect.

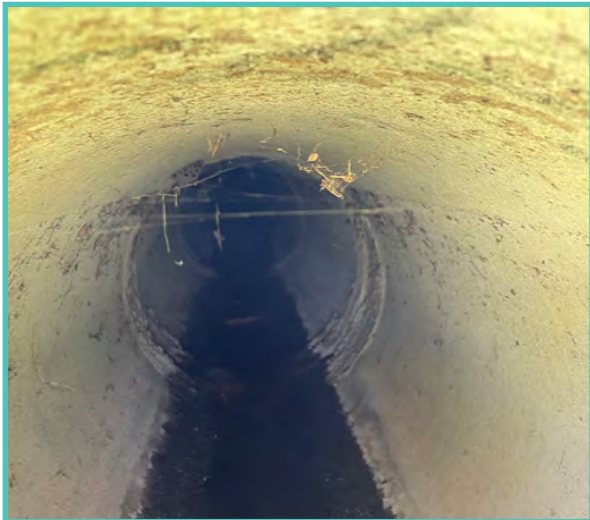
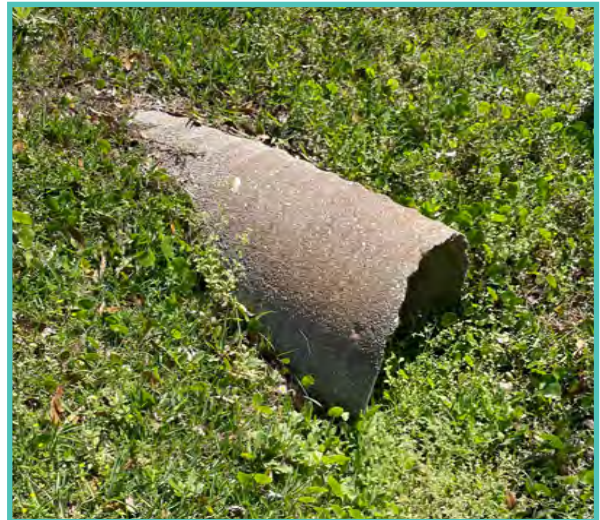
2. Deterioration due to pipe age.

Recommendation: Reinspect in 5 years.

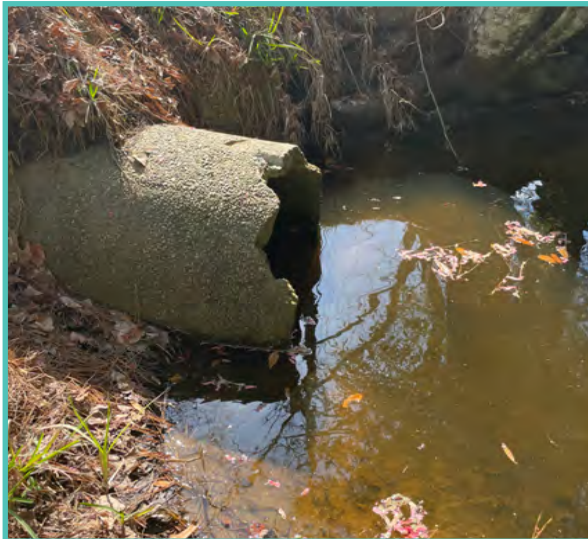
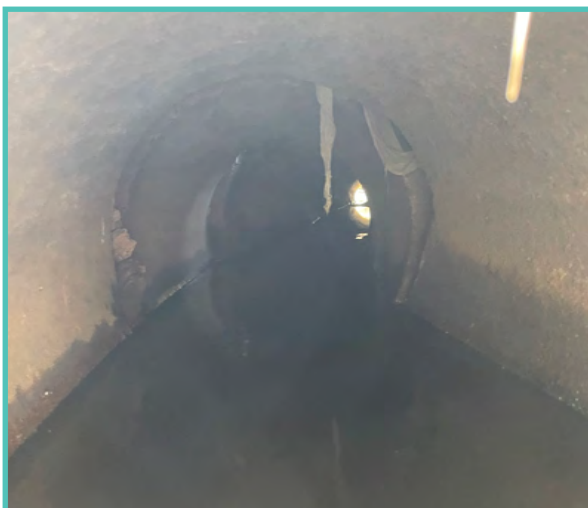
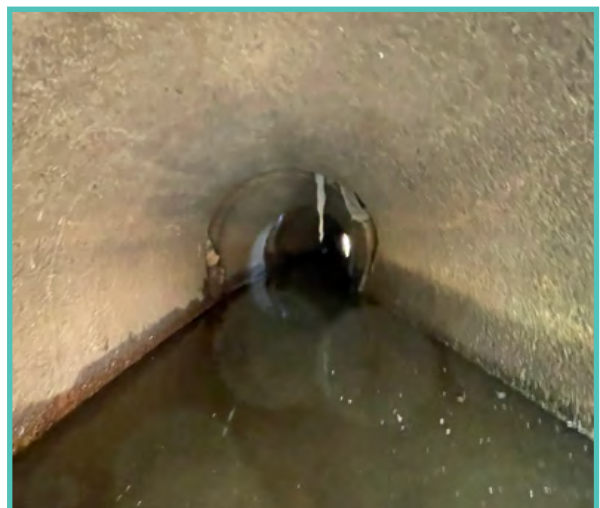
4. Deterioration due to pipe age.

Recommendation: Replace pipe.

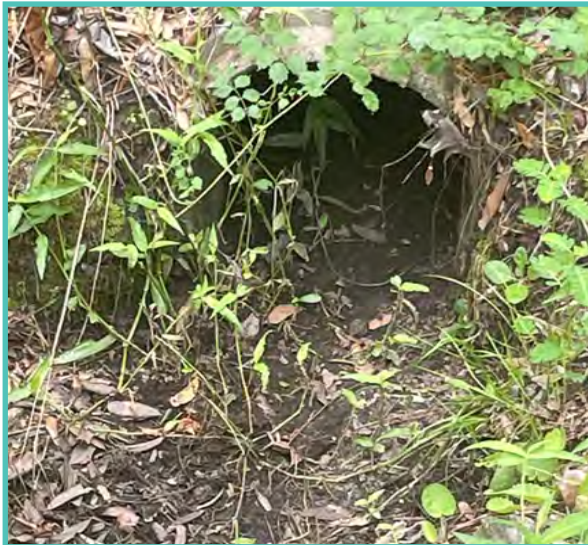
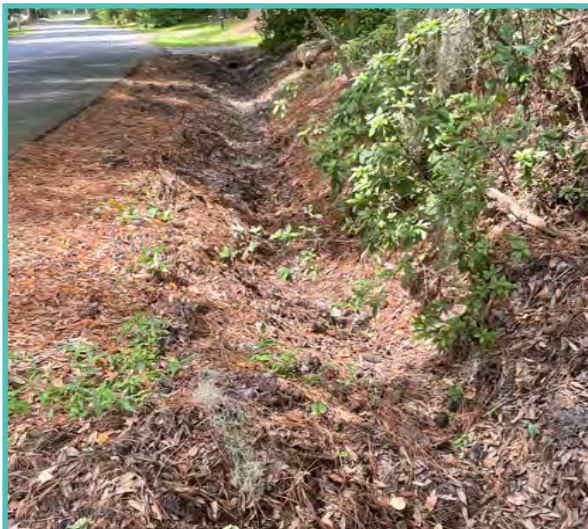
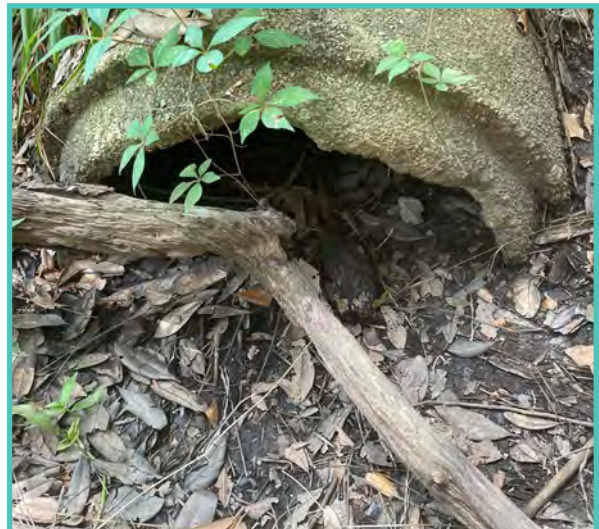
Reason: 1. Fully submerged.  
2. Partially full of sediment.

Recommendation: Clean and conduct channel maintenance.

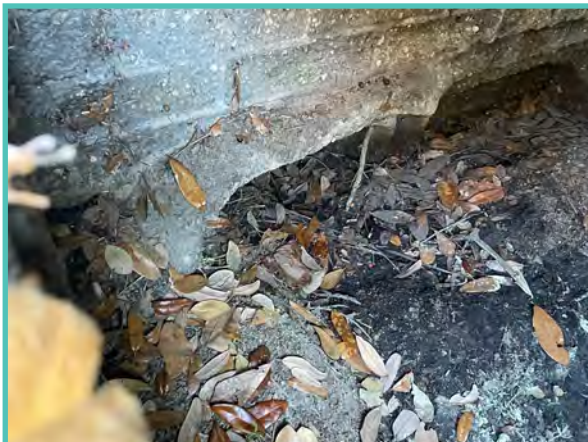
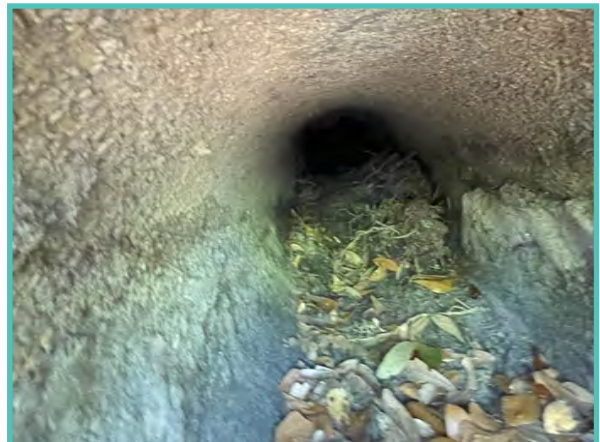
3. Unable to inspect east end of pipe, not accessible.

Recommendation: Clean pipe and replace catch basin.

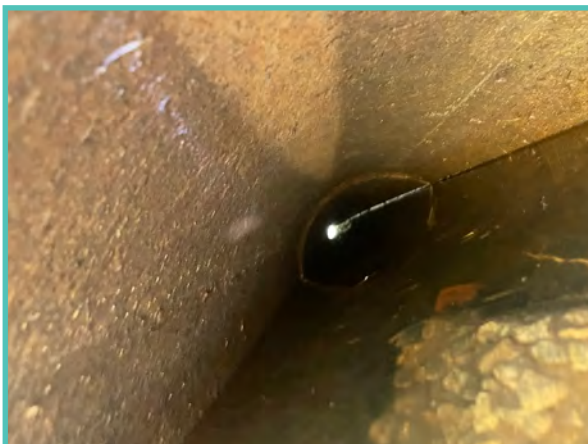
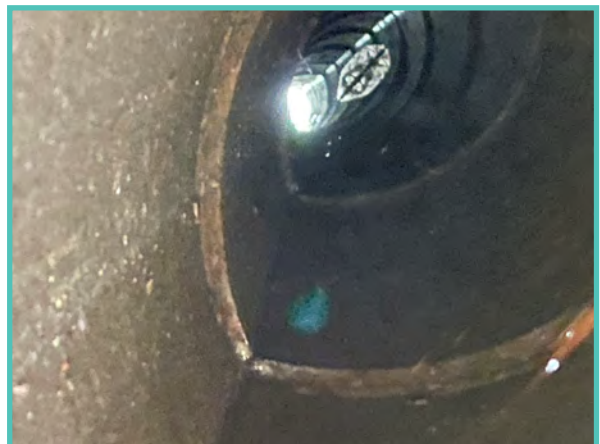
Reason: 1. Broken catch basin lid  
2. Deterioration due to pipe age.  
3. Unable to inspect east end of pipe, not accessible.

Recommendation: Replace pipe.

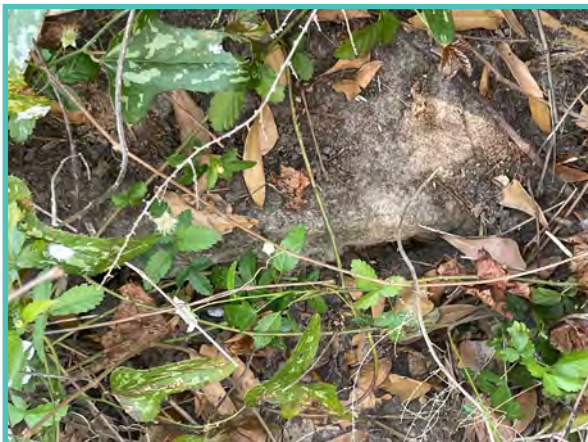
Performance Condition: Poor

2. Inlet Partially full of debris and sediment.

Recommendation: Clean and reinspect.

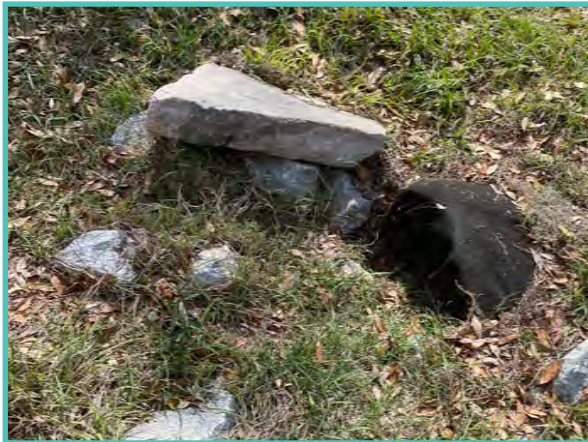
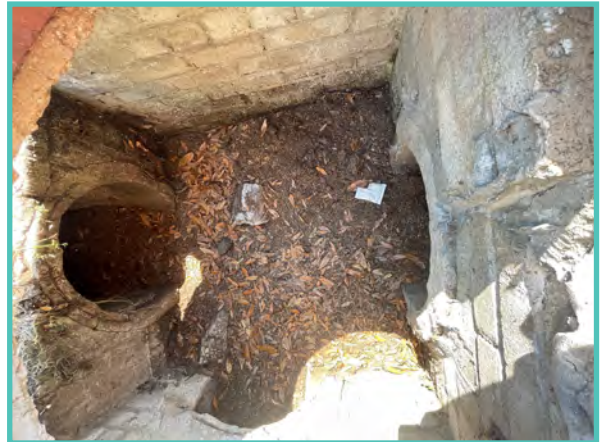
Crossline Pipe Inventory ID: **52857**

Performance Condition: Poor

Structural Condition: Good/Unknown

Reason: West end of pipe not accessible.

Recommendation: Clean and reinspect.

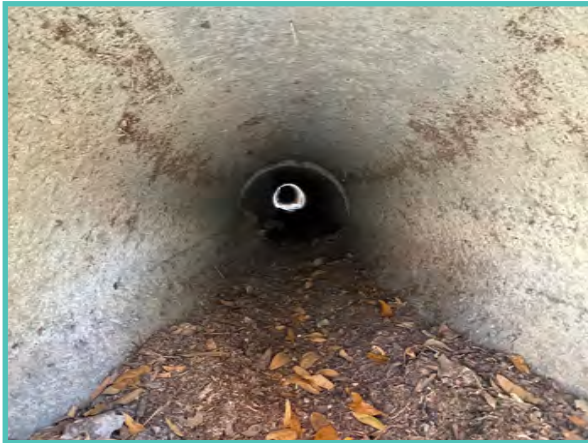
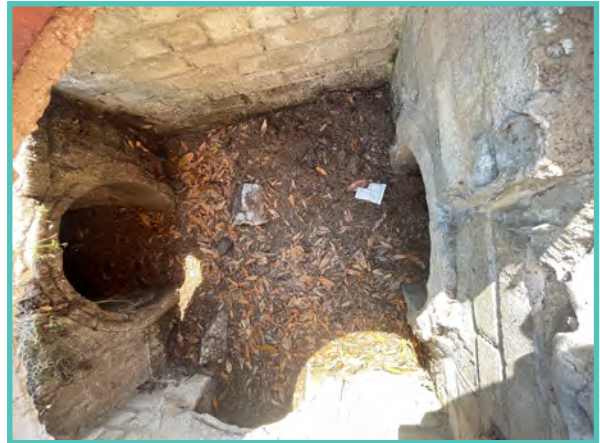
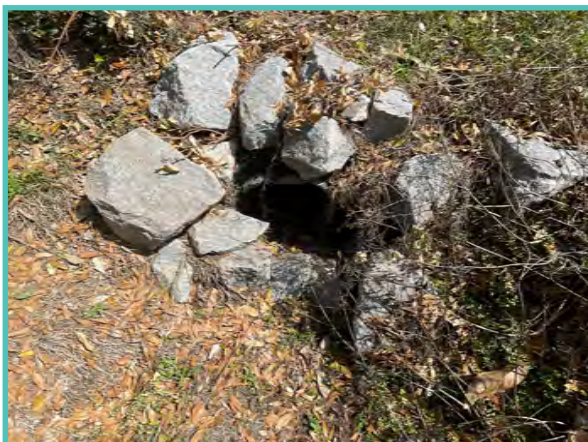
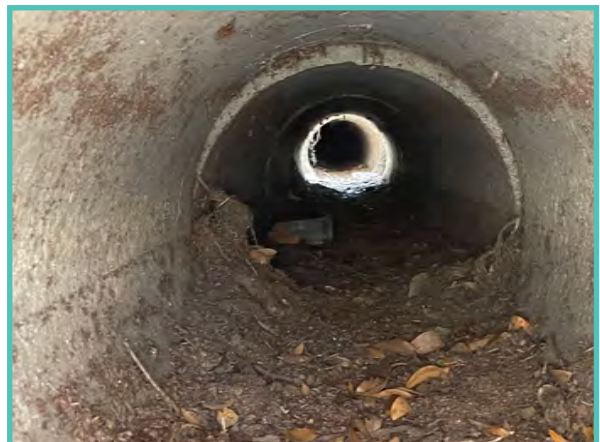
## Crossline Pipe Inventory ID: **59448**

Performance Condition: Poor

Structural Condition: Fair

Reason: Pipe joint displacement

Recommendation: Clean and reinspect in 5 years.

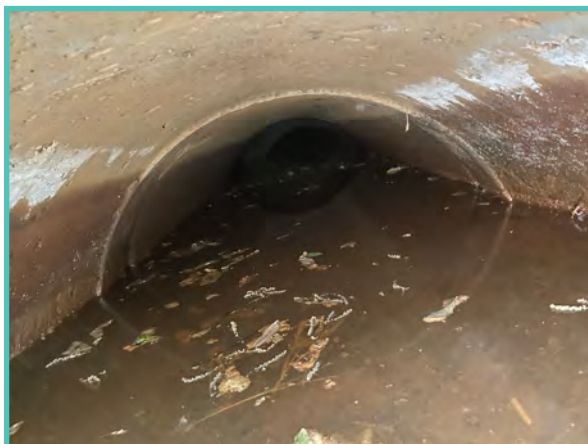
Performance Condition: Poor

Structural Condition: Poor

Reason: 1. Broken end bell.  
2. Severe pipe joint displacement.  
3. Deterioration due to pipe age.

Recommendation: Conduct channel maintenance and reinspect.

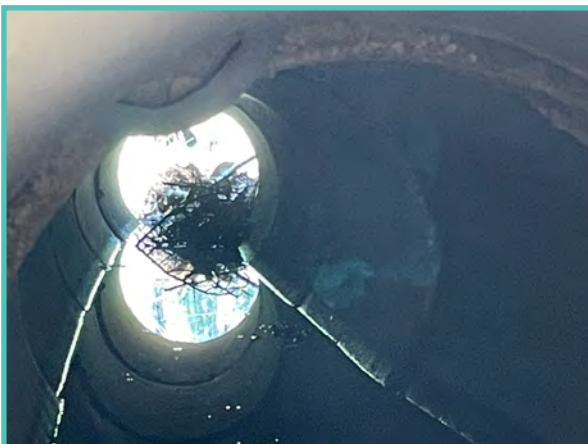
## Crossline Pipe Inventory ID: 57215

Performance Condition: Good

Structural Condition: Fair

Reason: Pipe joint displacement

Recommendation: Reinspect in 5 years.

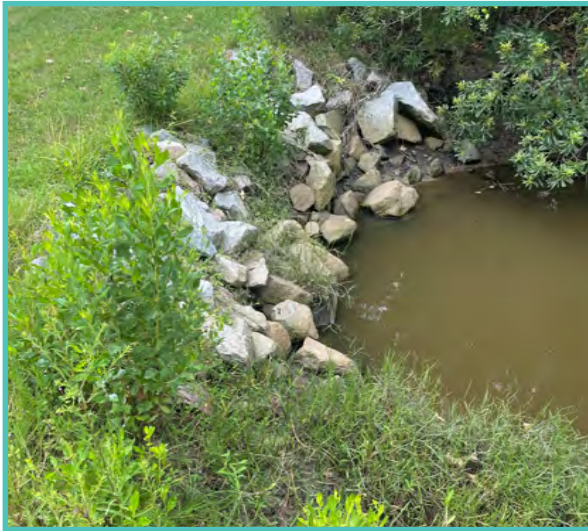
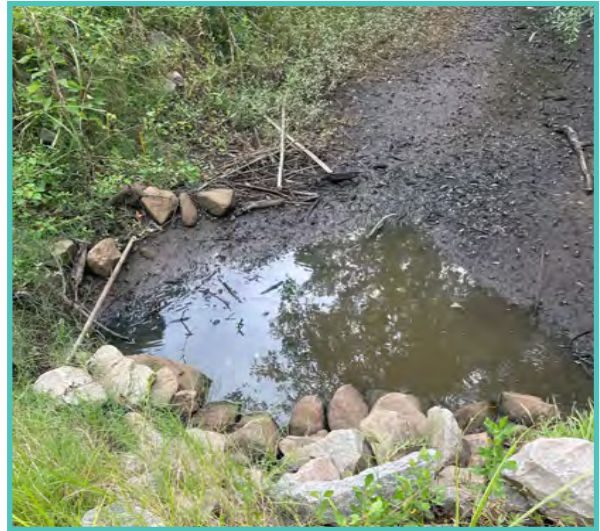
Performance Condition: Unknown

Structural Condition: Unknown

Reason: Fully submerged.

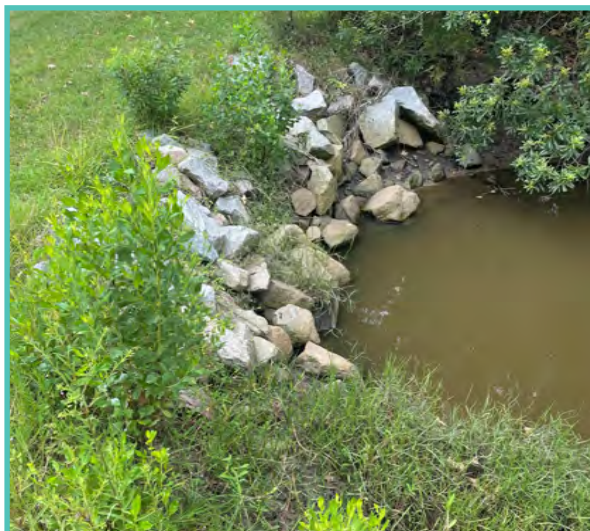
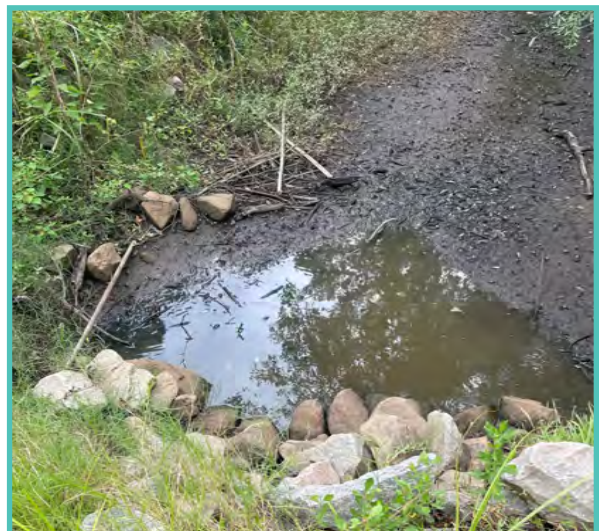
## Crossline Pipe Inventory ID: 53706

Performance Condition: Unknown

Structural Condition: Unknown

Reason: Fully submerged.

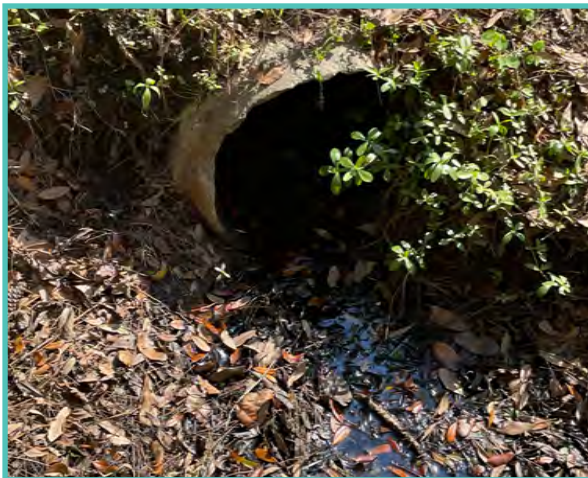
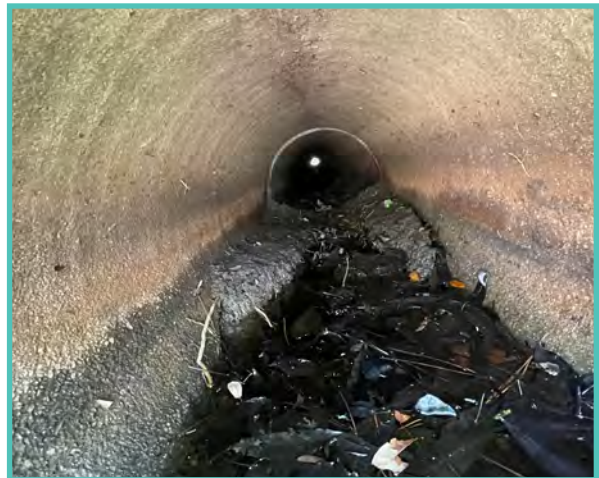
Performance Condition: Poor

Structural Condition: Poor

Reason: 1. Broken end bell.  
2. Severe pipe joint displacement.  
3. Deterioration due to pipe age.

Recommendation: Replace pipe.

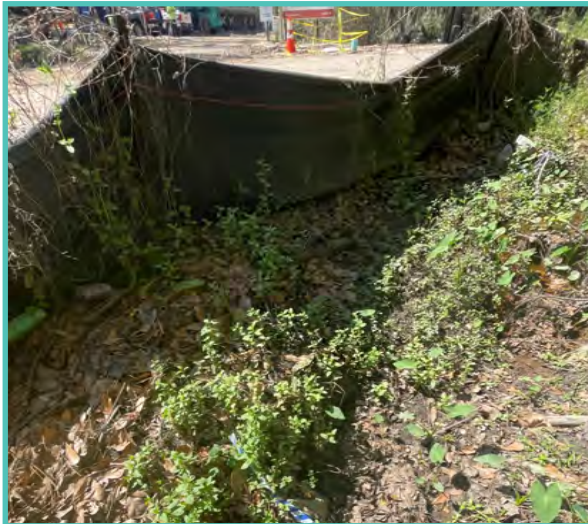
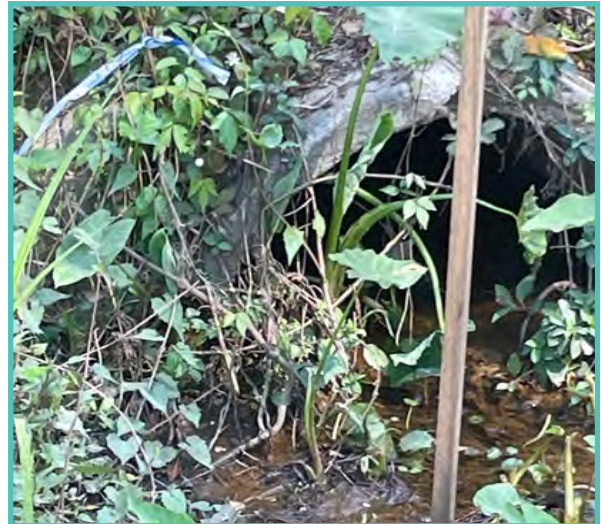
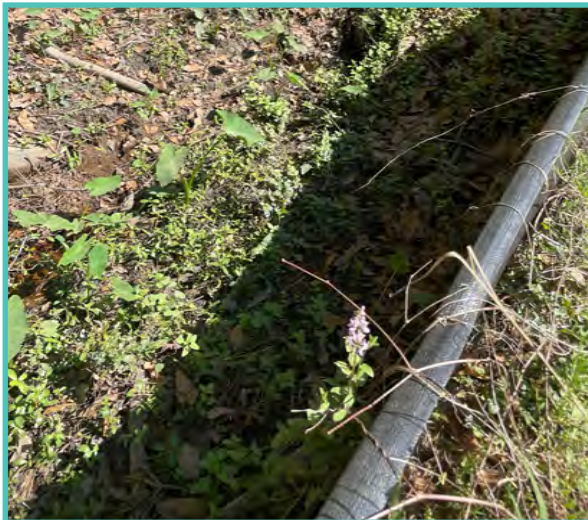
## Crossline Pipe Inventory ID: 57211

Performance Condition: Poor

Structural Condition: Fair/Unknown

Reason: 1. Interior not accessible.  
2. Broken end bell.

Recommendation: Clean and reinspect.

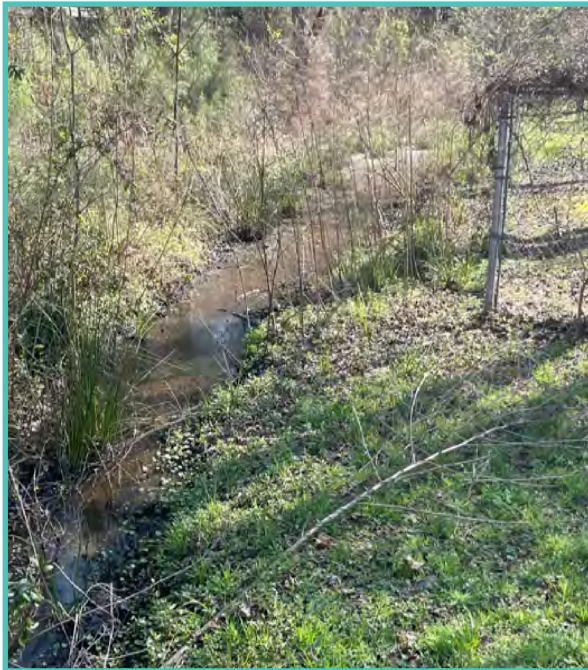
## Channel Inventory ID: **12706**

Performance Condition: Poor

Actions: 1. Remove vegetation.  
2. Daylight channel.

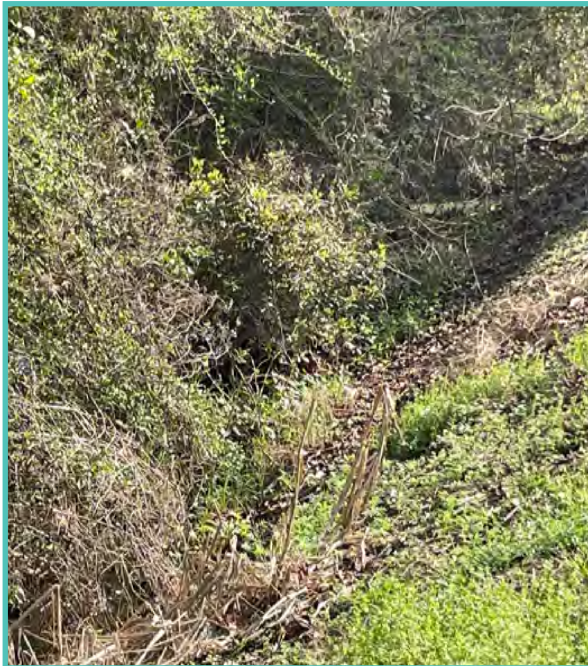
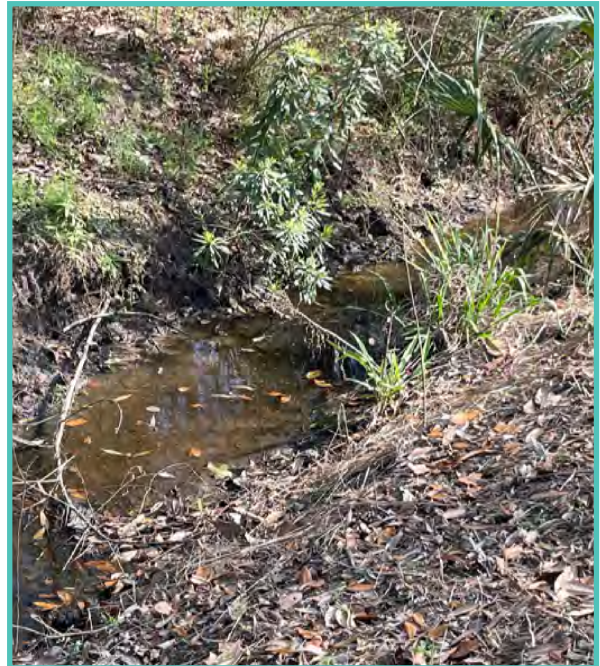
Channel Inventory ID: **12829**

Performance Condition: Poor

Actions: 1. Clean channel of debris and remove vegetation.

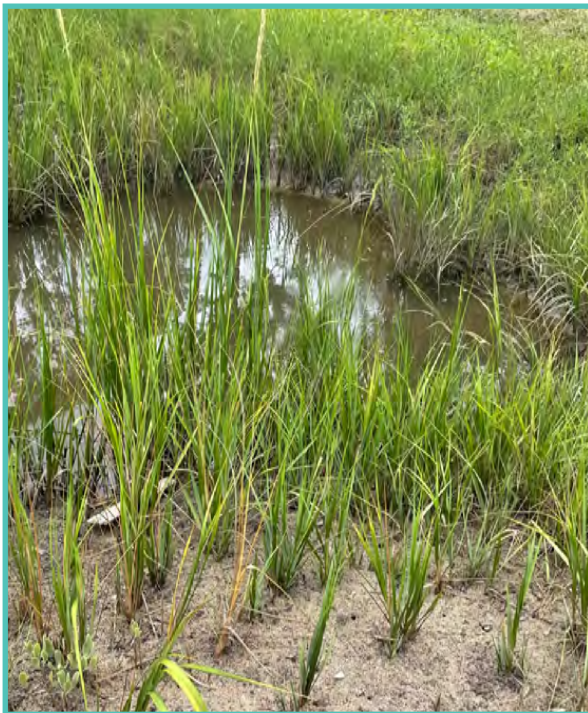
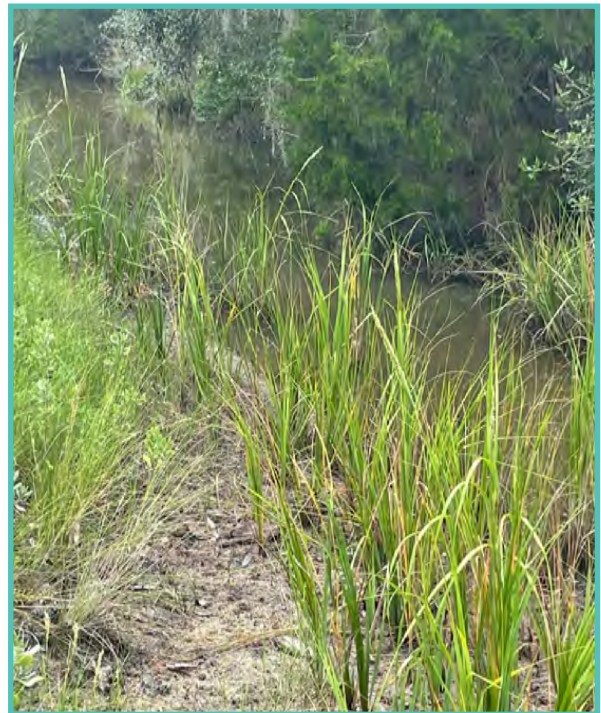
## Channel Inventory ID: 22301

Performance Condition: Poor

2. Nationwide #3 200-ft upstream and downstream of crossline pipe #60026. Requires work plan & checklist no permit.

3. Individual permit & mitigation.

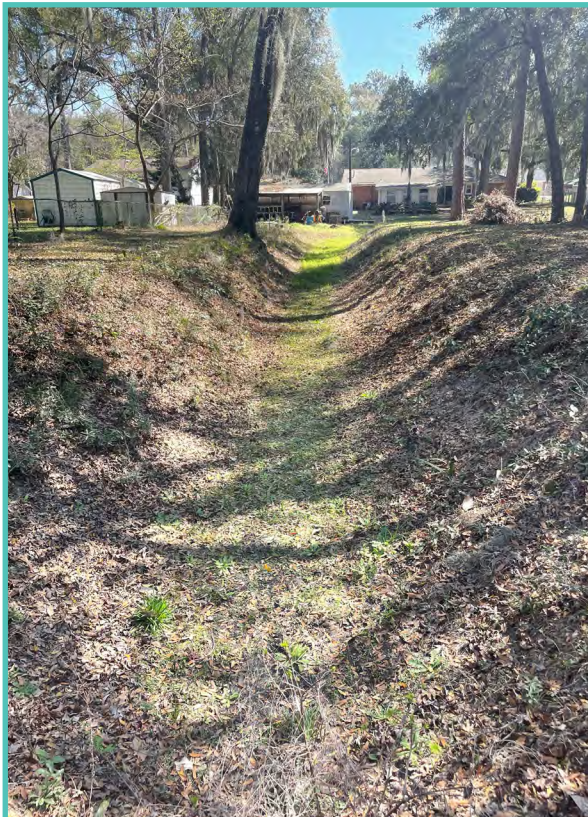
## Channel Inventory ID: **26310**

Performance Condition: Fair

Actions: Remove Vegetation

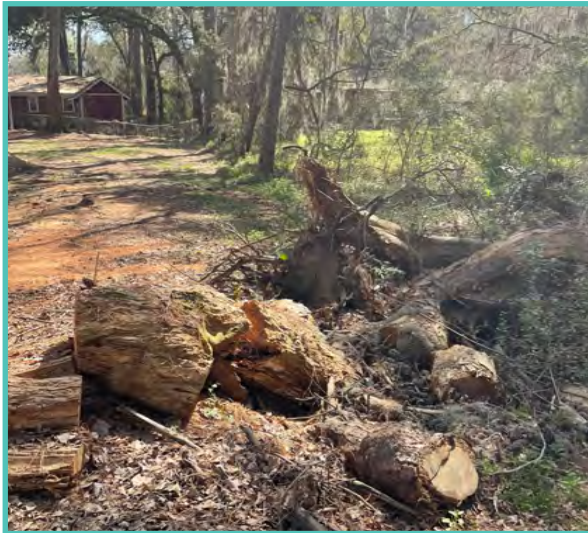
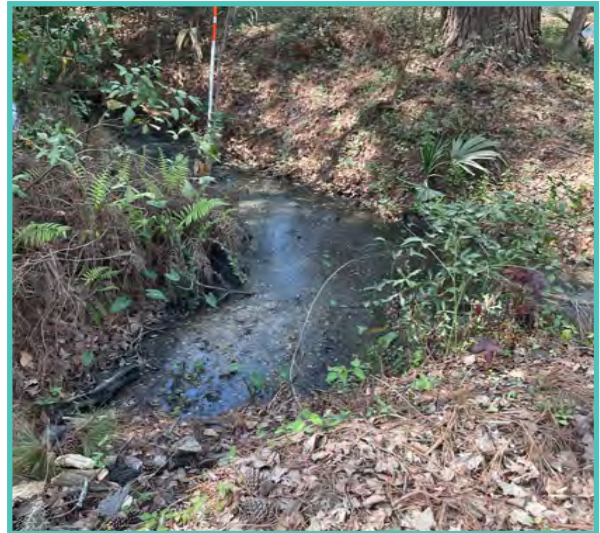
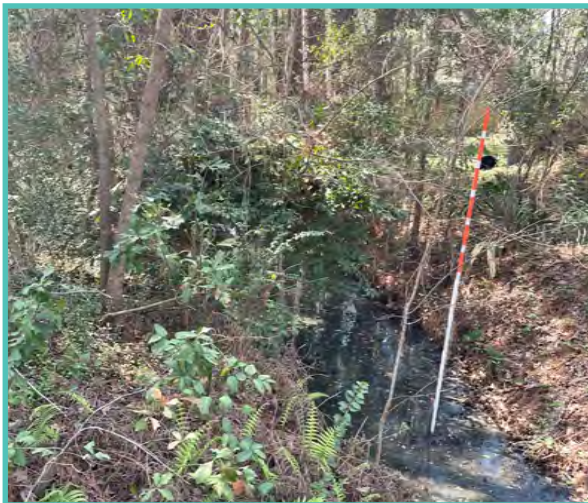
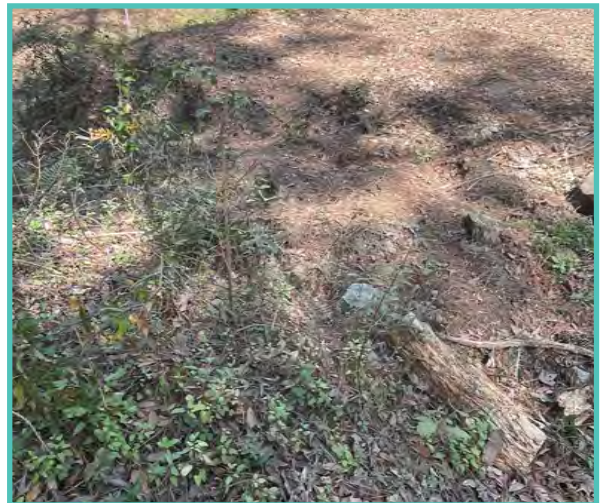
## Channel Inventory ID: **26311**

Performance Condition: Poor

Actions: None private residence/ditch. No complaints.

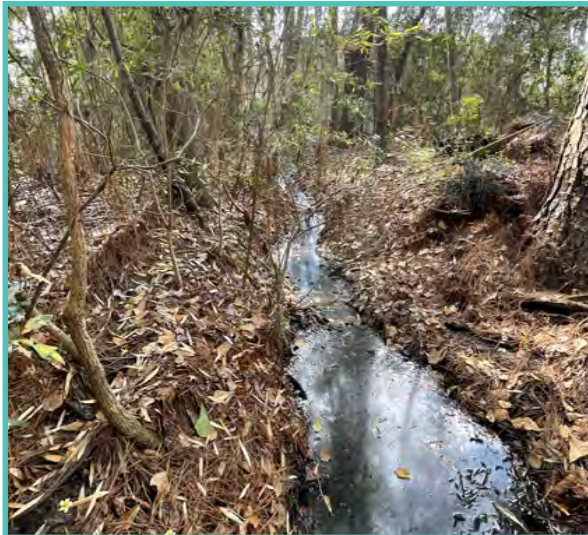
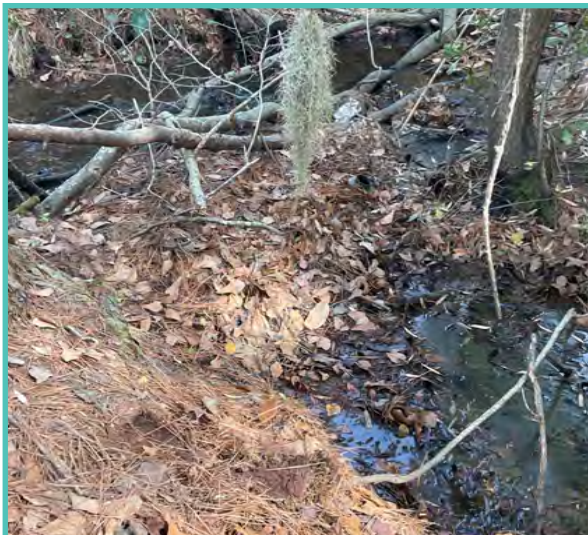
Performance Condition: Poor

Actions: Clean channel of debris, remove vegetation and some trees. Daylight channel. Cleaning of this channel will be important for upsizing crossline pipe #59399.

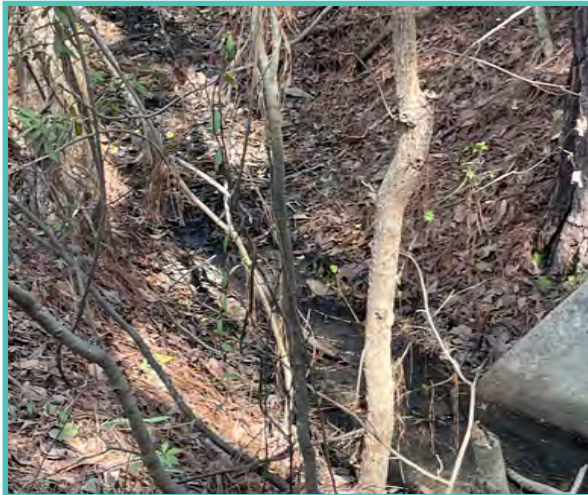
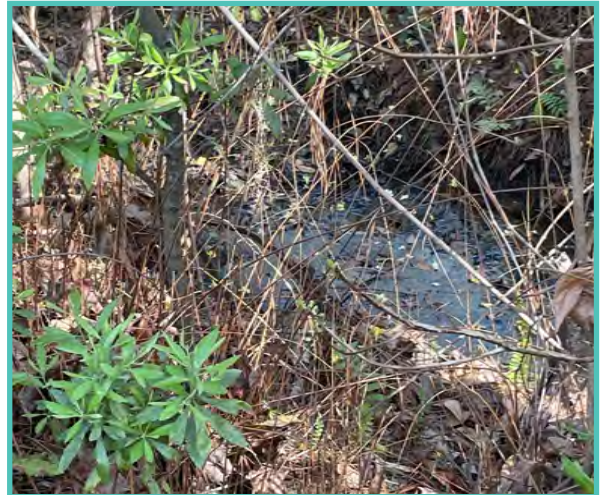
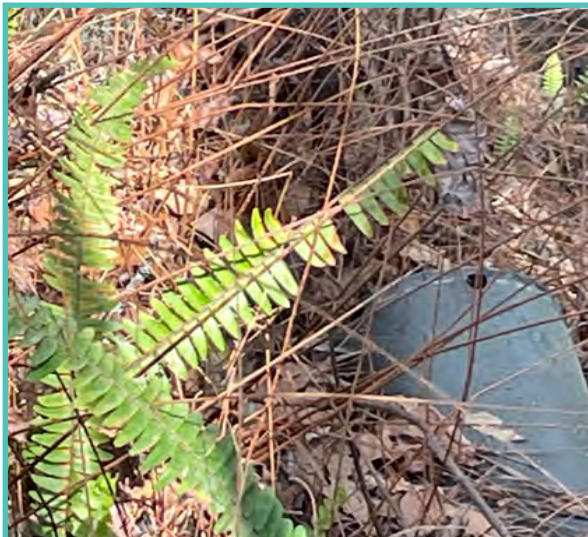
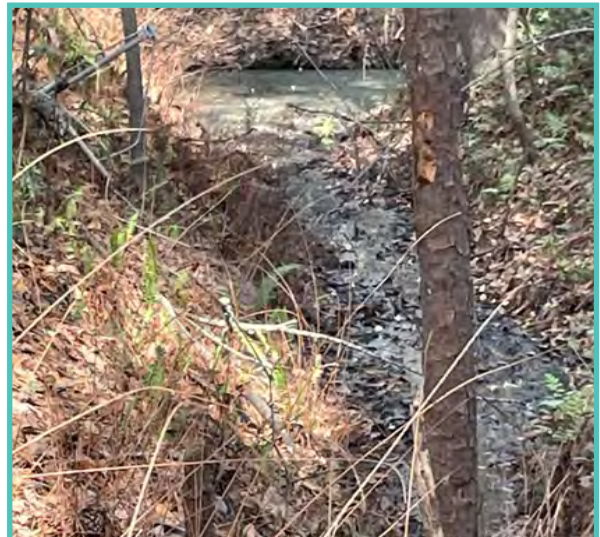
Channel Inventory ID: **26498**

Performance Condition: Poor

Actions: Clean channel of debris, remove vegetation and some trees. Daylight channel.

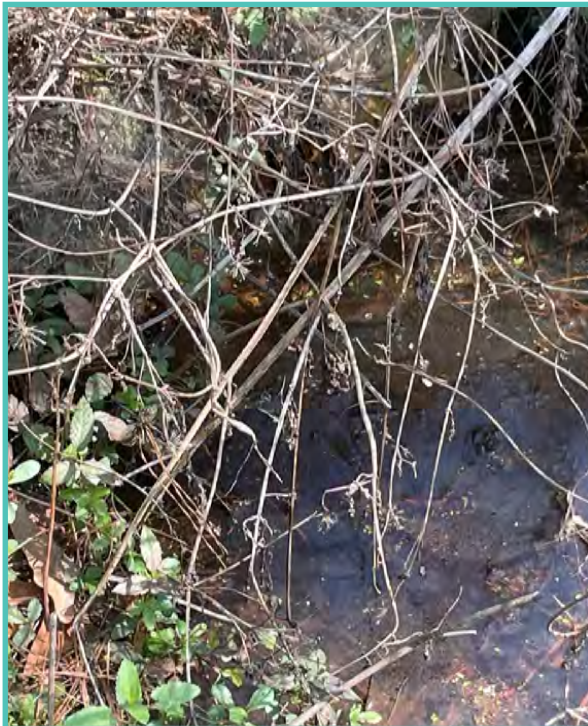
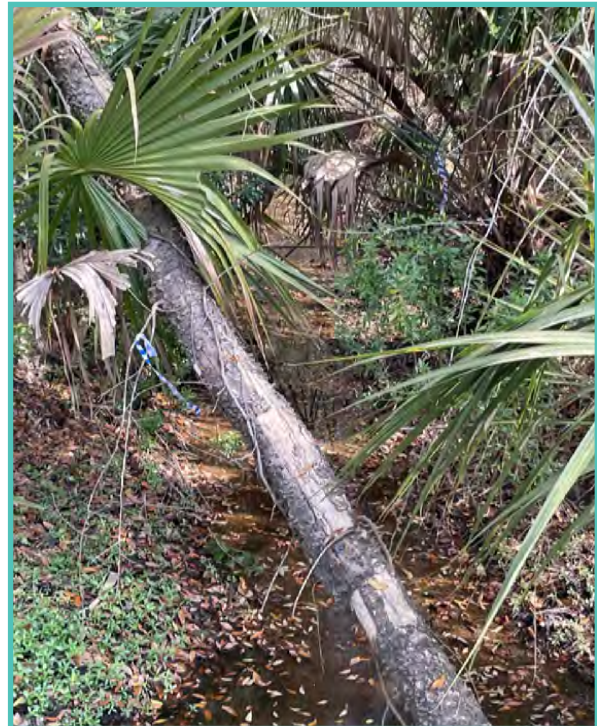
Channel Inventory ID: **28693**

Performance Condition: Fair

Reason: Adverse grade causing submergence of crossline pipe #23213 and downstream conditions.

2. Nationwide #3 200-ft upstream and downstream of crossline pipe #23213. Requires work plan & checklist no permit.

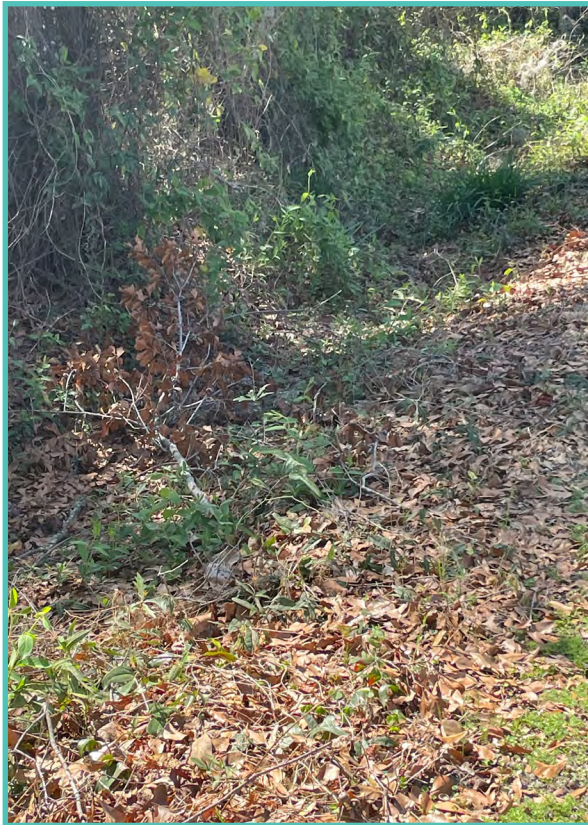
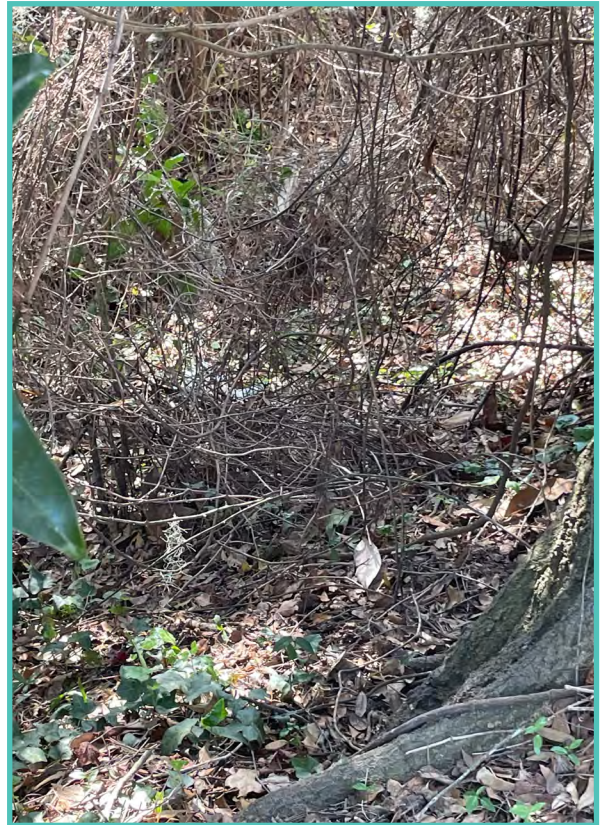
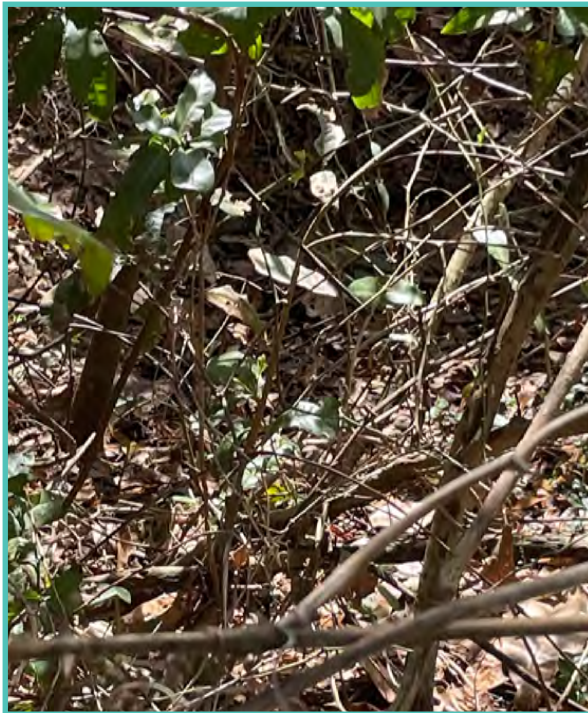
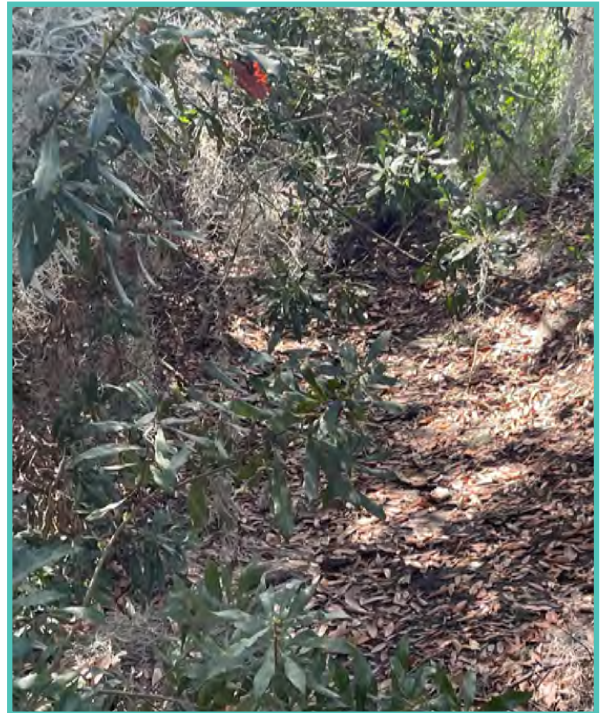
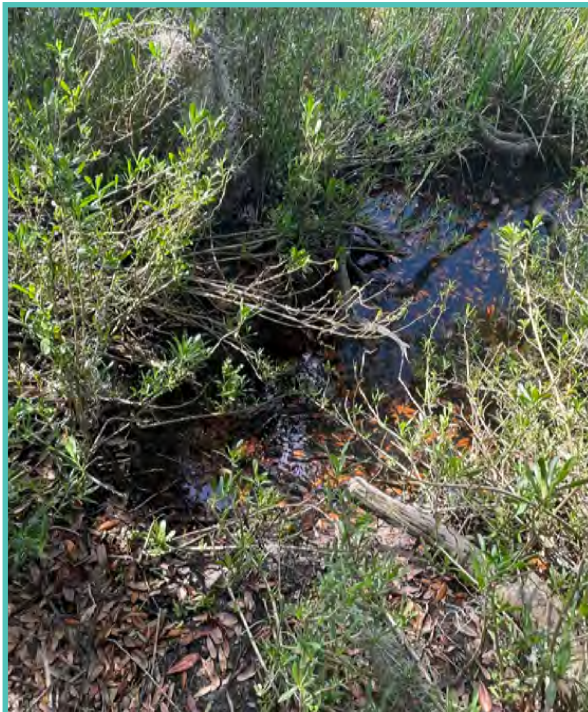
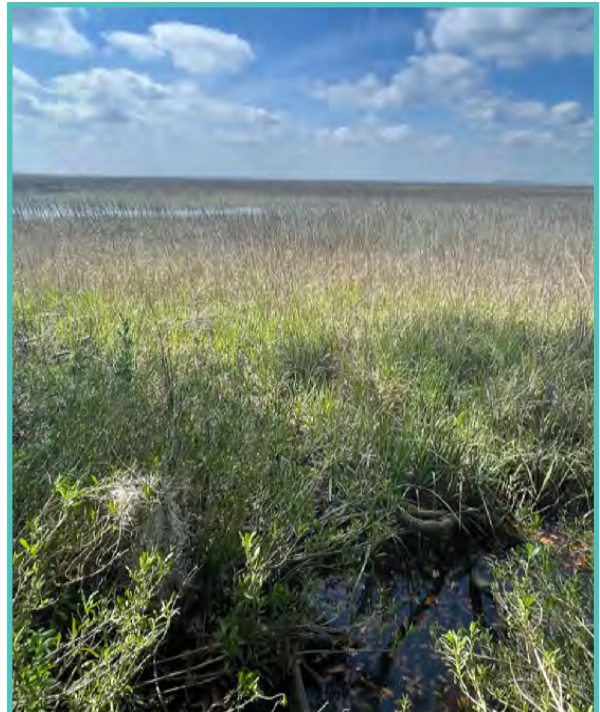
## Channel Inventory ID: **31169**

Performance Condition: Poor

Actions: Daylight channel.

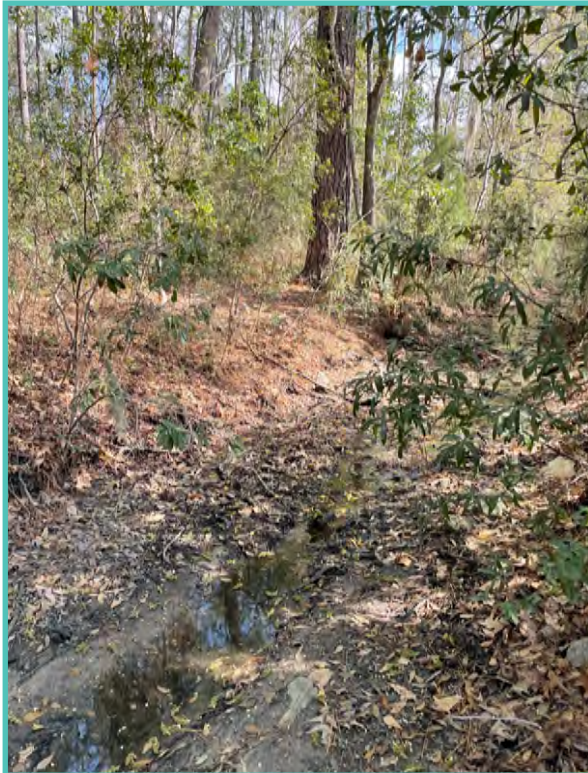
## Channel Inventory ID: **32183**

Performance Condition: Fair

Actions: 1. Channel cleaning and vegetation removal.  
2. Daylight channel.
