# STORMWATER MANAGEMENT SYSTEM CONDITION ASSESSMENT

## Shell Point Drainage Improvement Program

Beaufort County Stormwater  
120 Shanklin Rd  
Beaufort, SC 29906

April 2023

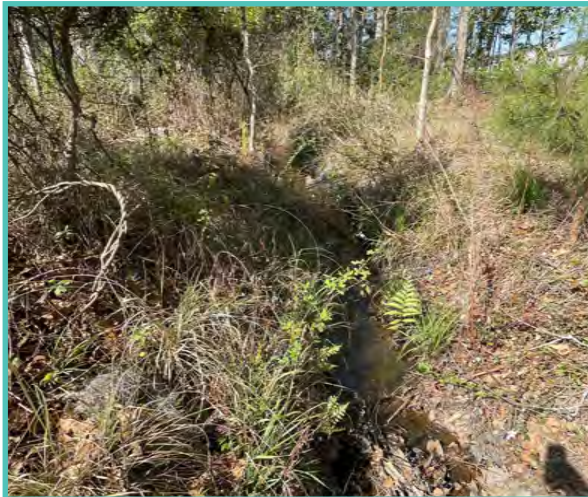
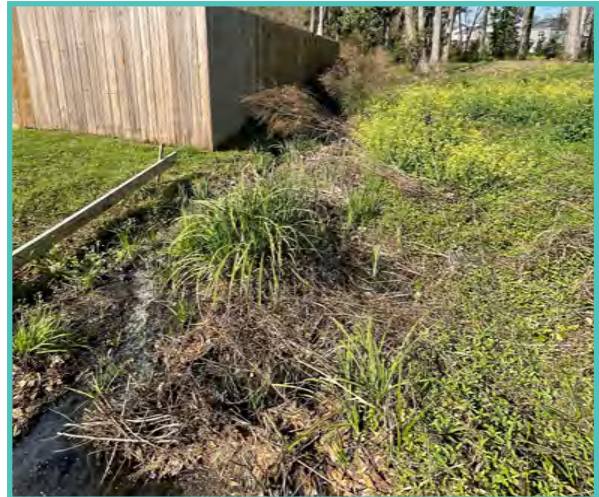
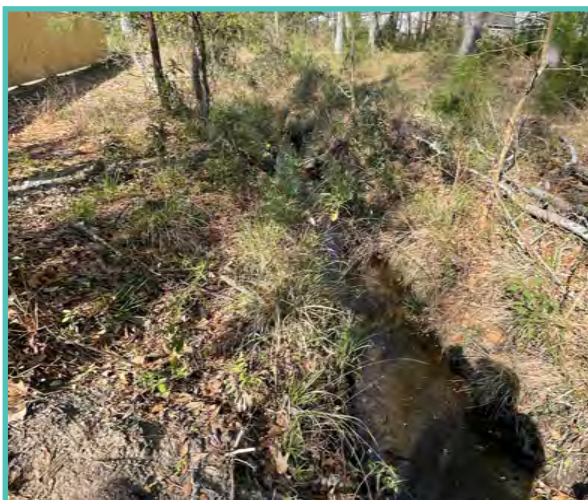
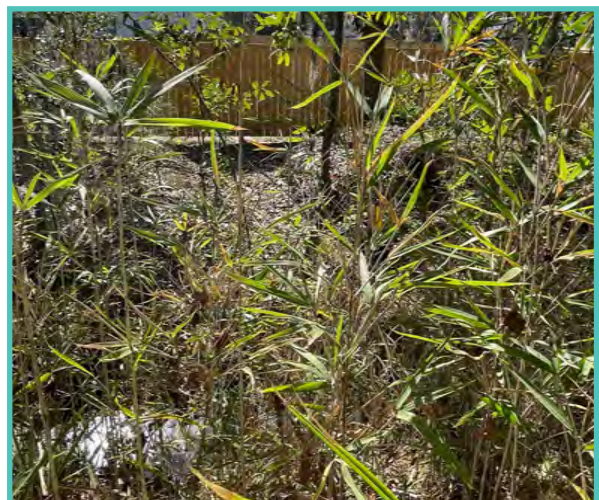
## Channel Inventory ID: **32581**

Performance Condition: Poor

Reason: Holding water due to downstream conditions. Adverse channel grade causing submergence of crossline pipe #37487. Work to be included with Nationwide #3 permit for crossline pipe.

Actions: Daylight channel.

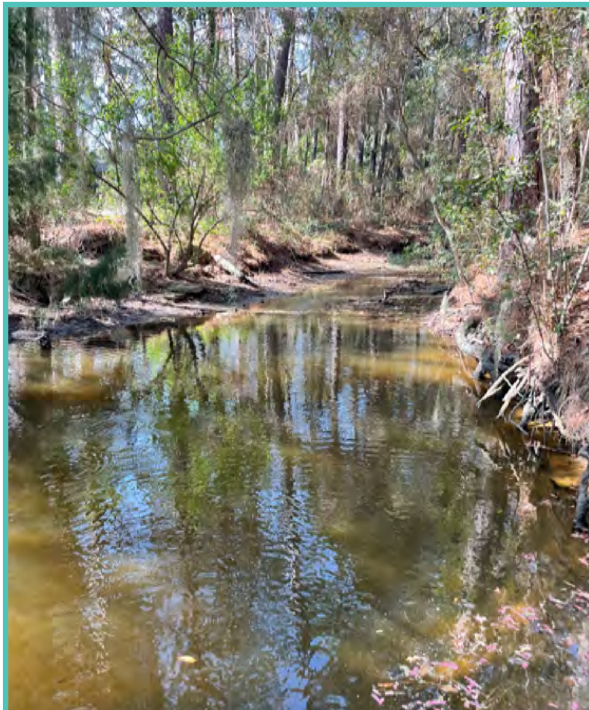
Channel Inventory ID: **32725**

Performance Condition: Fair

Actions: Daylight channel.

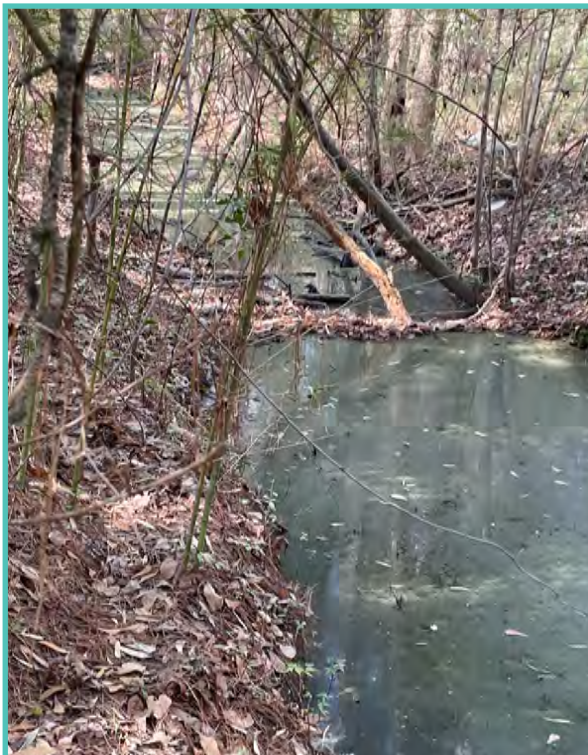
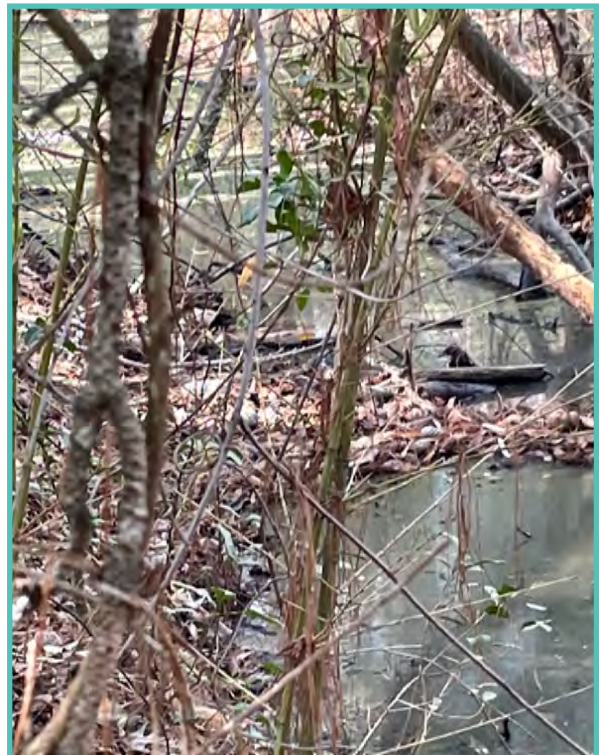
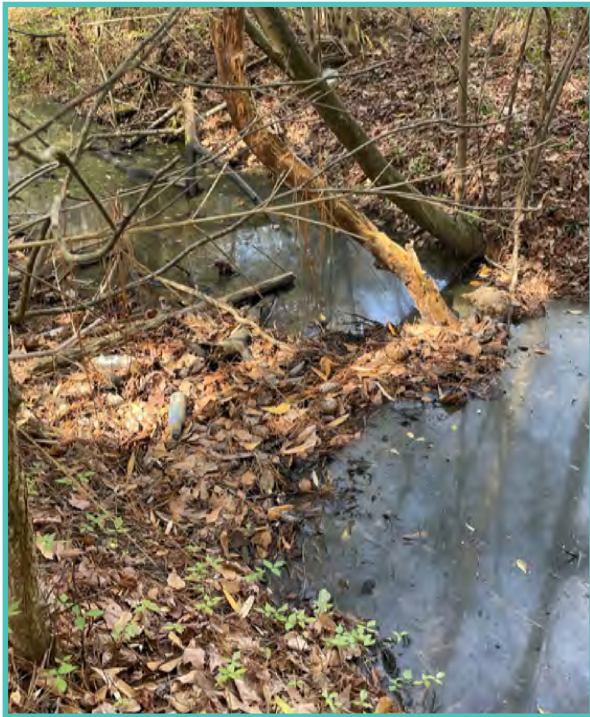
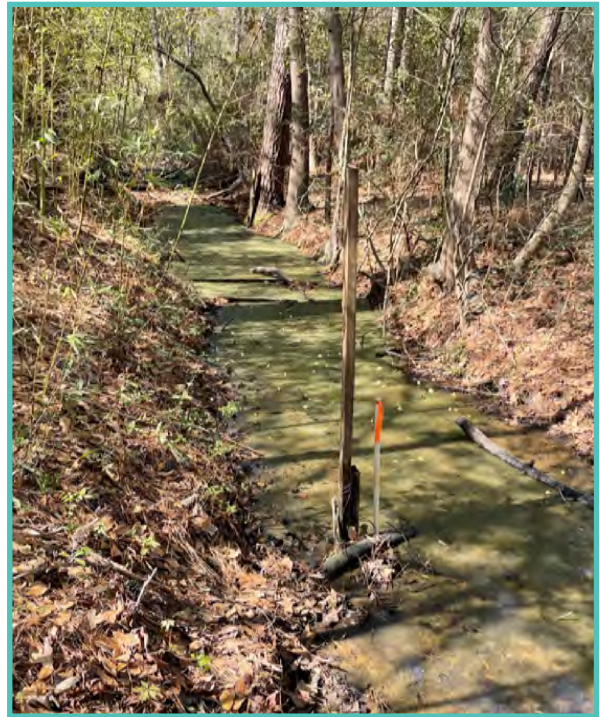
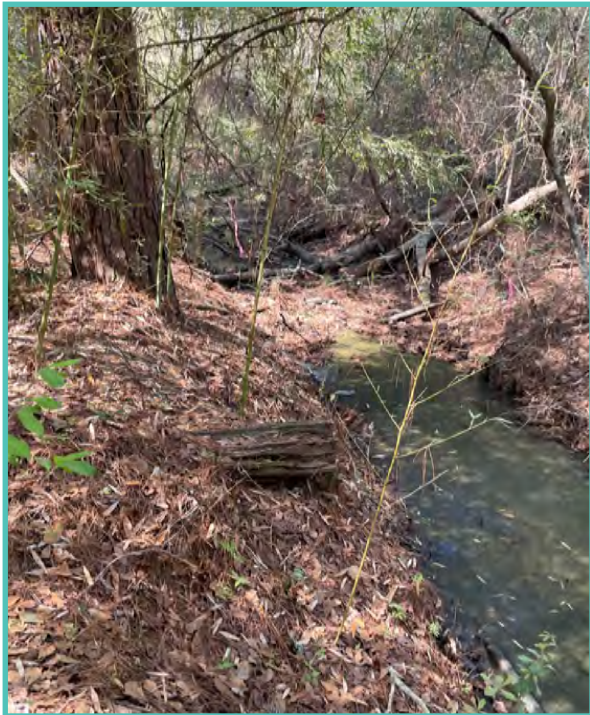
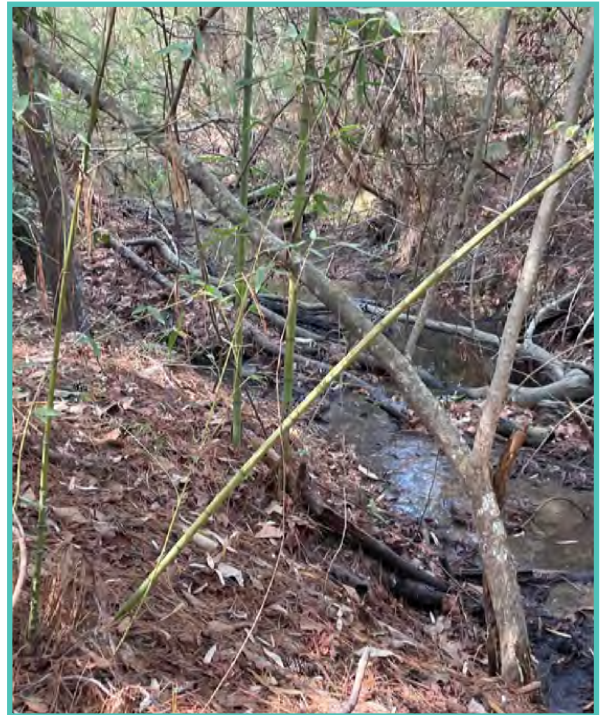
Channel Inventory ID: **33247**

Performance Condition: Poor

Reason: Holding water due to downstream conditions, debris blockage, vegetation and sediment infill.

Actions: Clean channel of debris, remove vegetation and some trees. Clean out sediment.

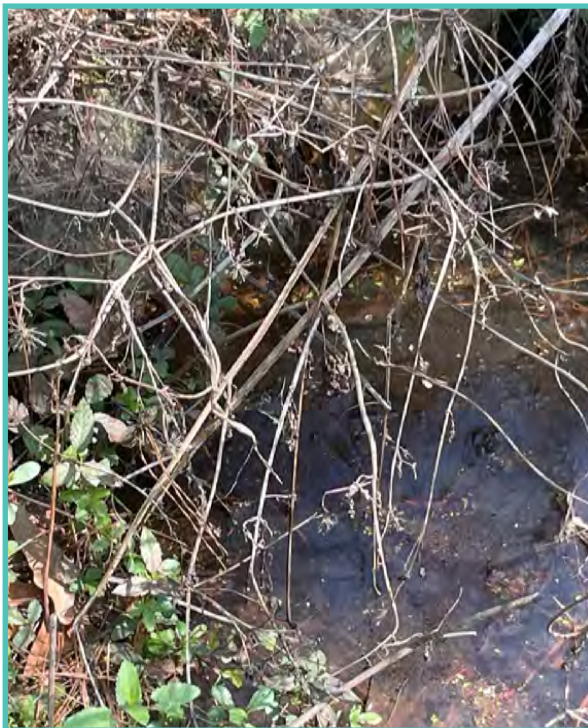
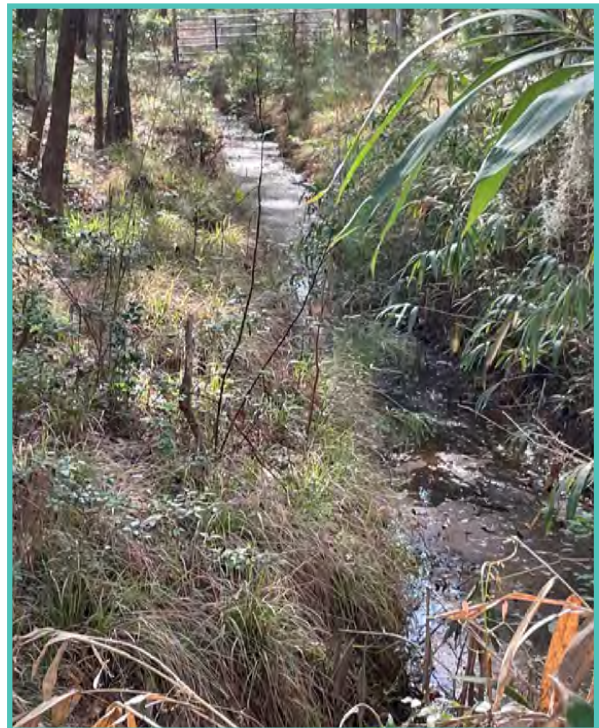
Channel Inventory ID: **34462**

Performance Condition: Fair

Actions: Daylight channel.

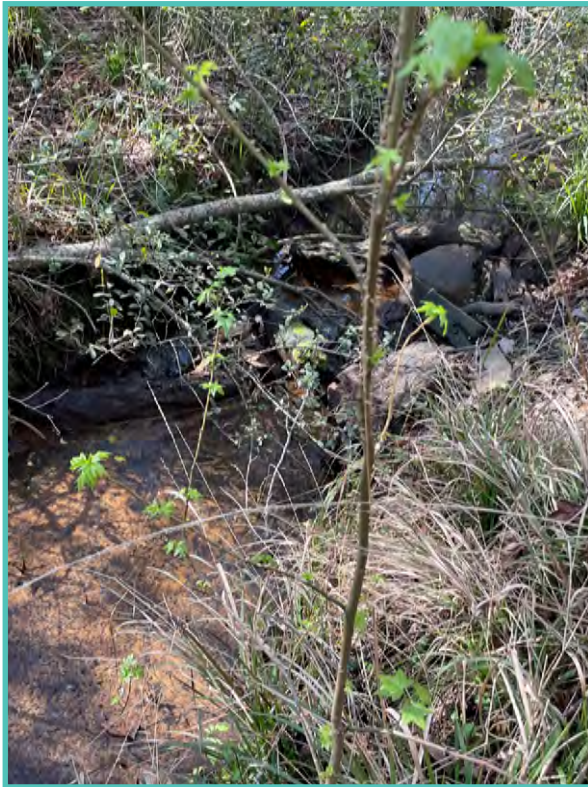
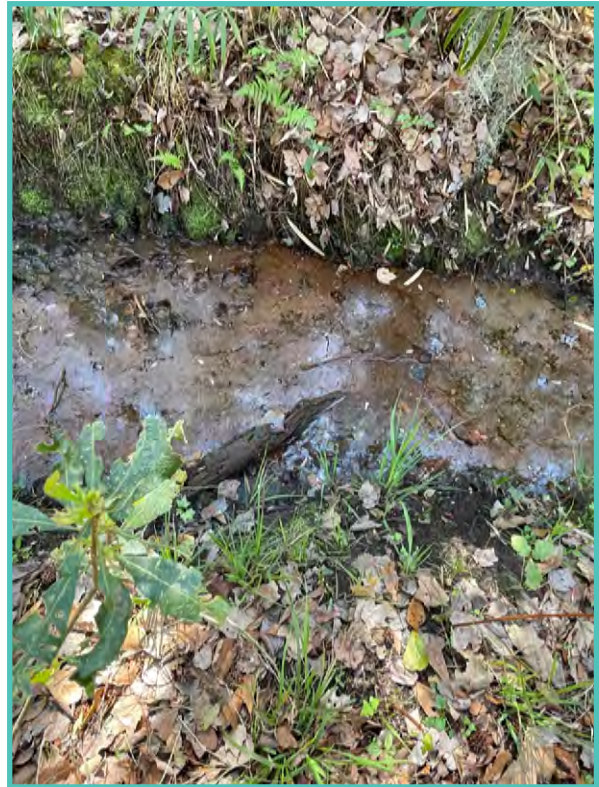
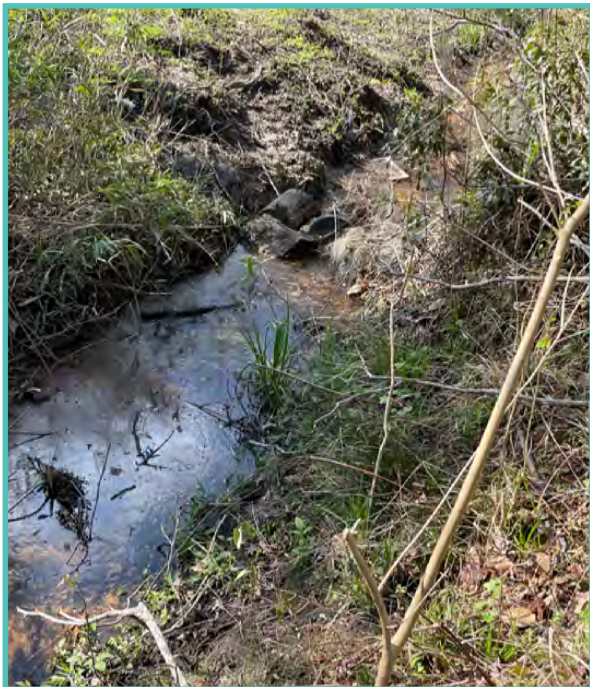
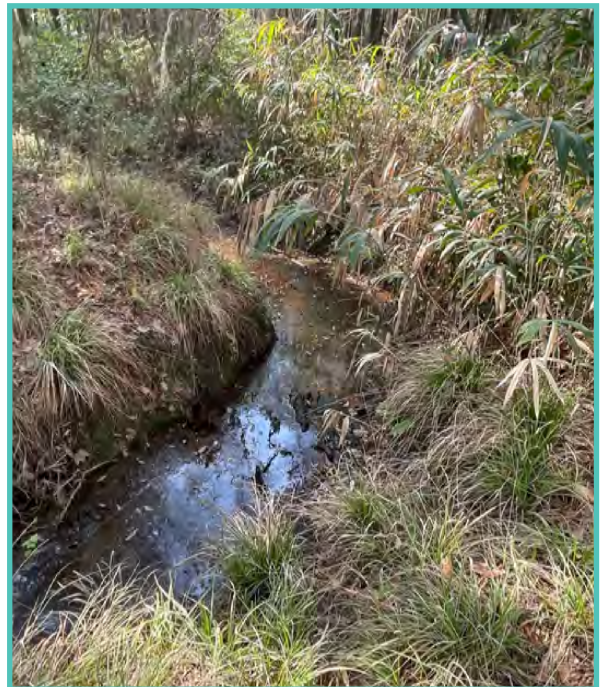
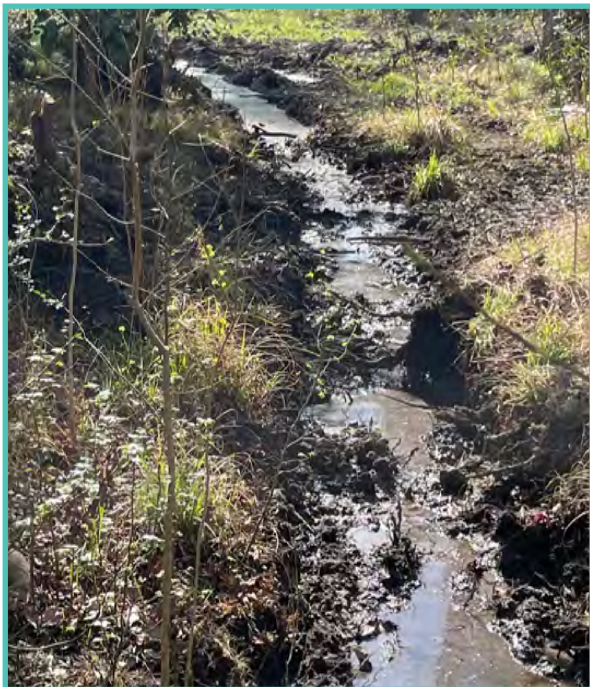
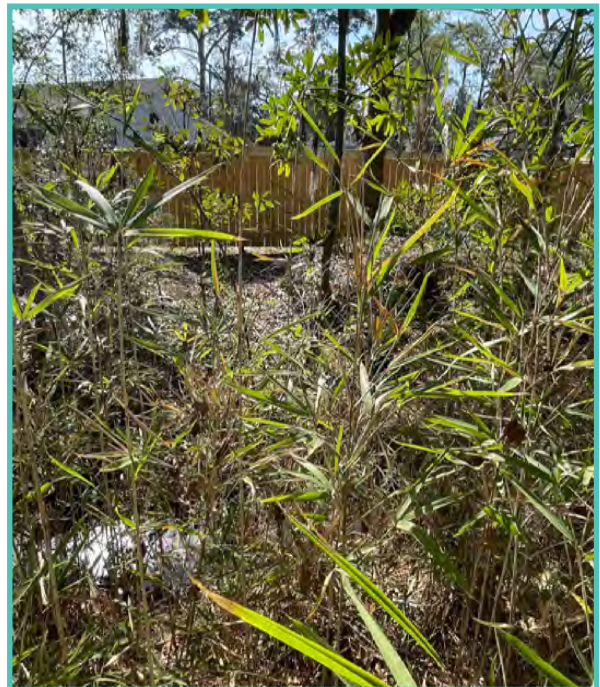
Channel Inventory ID: **34463**

Performance Condition: Fair

Actions: Daylight downstream portion of channel segment.

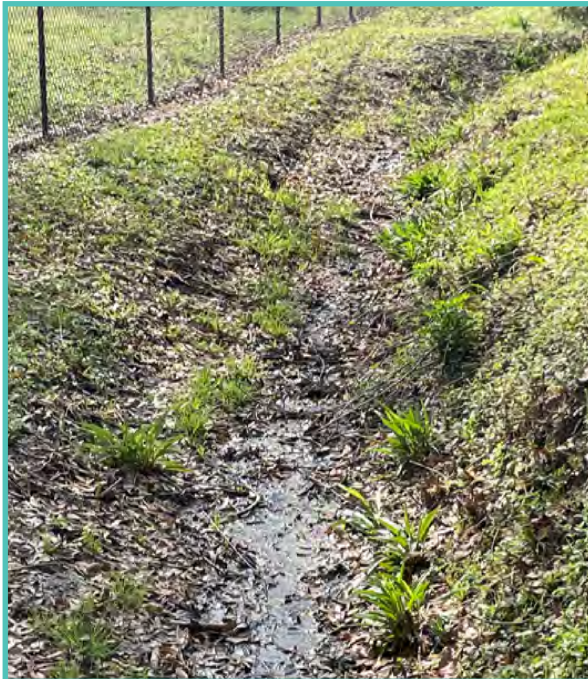
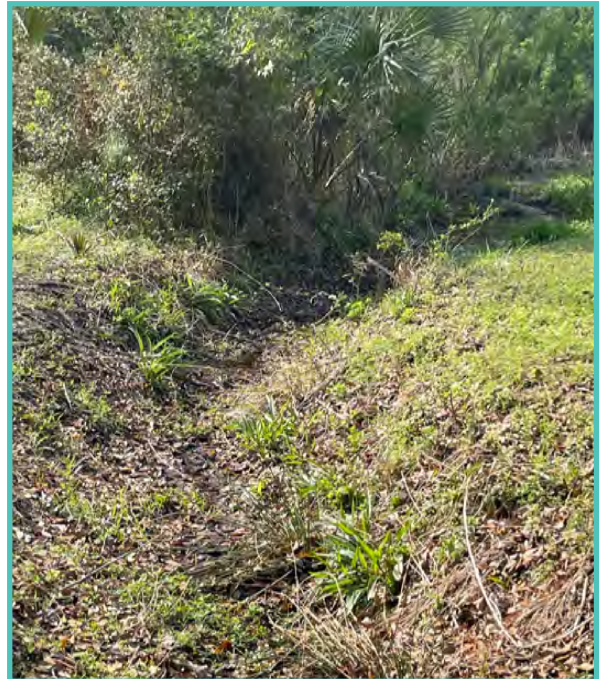
Channel Inventory ID: **34531**

Performance Condition: Good

Actions: None private residence/ditch. No complaints.

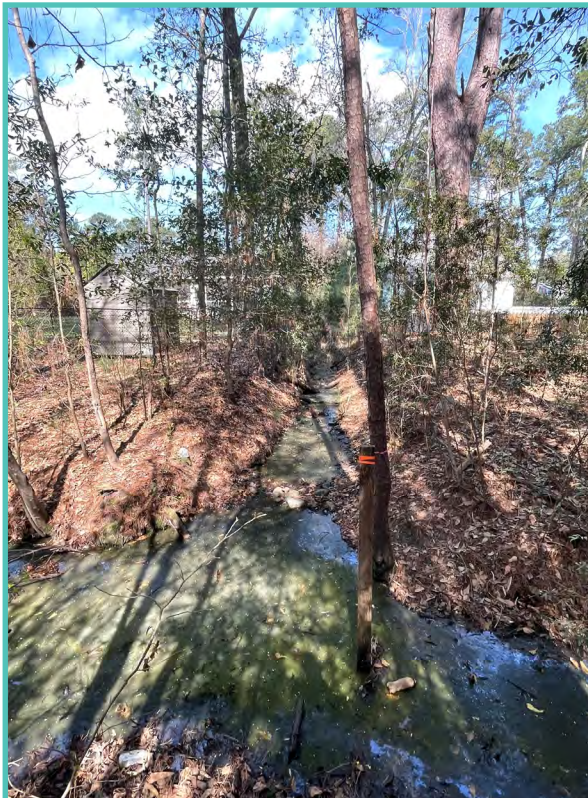
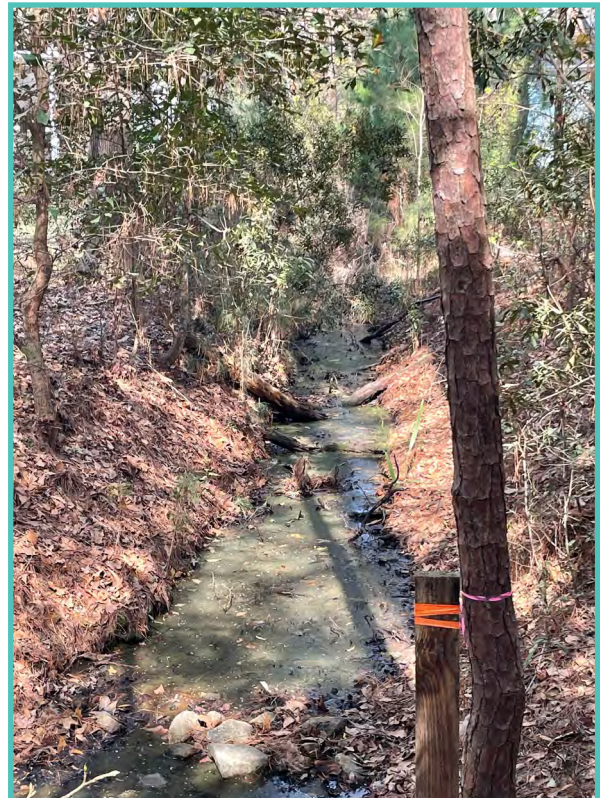
Channel Inventory ID: **34548**

Performance Condition: Poor

Reason: Holding water due to downstream conditions, debris blockage, vegetation and sediment infill.

Actions: Daylight channel, remove debris and vegetation.

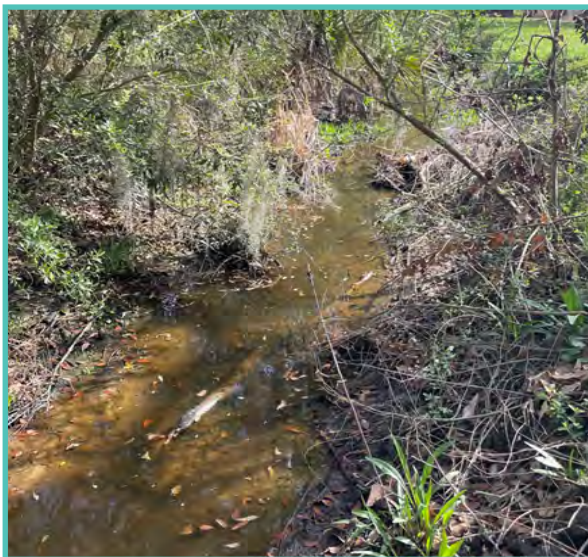
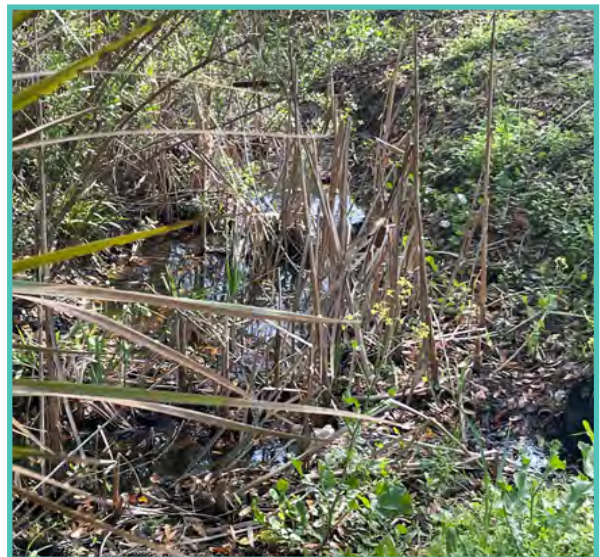
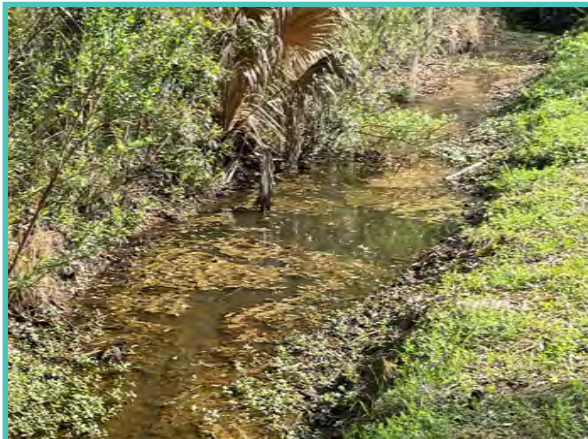
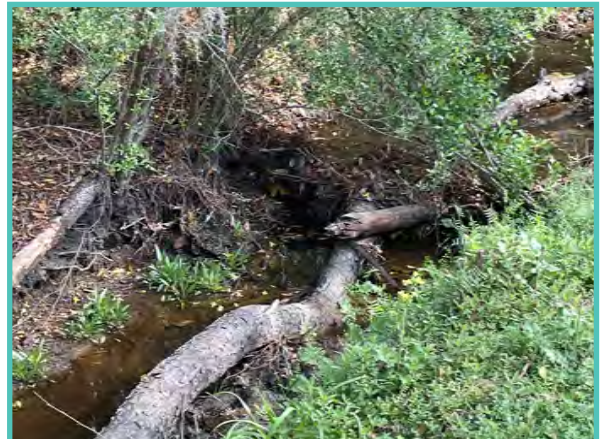
Performance Condition: Poor

Actions: Daylight channel.

USACE Requirements: Nationwide #3 200-ft upstream and downstream of crossline pipe #35786.  
Requires work plan & checklist no permit.

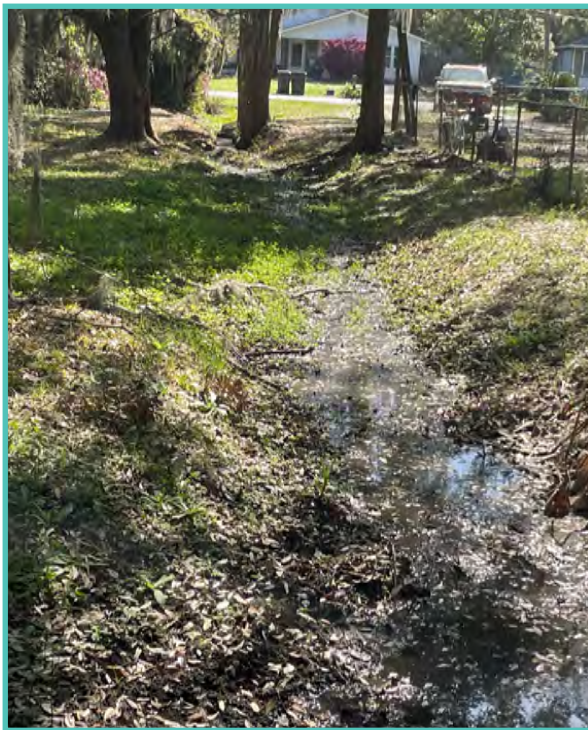
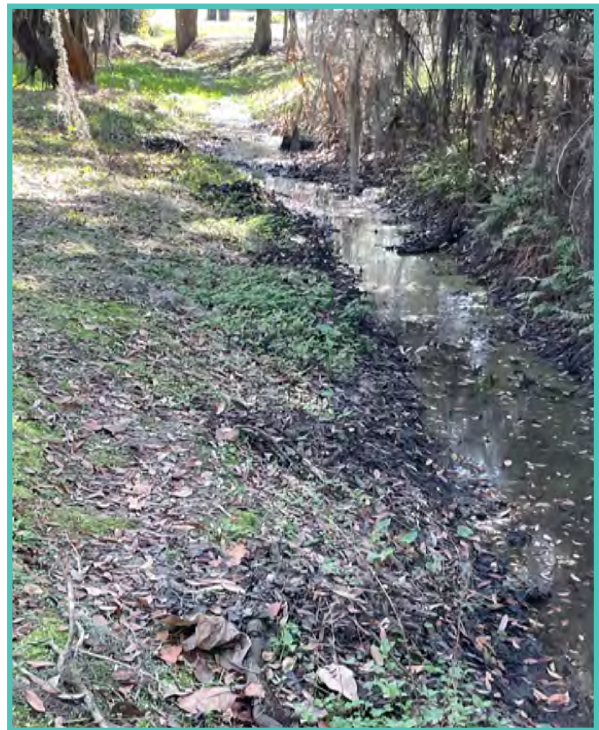
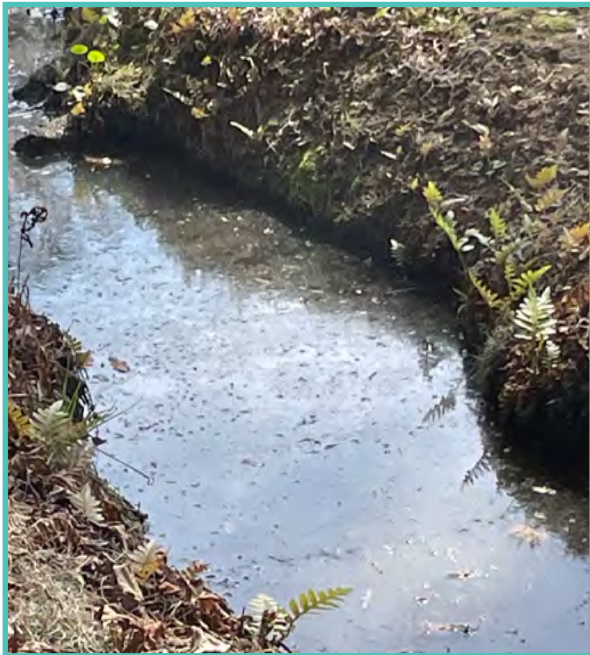
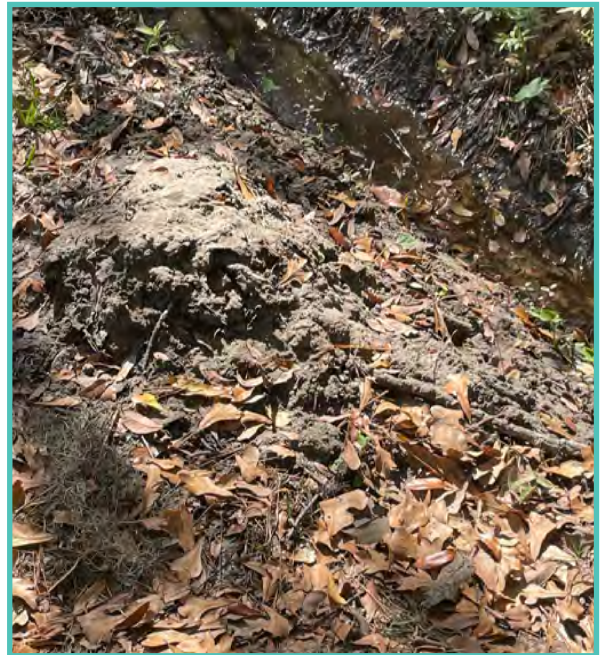
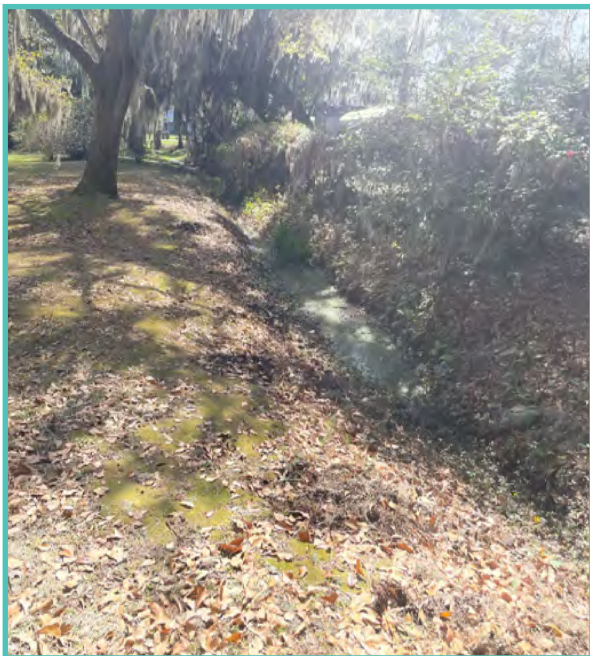
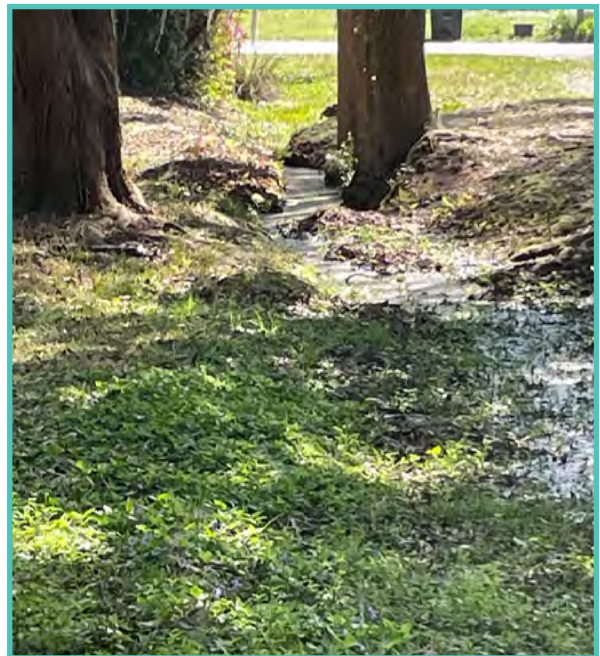
## Channel Inventory ID: **41936**

Performance Condition: Poor

Reason: Ditch cross section not sufficient for carrying storm-water flow. Low backyard grades allow flooding. Down stream conveyance require maintenance and may be inadequate.

Actions: Daylight channel, widen cross section, remove sediment from downstream crossline #59399. Tree removal involved.

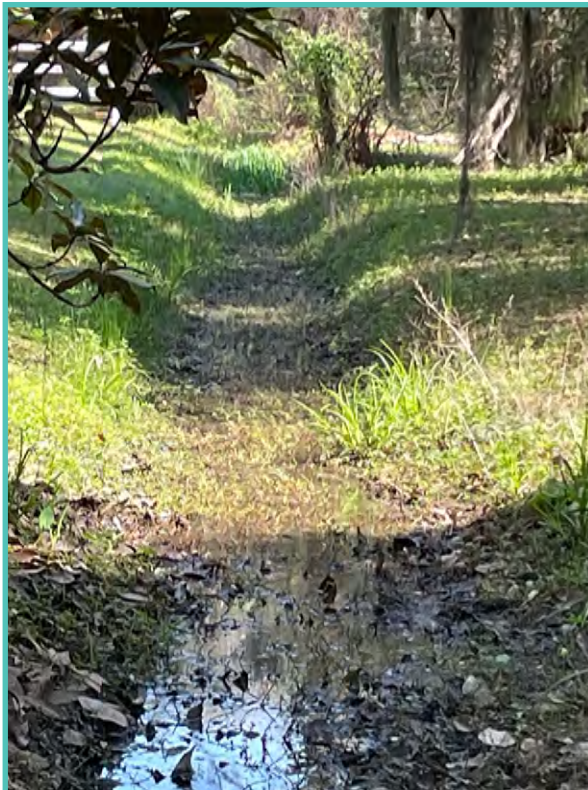
Channel Inventory ID: **42204**

Performance Condition: Poor

Actions: Remove vegetation.

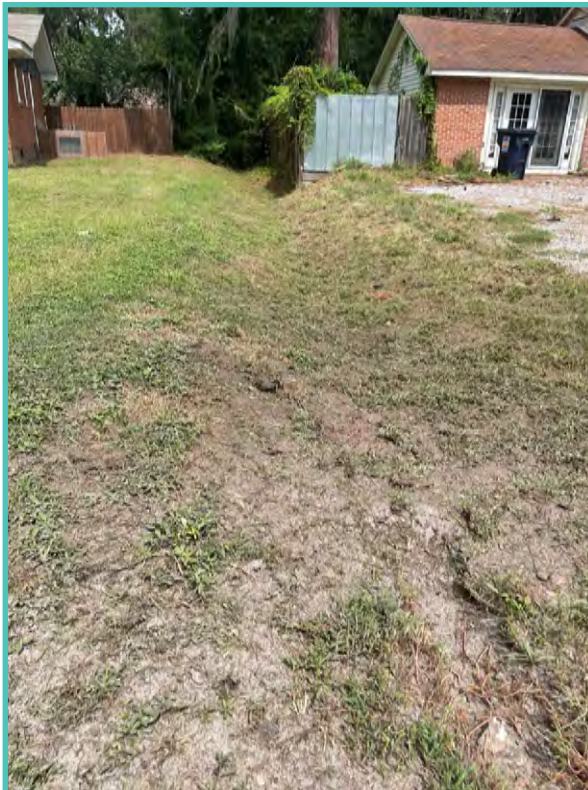
Channel Inventory ID: **42388**

Performance Condition: Good

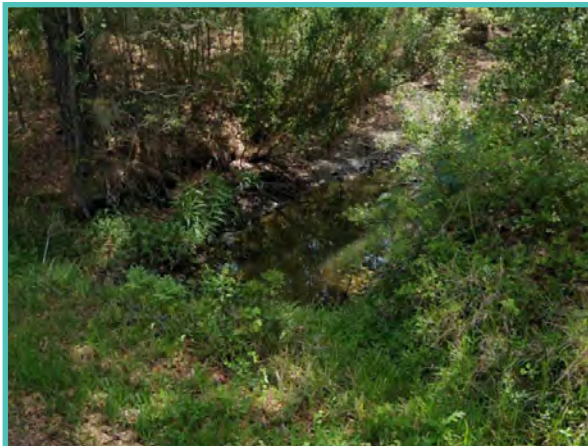
Channel Inventory ID: **45900**

Performance Condition: Poor

Actions: Daylight channel.

USACE Requirements: Nationwide #3 200-ft upstream and downstream of crossline pipe #35786. Requires work plan & checklist no permit.

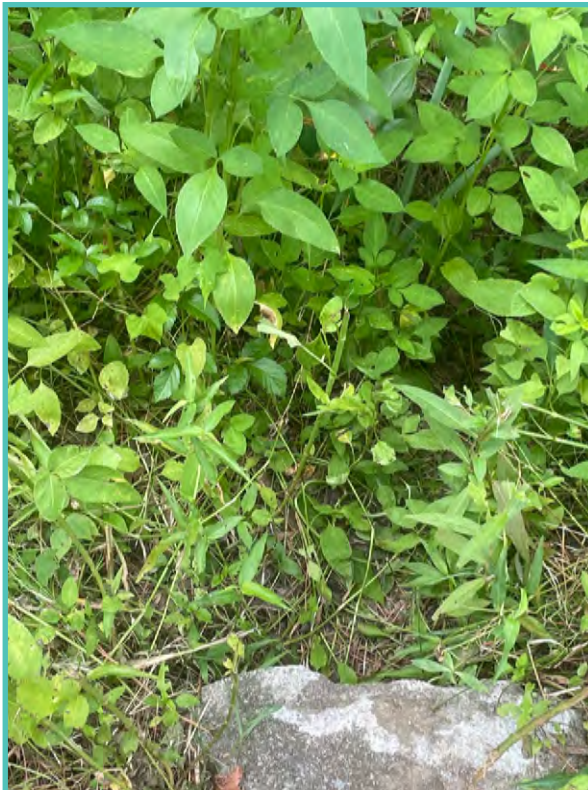
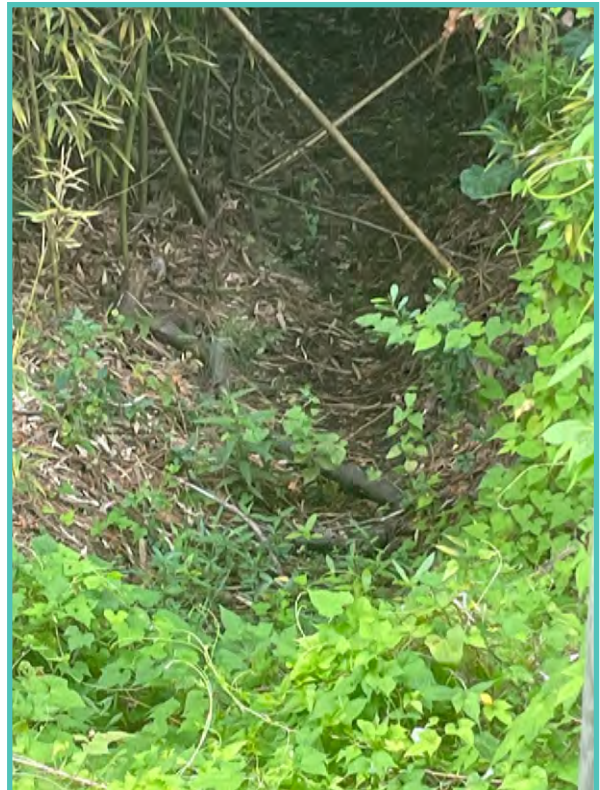
Channel Inventory ID: **51186**

Performance Condition: Poor

Actions: Remove vegetation, daylight channel.

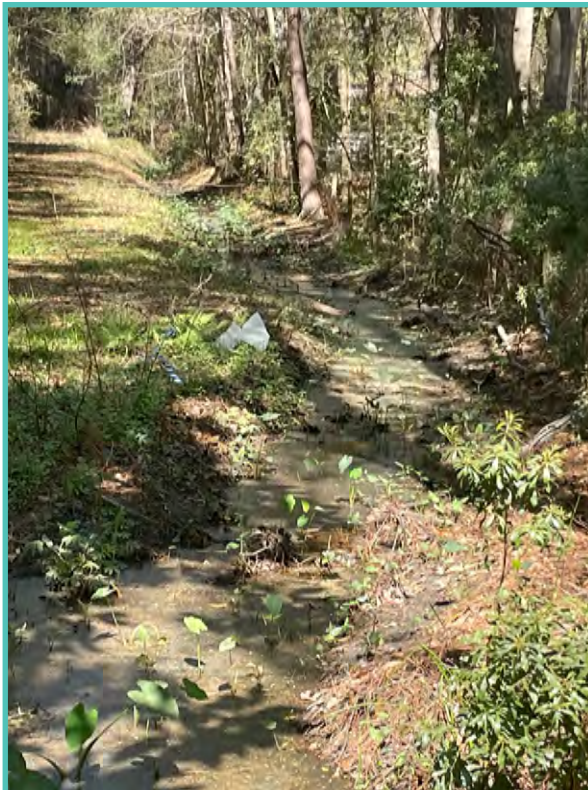
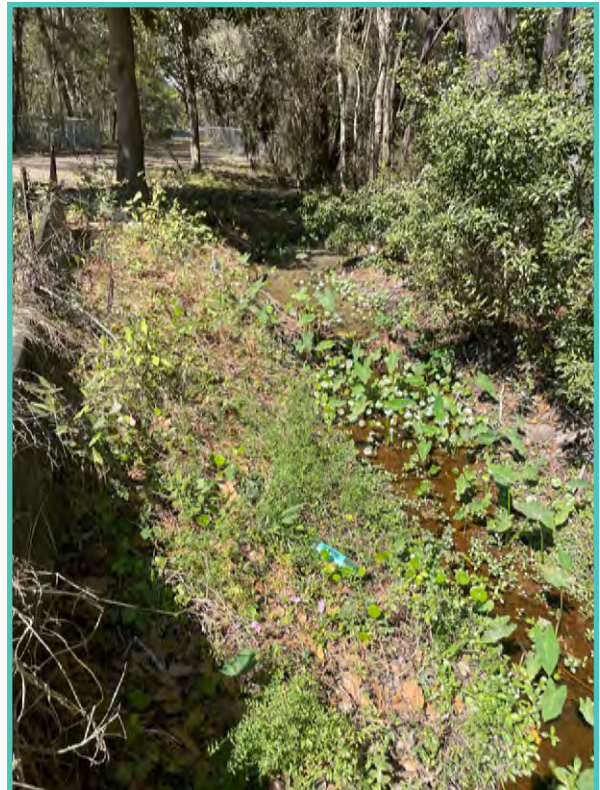
Channel Inventory ID: **51390**

Performance Condition: Good

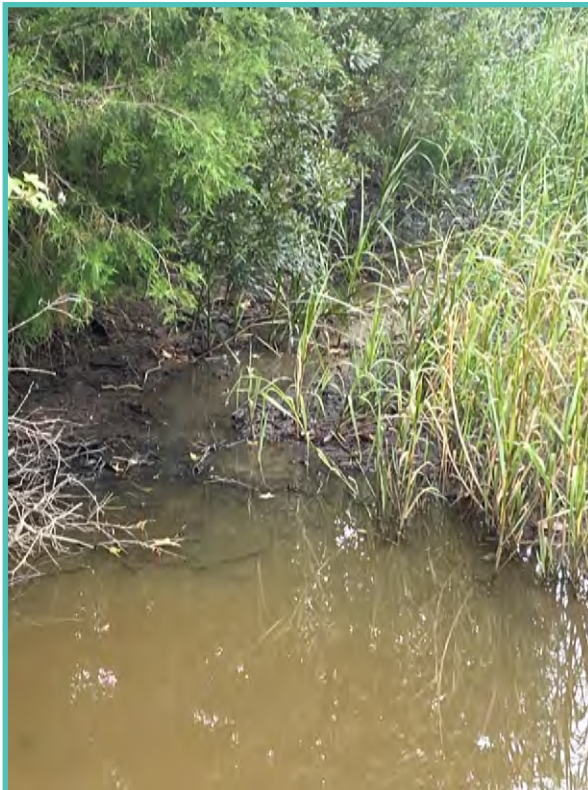
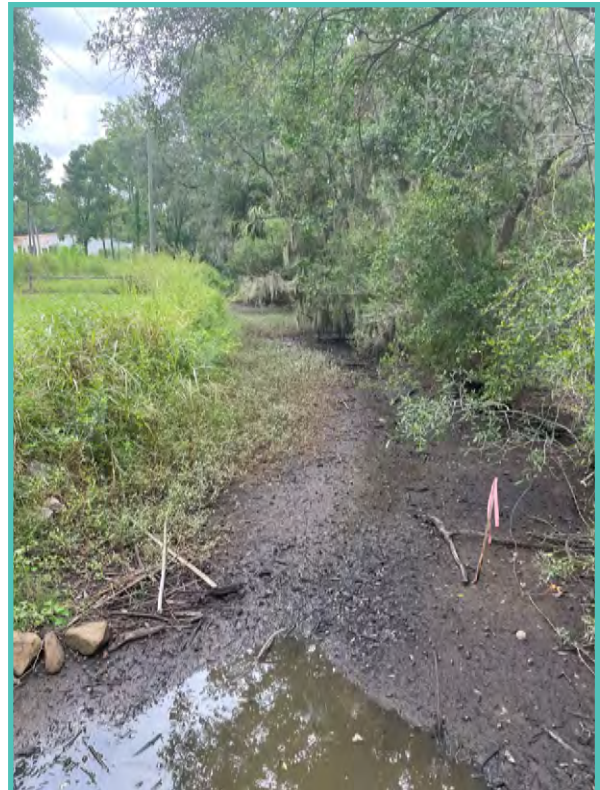
## Channel Inventory ID: **53705**

Performance Condition: Poor

Actions: 1. Overflow Bench  
2. Daylight and widen channel

USACE Requirements: 1. Individual permit and Mitigation.  
2. Individual permit and Mitigation.

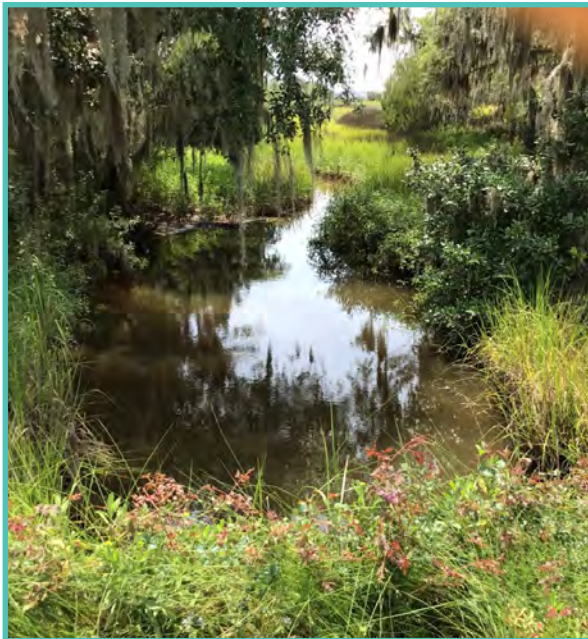
Channel Inventory ID: **None**

Performance Condition: Poor

USACE Requirements: 1. Daylight Channel

2. Dredge channel approximately 1000ft.

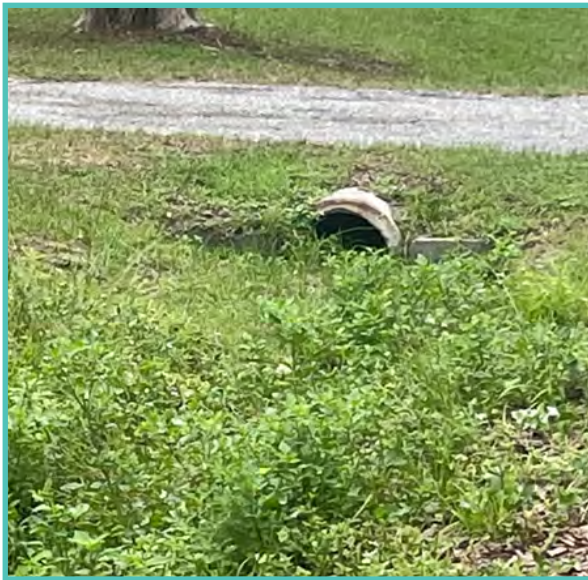
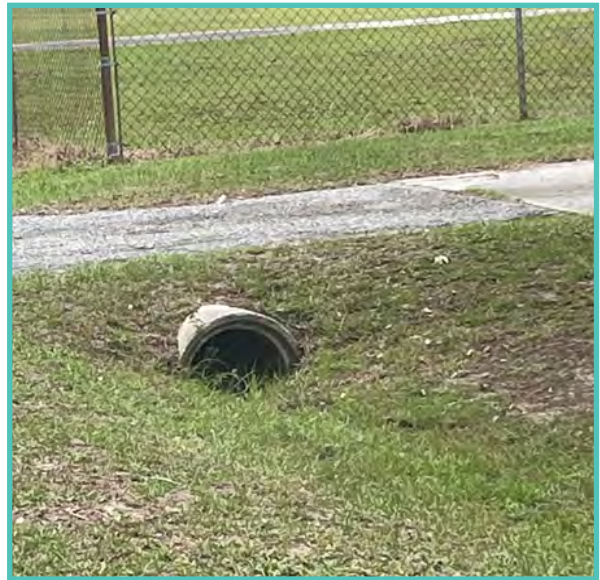
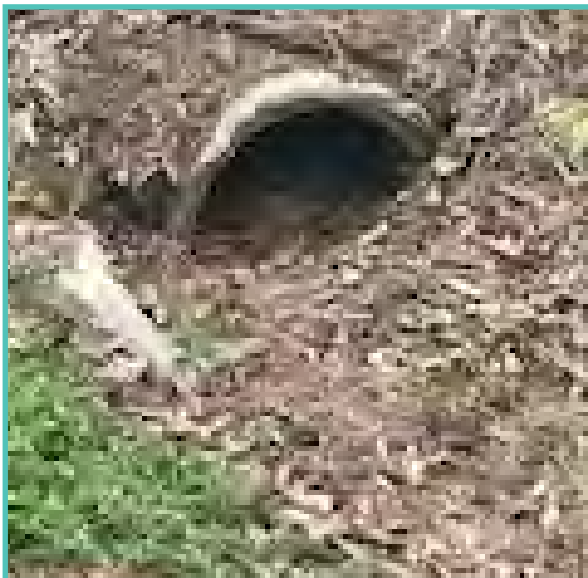
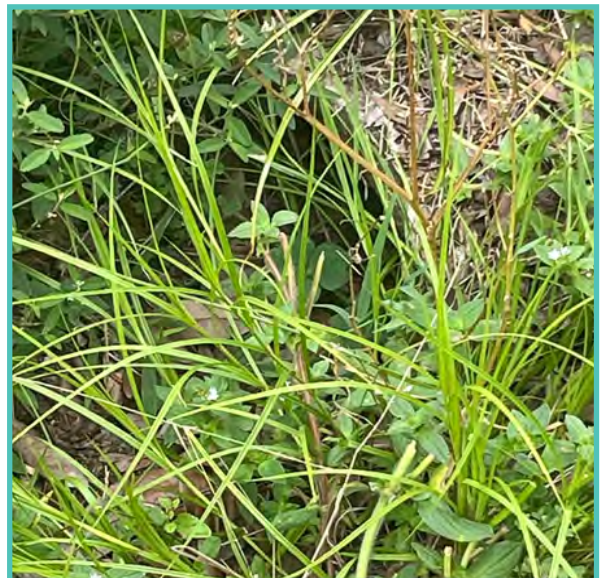
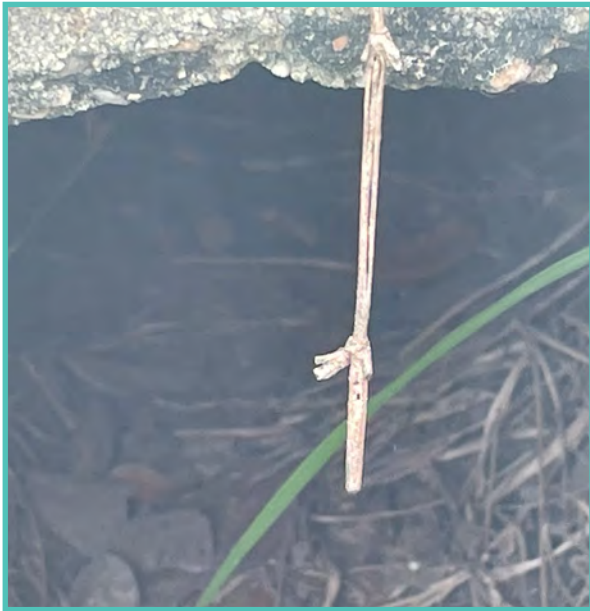
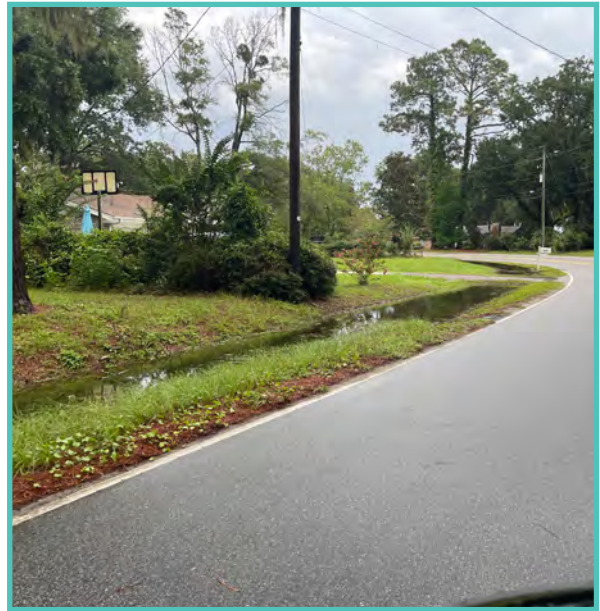
Notes: Both sides of roadway

Ditching Status: Most portions completed.

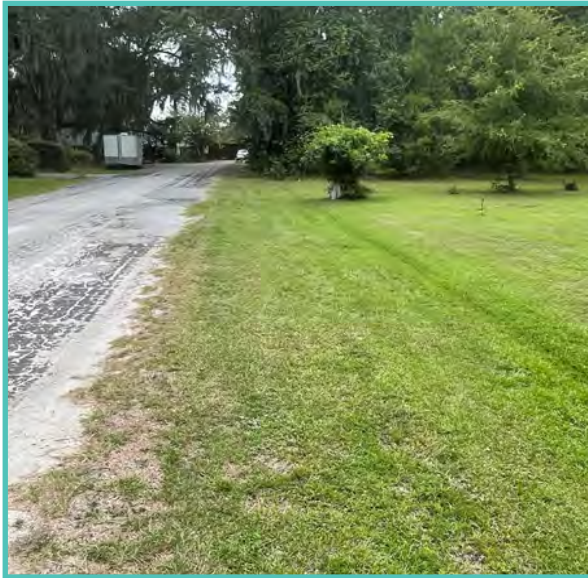
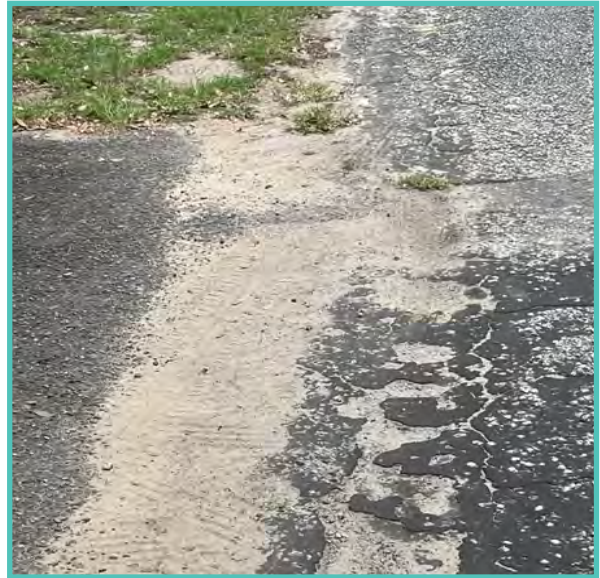
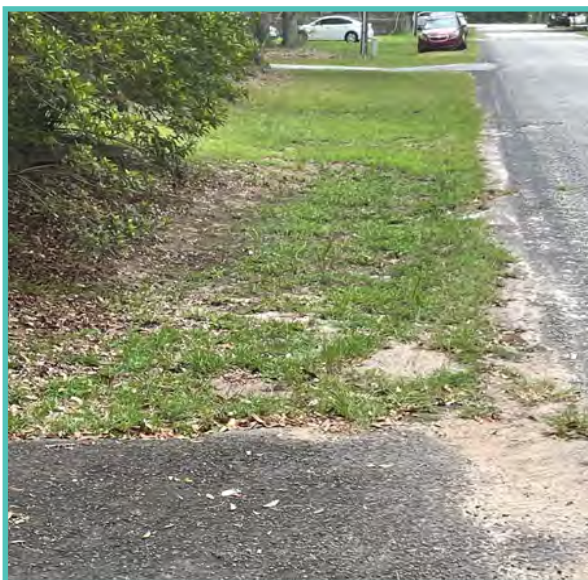
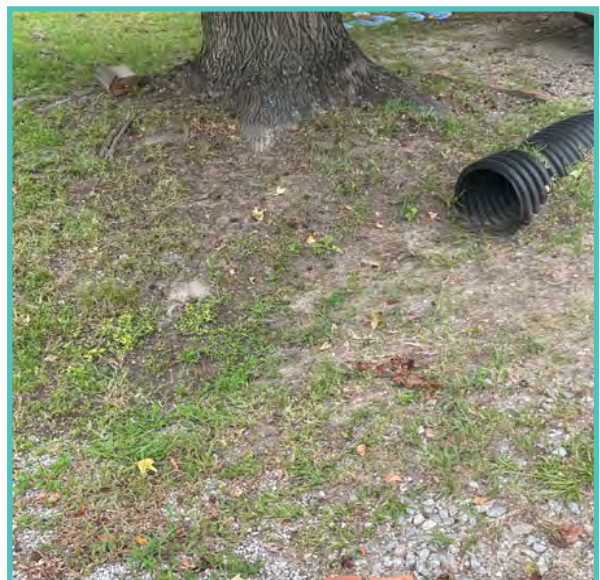
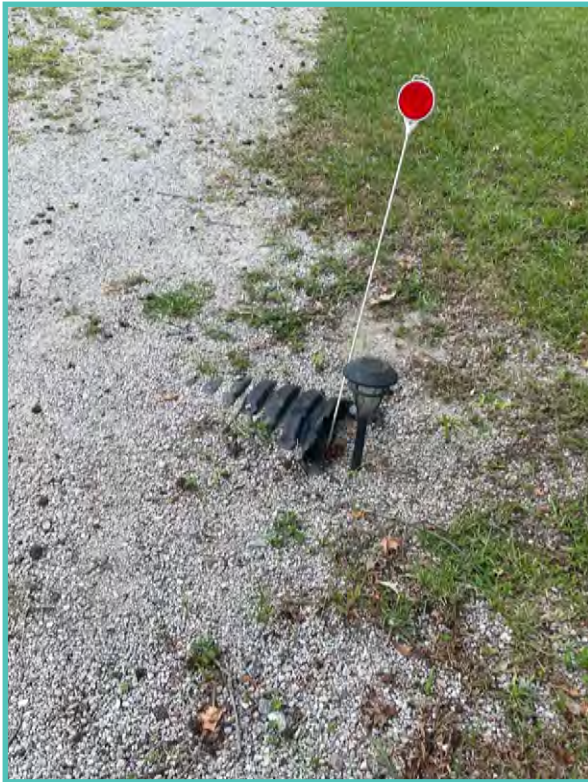
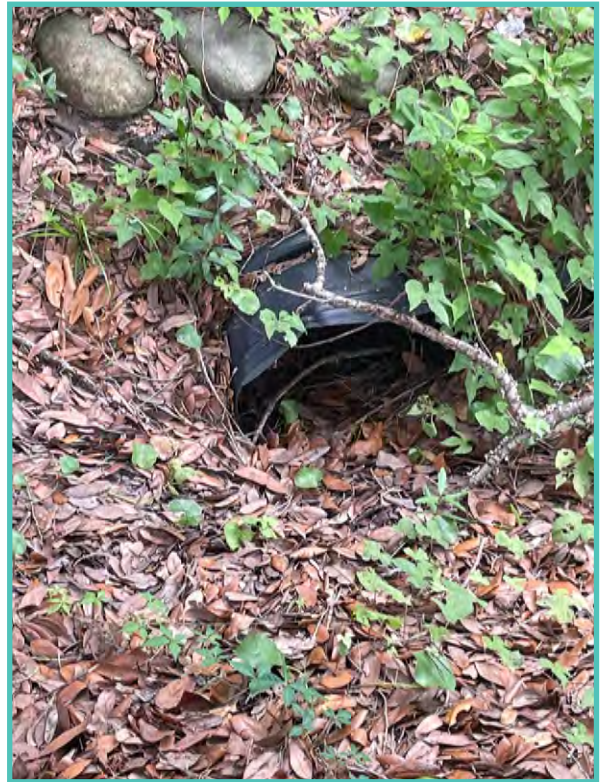
SCDOT Right-of-Way Inventory ID: **Ashwood Circle**

Notes: Partially completed on right side to Palmetto Ridge St

Ditching Status: No Status
