# STORMWATER MANAGEMENT SYSTEM CONDITION ASSESSMENT

## Shell Point Drainage Improvement Program

Beaufort County Stormwater  
120 Shanklin Rd  
Beaufort, SC 29906

April 2023

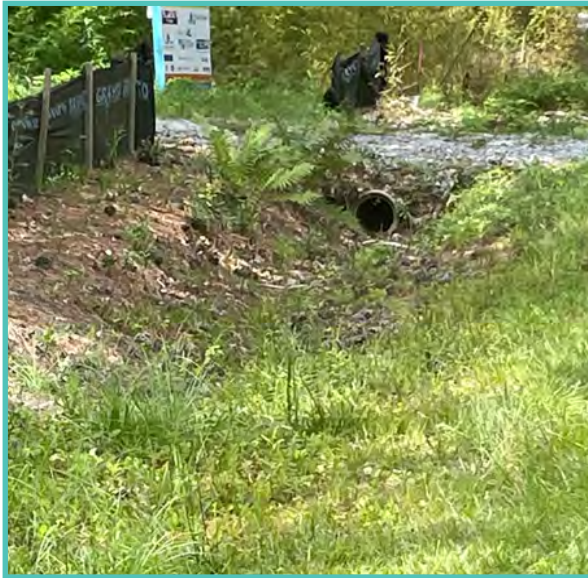
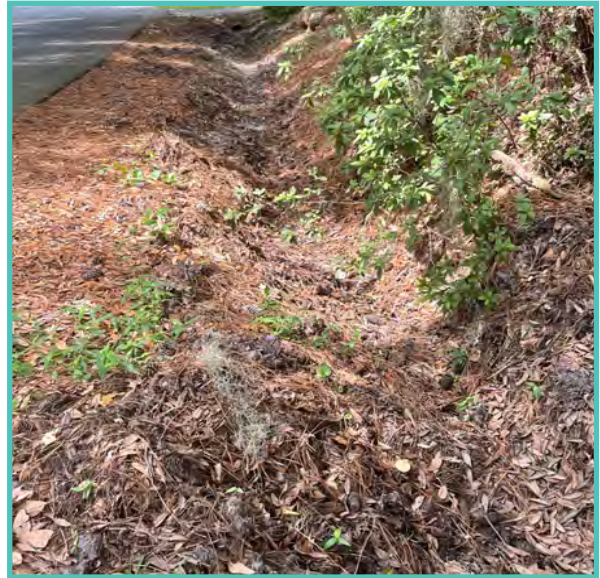
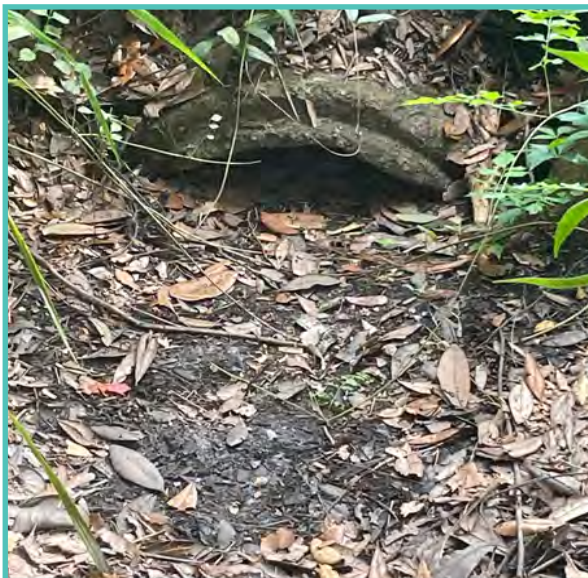
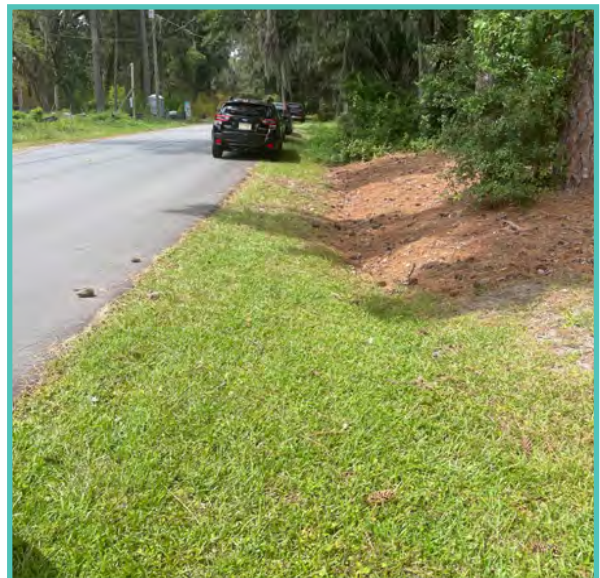
Notes:

Ditching Status: Not complete.

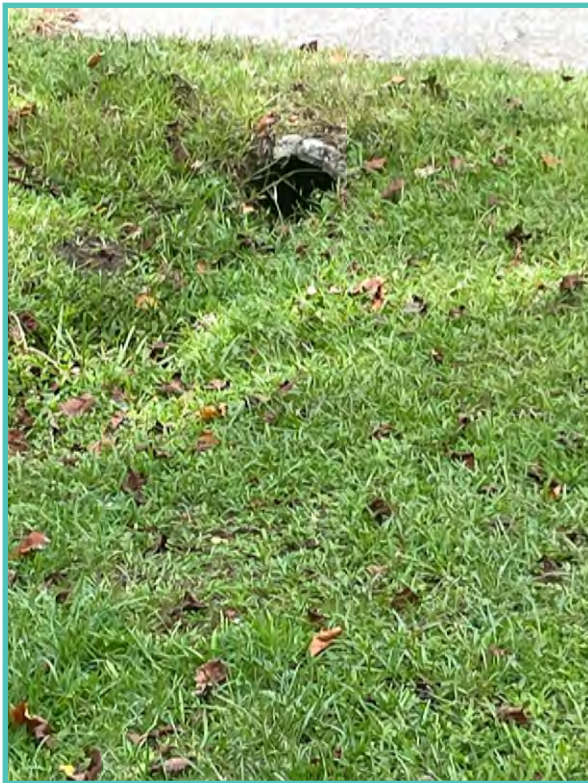
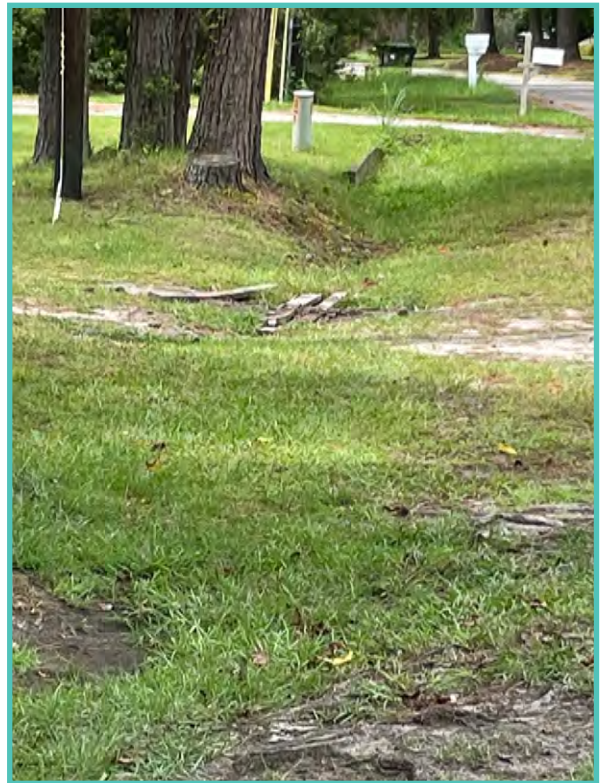
SCDOT Right-of-Way Inventory ID: **Palmetto Ridge Street**

Notes: Both sides of roadway completed

Ditching Status: Complete

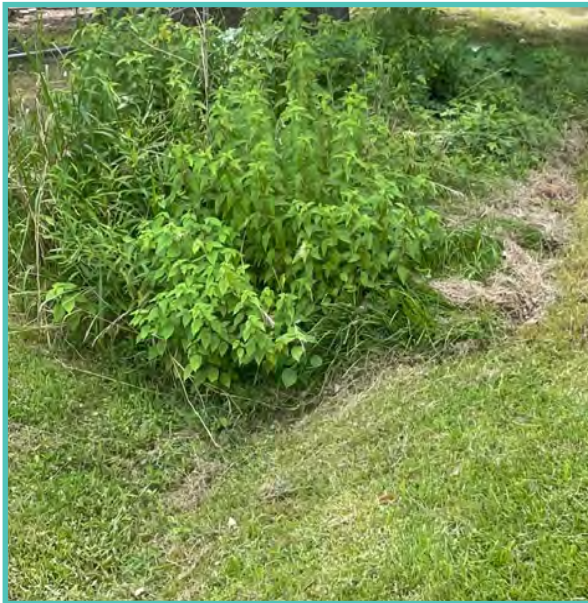
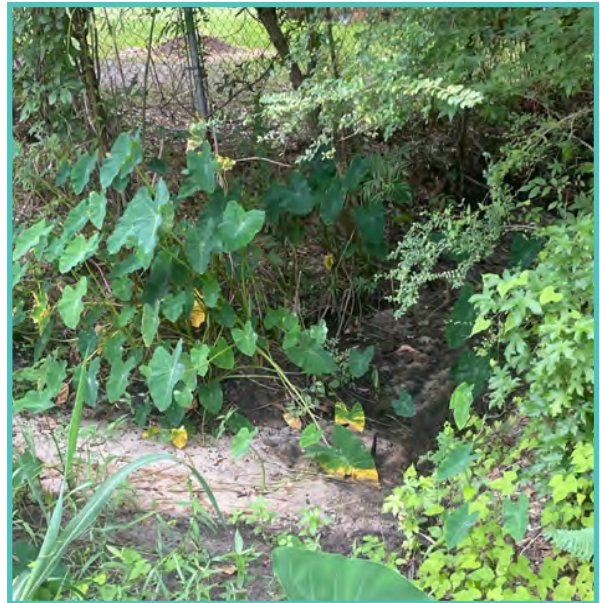
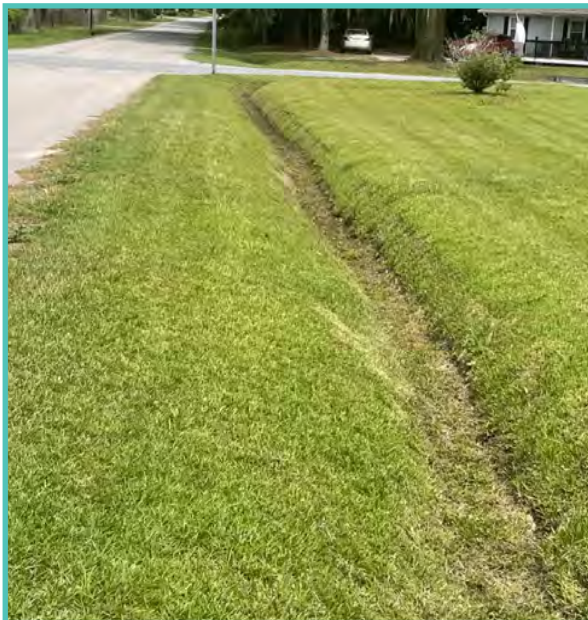
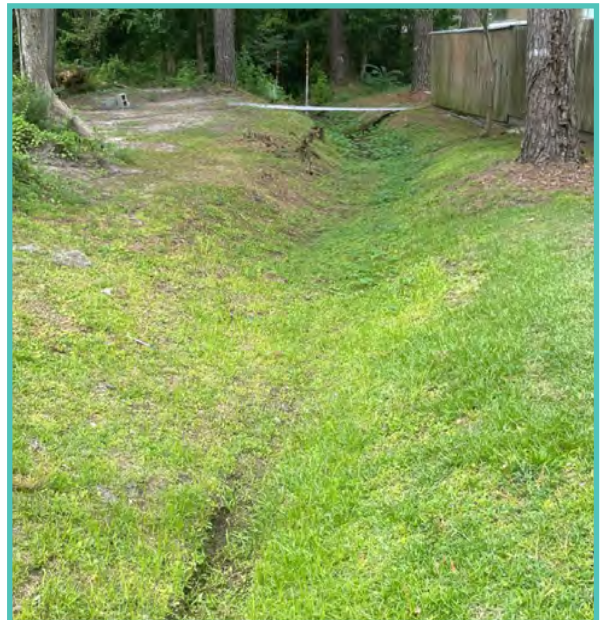
SCDOT Right-of-Way Inventory ID: **Hickory Street**

Notes: Both sides of roadway

Ditching Status: Complete

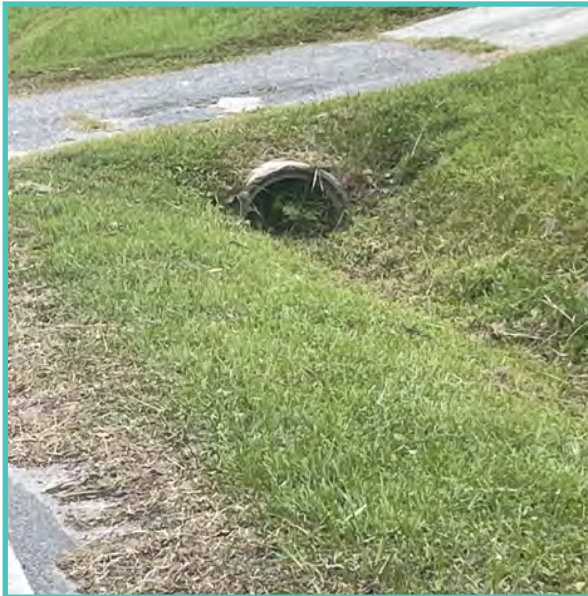
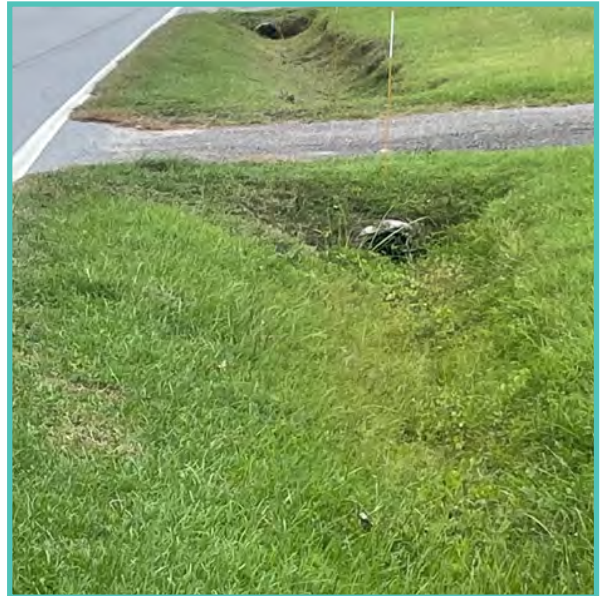
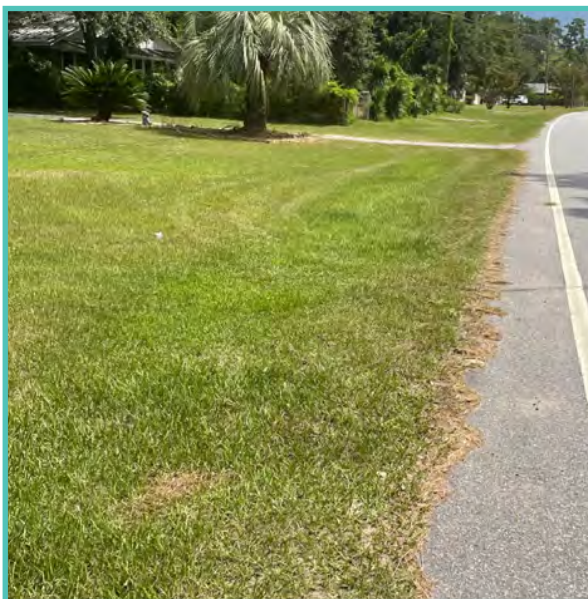
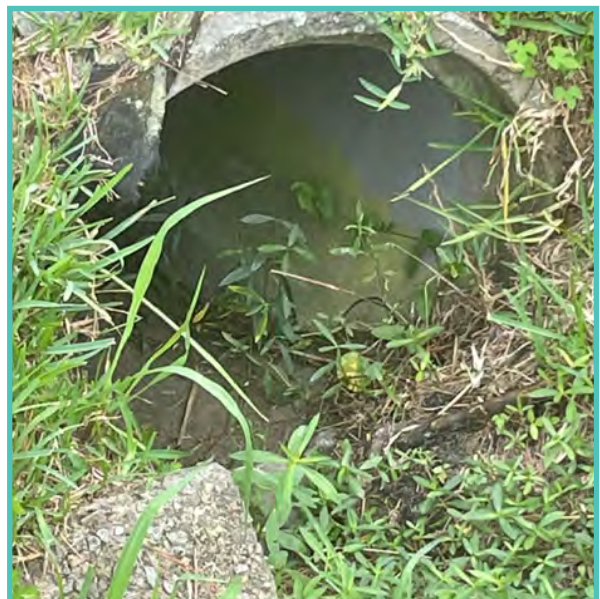
SCDOT Right-of-Way Inventory ID: **Shell Point Road**

Notes: Both sides of roadway

Ditching Status: Scheduled week of 2/27/2023

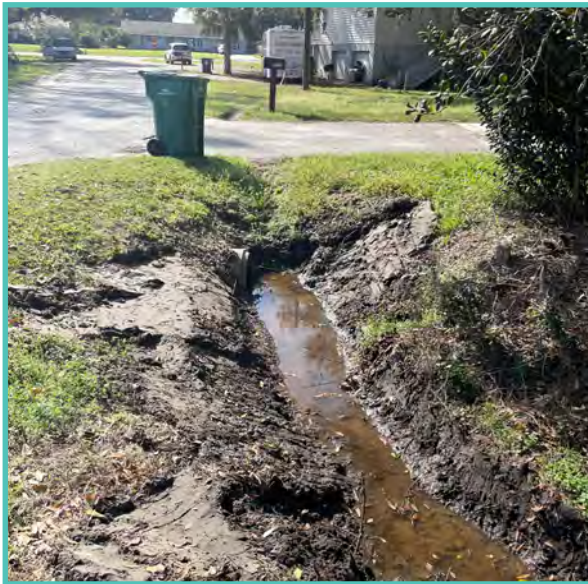
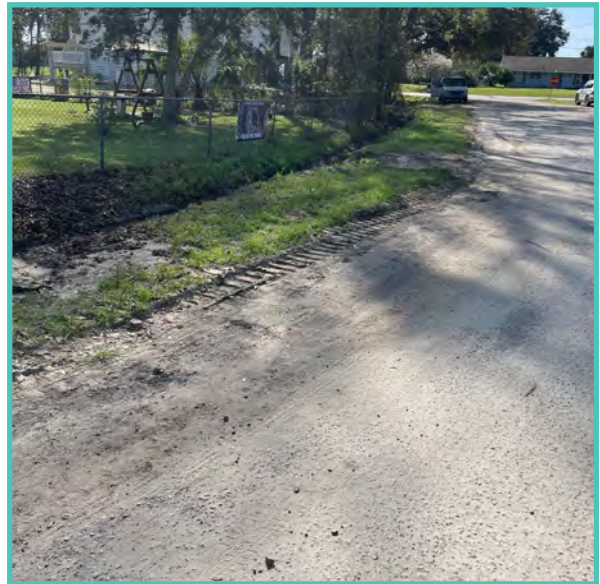
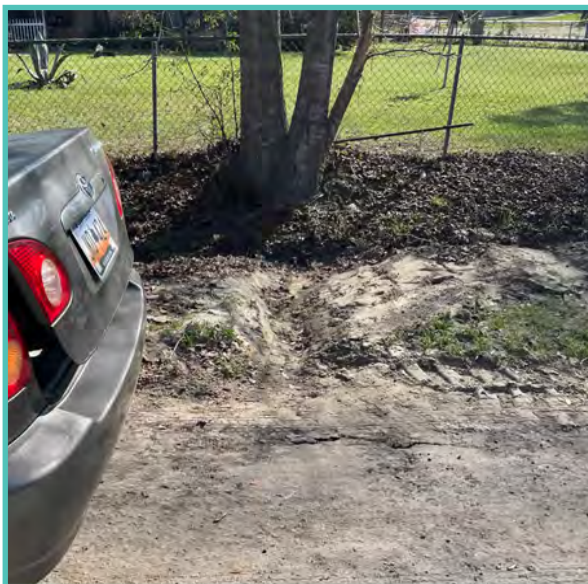
SCDOT Right-of-Way Inventory ID: **Morning Mist Drive**

Notes: Right side of roadway

Ditching Status: Complete

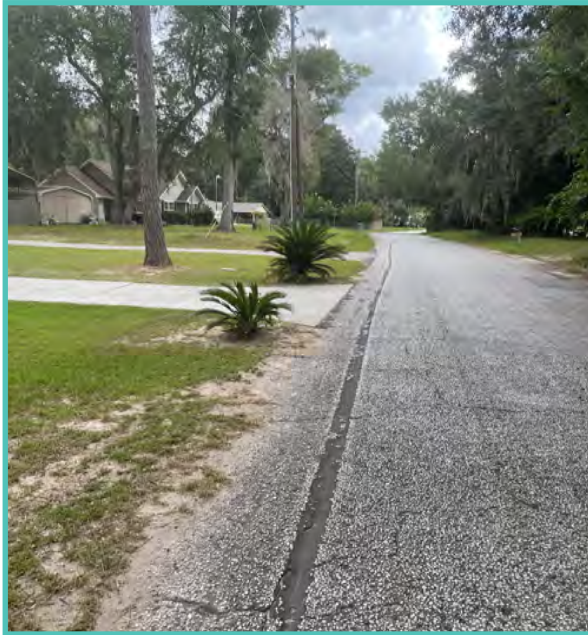
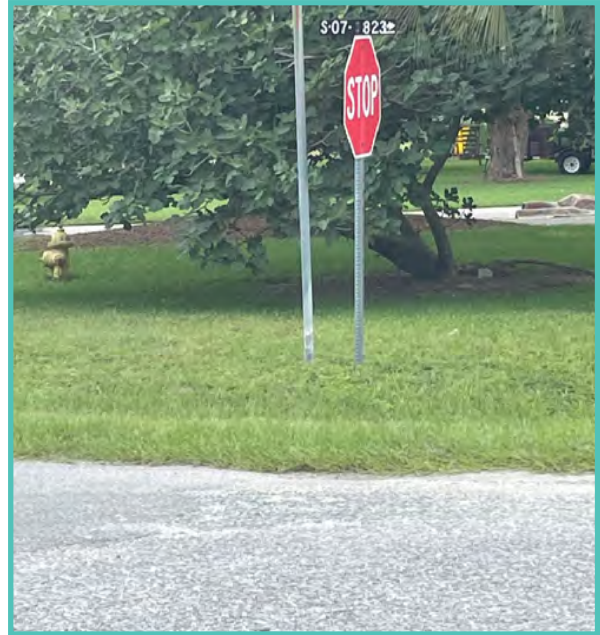
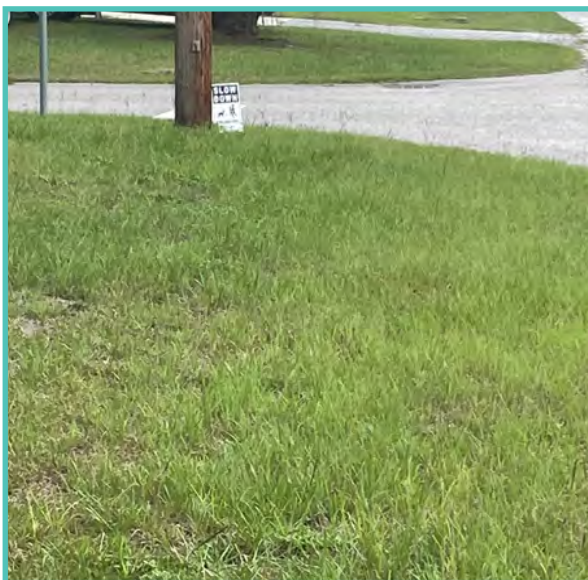
Notes: Both sides of road includes cleaning of culvert at 5003  
Green Pond Rd

Ditching Status: Scheduled week of 3/13/2023

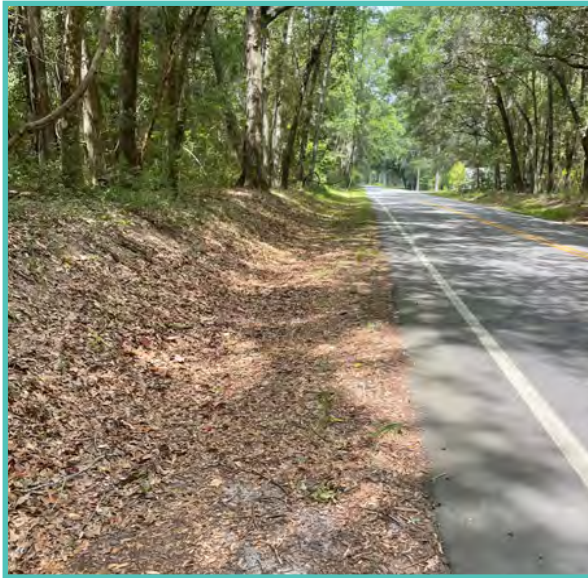
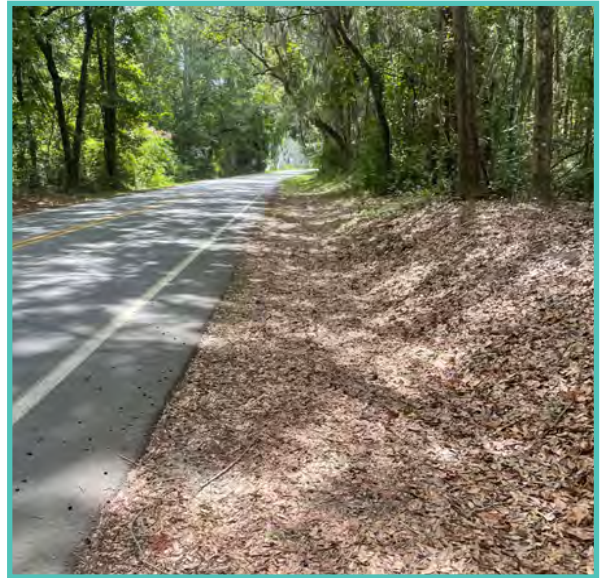
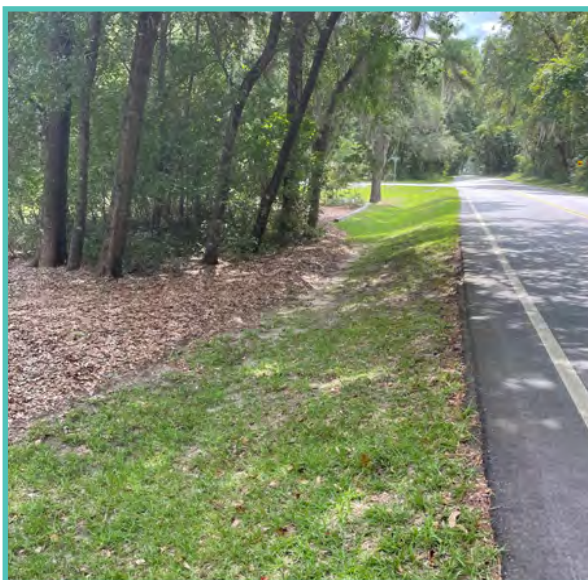
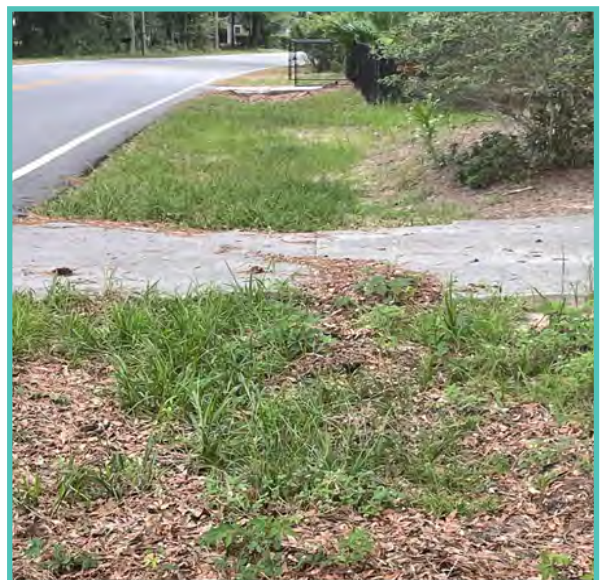
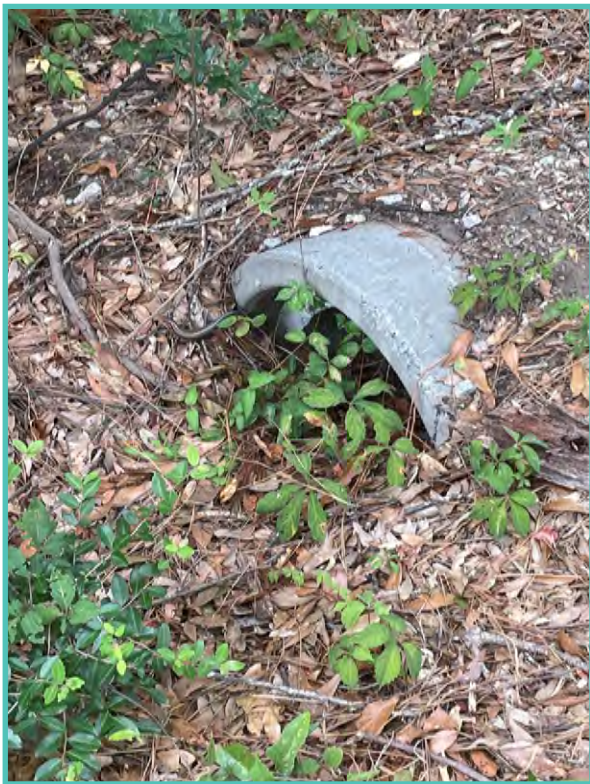
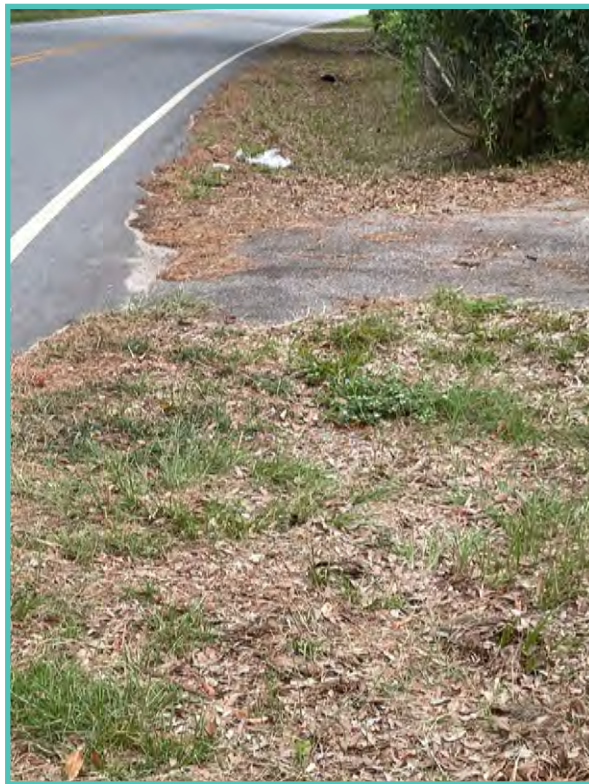
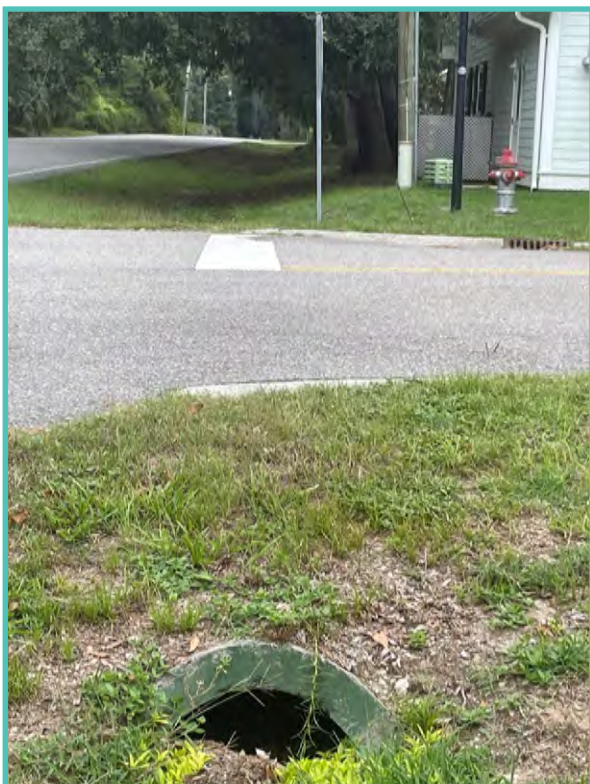
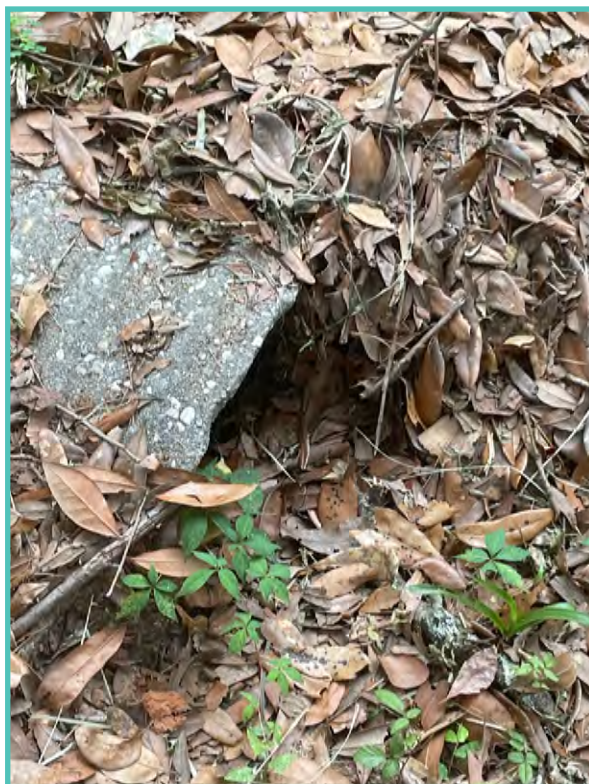
Notes:

Ditching Status: No Status
